Selection of Option for Replacement of Major Bridge Expansion Joints

Greg Forster, Roads and Traffic Authority, NSW

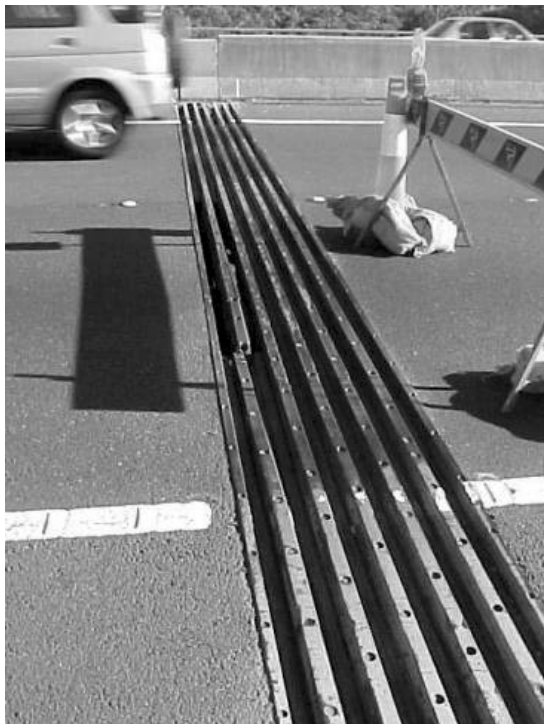
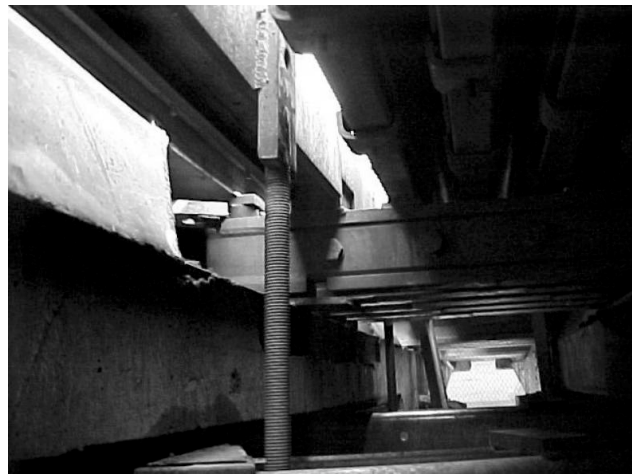
cantilevers, an asphalt correction was applied, and in the mid-1990s external post-tensioning was installed to lift the cantilevers. To match the asphalt correction, steel plates were welded to the tops of the joint centrebeams, with holes matching the seal anchor bolts locations provided in those plates. However, these holes acted as stress concentrations, and some time after welding the centrebeams fractured at some of the hole locations, after which mild steel plates were welded on both sides of fractured or severely cracked centrebeams.

Cropping of the webs at the ends of some support bars at the pivot of the swivel joints during joint fabrication resulted in early failure of some of the flanges of those bars, necessitating temporary maintenance to support the support bars. However, the cumulative damage that occurred to the joints led to the decision in mid-2002 to replace the joints, as unexpected failure of the joints could pose a severe hazard to traffic.

*State of Pheasants Nest
southbound bridge expansion
joint before replacement*
