# Condition assessment of a reinforced concrete jetty structure, its load capacity and suggested rehabilitation strategy

*Ahmad Shayan,\* Aimin Xu\* and Riahd Al-Mahaidi†*

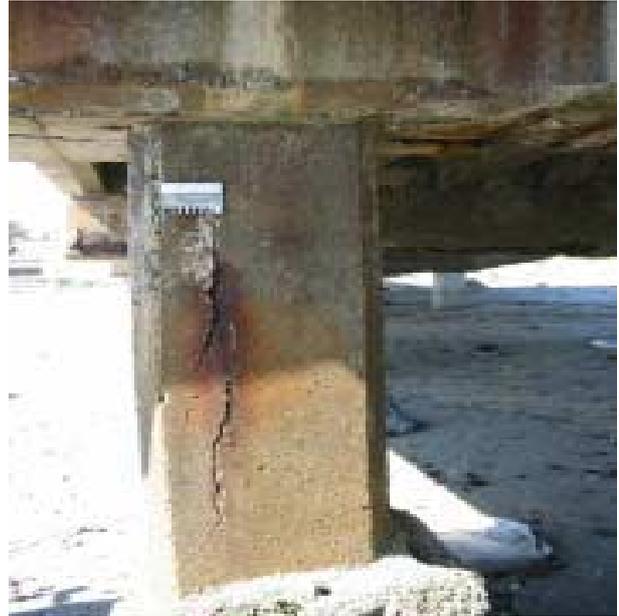
Many piles displayed large vertical cracks running parallel to the reinforcing bars at the corners of the piles (Figure 2). Rust stains are seen at some of the cracks and more at the junction of crosshead and pile. Delamination has occurred for some piles (Figure 3), where large cracks have developed at the two sides of one corner of the pile. In general, it appears that large cracks and delamination in piles mainly occur in bents near the shore. Approximate frequency of defects in the piles in the form of delamination, large cracks and rust staining, was 5%, 20% and 40%, respectively, of the total number of piles.

*Figure 2: Vertical cracking in pile caused by corrosion of steel bar*

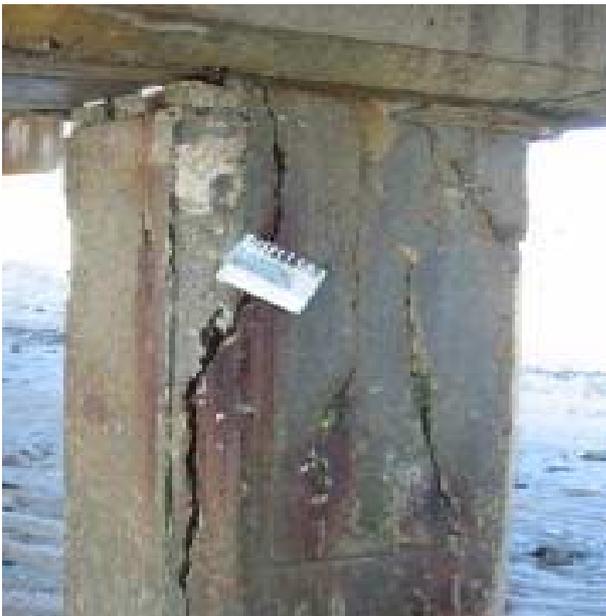
*Figure 3: Cracking and delamination in pile induced by corrosion*

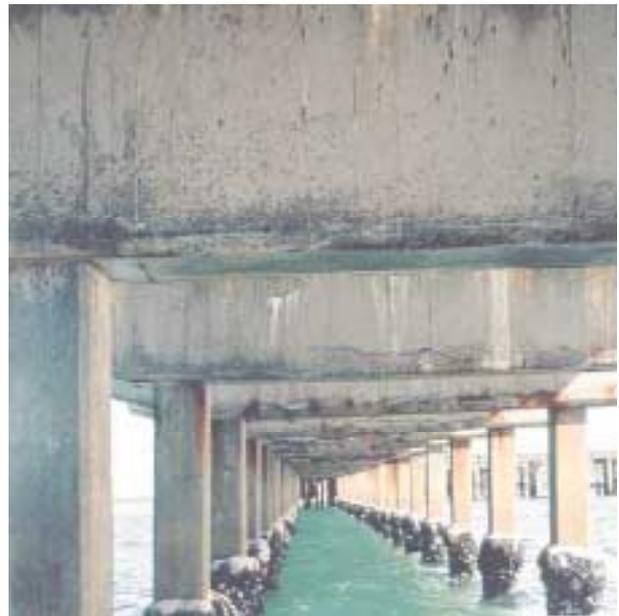
Reinforcement corrosion has occurred in most crossheads. Large cracking was present along the main reinforcing bars at the lower part of crossheads, about 100 mm from the soffit, and traverses the distance between the piles (Figure 4). Many crossheads have suffered delamination at this part, and large areas of spalling has occurred for some of the crossheads

*Figure 4: Cracking with rust stains appearing at lower part of crossheads*

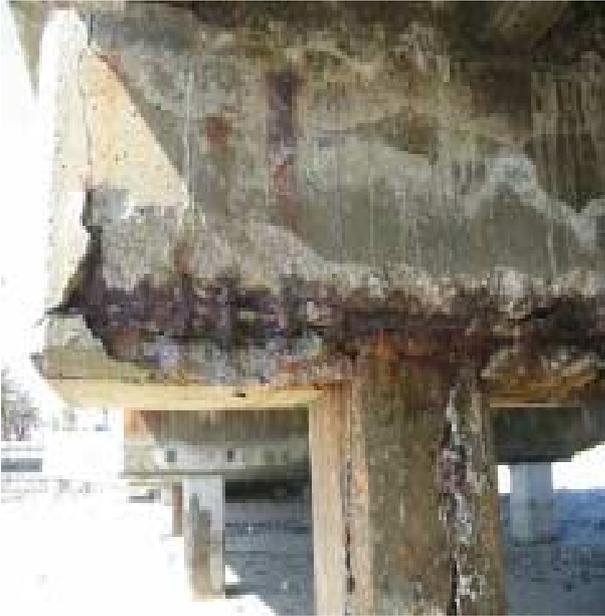
(Figure 5, 6). Significant loss of steel was noted in some of the stirrups in the spalled areas, and some stirrups appeared to have broken at the soffit. A significant loss of stirrup sectional area may affect the shear capacity of the crossheads. Honeycombing was also seen at the bottom edges of some crossheads (Figure 7). The steel section loss due to corrosion, in a location where the rusted reinforcement was exposed, was about 1-1.5 mm in depth, i.e. the diameter of the main steel bars (7/8 inch bar = 22.2 mm) was reduced to about 19-20 mm, after clearing the rust.

***Figure 5: Spalling of cover concrete at crosshead soffit***

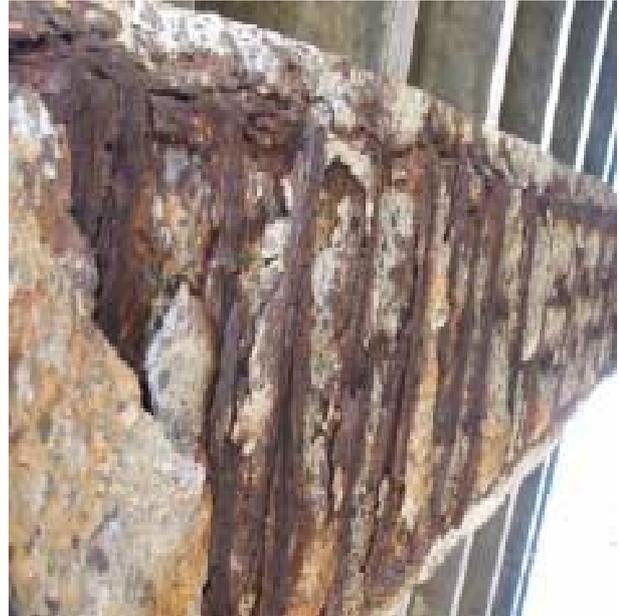
***Figure 6: Complete delamination of cover concrete at crosshead soffit***

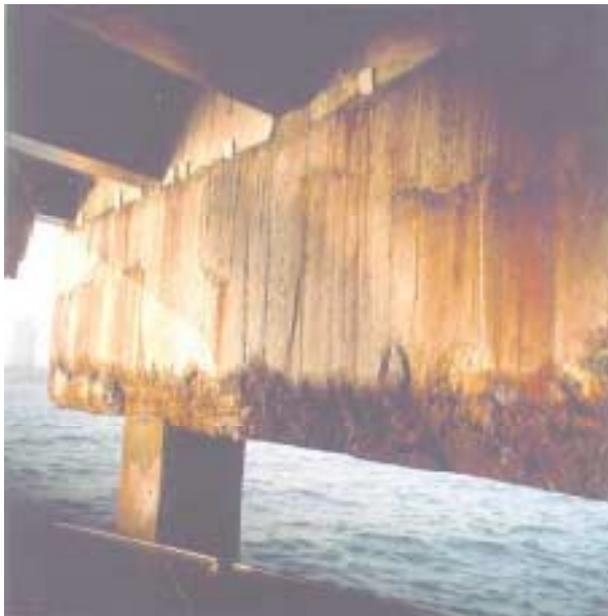
Corrosion of the upper main reinforcing bars has also caused cracking, but only in some of the crossheads. Scaling and efflorescence were common on crosshead surfaces, particularly at the crack sites.

***Figure 7: Cracking along the upper reinforcing bars and honeycombing at the bottom edge of crosshead***

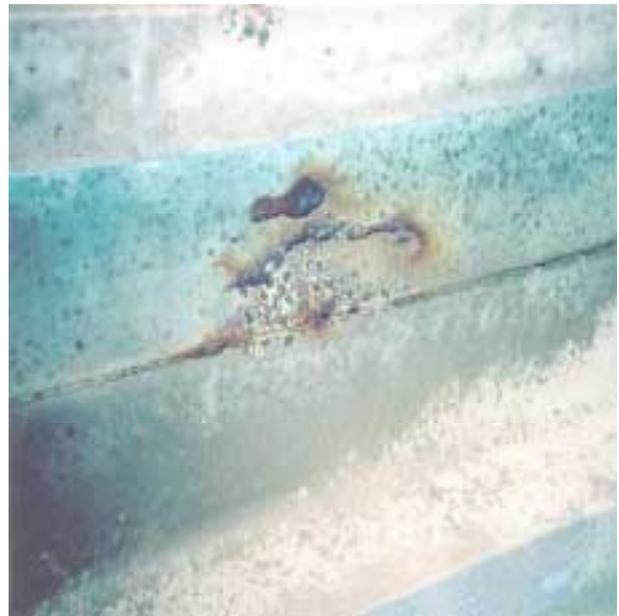
Some local reinforcement corrosion and small cracking have occurred at edges and corners of the deck planks (Figure 8), and on side surfaces of double T-beams. Slight scaling was evident on the top surface and soffit of the deck. Concrete coring at the top of deck exposed steel bars which showed very slight corrosion at 79 mm and 85 mm, and a light corrosion at 55 mm. At the side of a double-T plank, exposed prestressing strands (depth of 72 mm) showed no signs of corrosion.

***Figure 8: Localised corrosion at the edge of deck plank Bent 77***

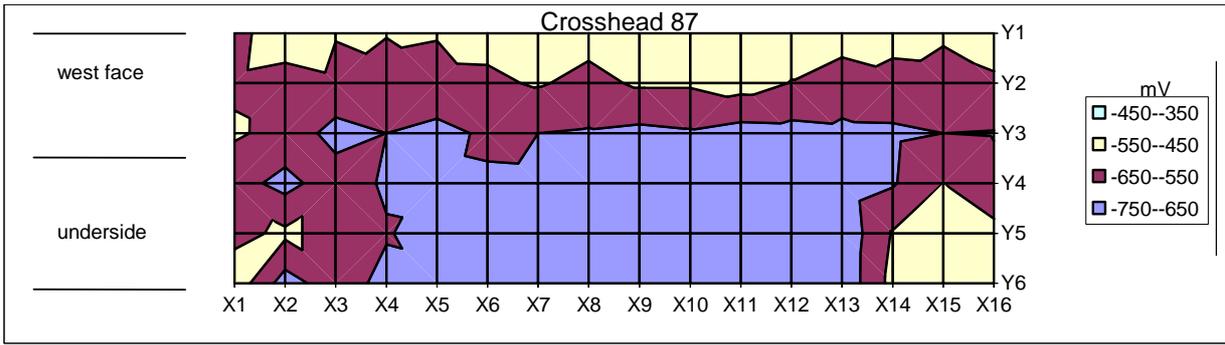
In Zone 1, both piles have shown half-cell potential values more negative than -450 mV CSE, and a high gradient in areas adjacent to the crosshead, indicating corrosion activity. The crosshead also showed a high corrosion activity, indicated by its very negative potential (-450 to -750 mV CSE), particularly in areas near the piles. The deck soffit showed corrosion activity near the crosshead area.

The same pattern was noted in Zone 2, where results indicated a high corrosion activity in the crosshead, and isolated corrosion spots in the deck slab and piles.

**Figure 9: Half-cell potential map showing elements tested**

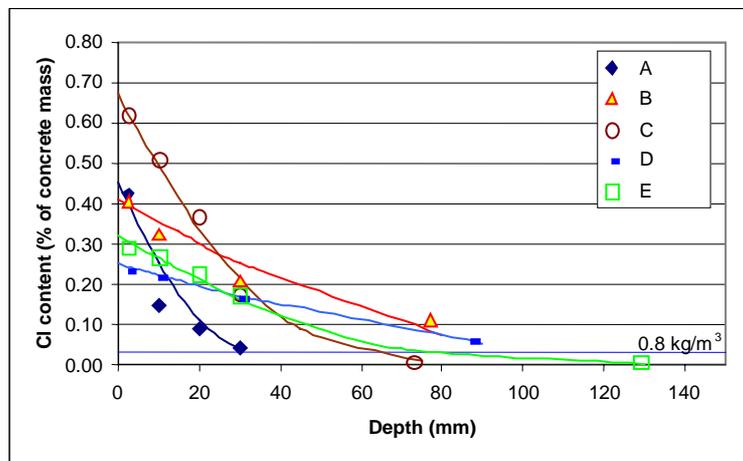
The  $Cl^-$  content at the concrete surface was generally high, due to the marine environment of this structure. At the depth of reinforcement,  $Cl^-$  content was higher than or near the acceptable value of  $0.8 \text{ kg/m}^3$ . The higher values refer to the deck plank soffits, and crosshead underside where the cover concrete is thin, and the chloride content is three times higher than the acceptable level.

**Figure 10: Chloride profiles for the elements tested. Both experimental points and fitted curves are shown**

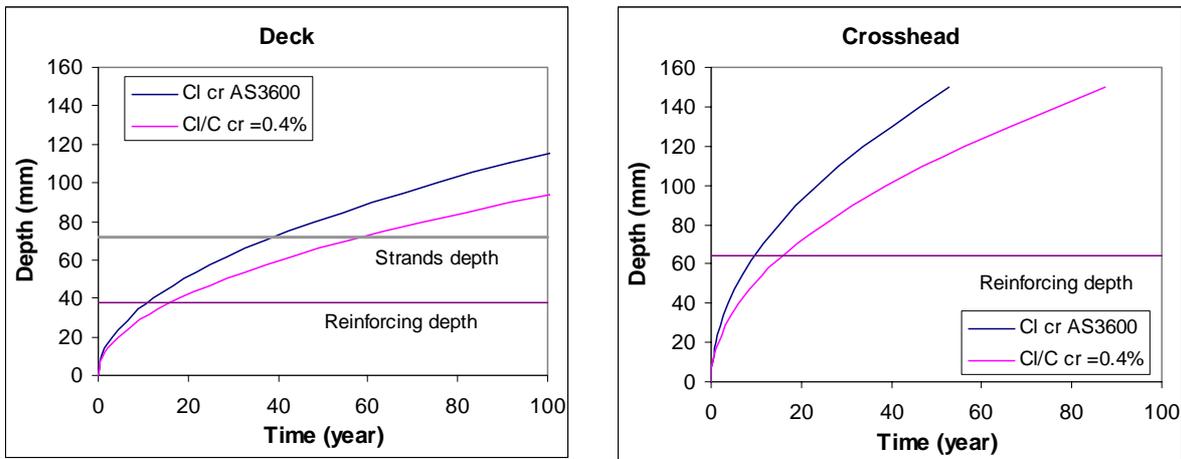
The predicted trends of chloride ingress (Figure 11) show that the critical chloride level for initiation of corrosion (0.4% by mass of cement) will reach the reinforcement level at around 16 years and 60 years for the crosshead and the deck respectively. Considering that the structure is 30 years old, the level in the crosshead was probably exceeded 14 years ago, and that in the deck will be reached in 30 years time.

**Figure 11: Prediction of chloride penetration into concrete for the deck and crosshead**

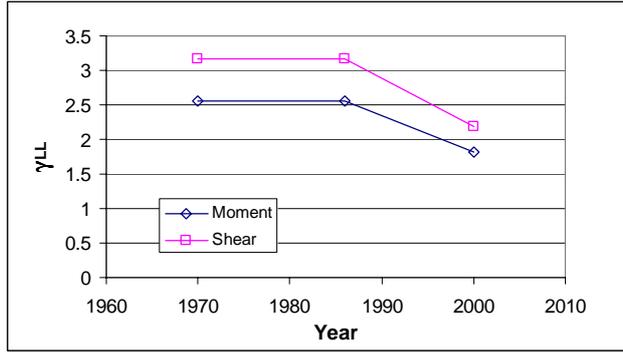
Based on the load distribution for single and double axle loading the  $\gamma_{LL}$  of crosshead, which is the worst deteriorated element of this structure was calculated and its values with time are plotted against time as shown in Figure 12. Alternatively, the trend can be presented in terms of axle load as shown in Figure 13 based on  $\gamma_{LL} = 1.5$ . Existing information from previous inspections were used to produce these graphs. The calculation for the present situation was based on our current results for strength of concrete and the rate of the reinforcing steel corrosion. It was also based on the current chloride profile, according to which the corrosion of reinforcing steel bars may have started in the late 1980s.

**Figure 12: The live load safety factors of deteriorated crosshead under 10 tonne double axle load**

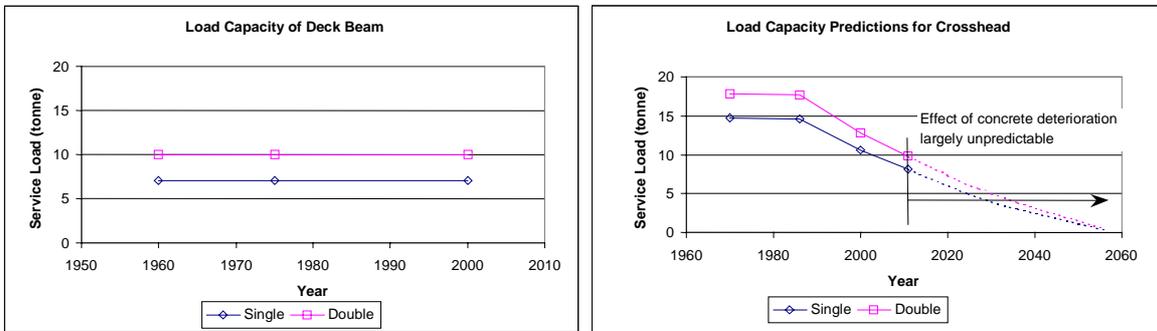
Figure 13 are load rating graphs for both the deck beams and the crossheads. Given the current condition of the crossheads and the anticipated future deterioration of these members, it is predicted that crossheads will become critical in the future while the condition of the deck beams will remain relatively stable. Hence, future life predictions are based on the condition of the crossheads as being critical. Of course, the structure should be re-inspected within 5 years to reassess the condition of its components and re-determine appropriate load ratings.

**Figure 13: The service load capacity of deck beams and crossheads**
