Learning the lessons from bridge collapses around the world

Mungo Stacy

Principal Engineer, Parsons Brinckerhoff

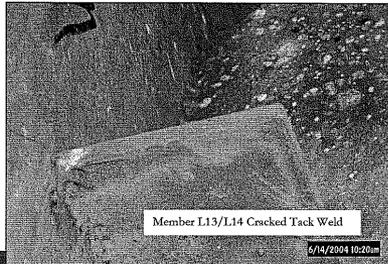
Water from deck drains fall directly into river. [99/2002] Bottom chord gusset plate has section loss, flaking & pack rust. [1999] Truss bottom chord member L13/L14 has cracked tack welds at two interior stiffeners. [2004] Bottom chord member L13/L14 cracked tack weld @ diagram tab (diagram #1?). Cracked tack weld @ diagram tab member L13/U14 see photos.

Bottom Chord Connection Condition

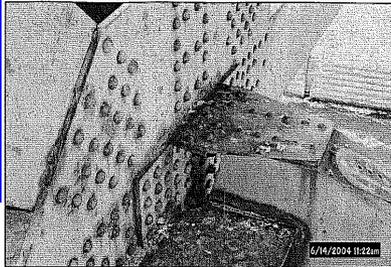
Panel Point #13 (East Truss):
Water from deck drains fall directly into river. [99/2002]
Bottom chord gusset plate has section loss, flaking & pack rust. [1999] Truss bottom chord member L13/L14 has cracked tack welds at two interior stiffeners. [2004] Bottom chord member L13/L14 cracked tack weld @ diagram tab (diagram #1?). Cracked tack weld @ diagram tab member L13/U14 see photos.

Bottom Chord Connection Condition

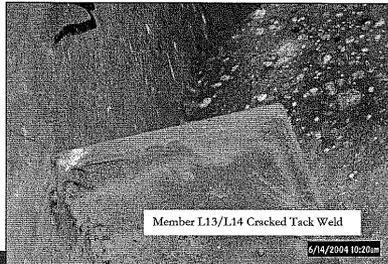
Member L13/L14 Cracked Tack Weld

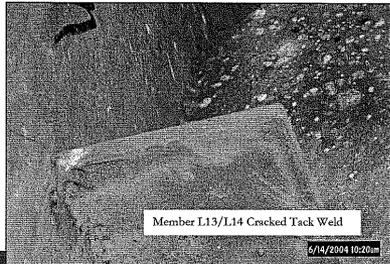
Water from deck drains fall directly into river. [9/9/2002] Bottom chord gusset plate has section loss, flaking & pack rust. [1999] Truss bottom chord member L13/L14 has cracked tack welds at two interior stiffeners. [2004] Bottom chord member L13/L14 cracked tack weld @ diagram tab (diagram #1?). Cracked tack weld @ diagram tab member L13/U14 see photos.

Bottom Chord Connection Condition

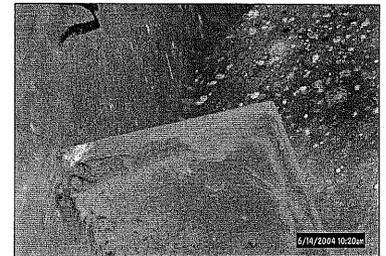
Water from deck drains fall directly into river. [9/9/2002] Bottom chord gusset plate has section loss, flaking & pack rust. [1999] Truss bottom chord member L13/L14 has cracked tack welds at two interior stiffeners. [2004] Bottom chord member L13/L14 cracked tack weld @ diagram tab (diagram #1?). Cracked tack weld @ diagram tab member L13/U14 see photos.

Condition @Bottom Chord Connection

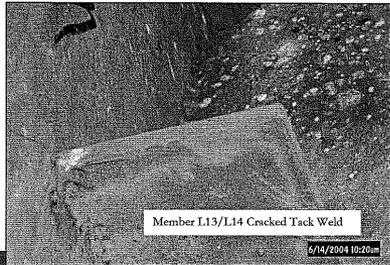
Water from deck drains fall directly into river. [99/2002] Bottom chord gusset plate has section loss, flaking & pack rust. [1999] Truss bottom chord member L13/L14 has cracked tack welds at two interior stiffeners. [2004] Bottom chord member L13/L14 cracked tack weld @ diagram tab (diagram #1?). Cracked tack weld @ diagram tab member L13/U14 see photos.

Bottom Chord Connection Condition

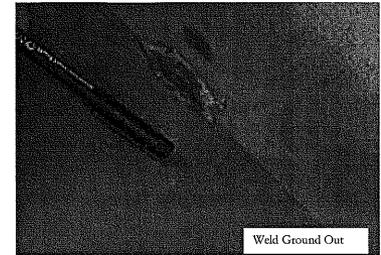
[1999] Truss bottom chord member L12/L13 has a cracked tack weld at an interior stiffener. [2004] Ground out pit from past inspection.

Weld Ground Out

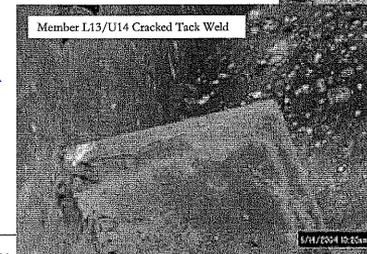
Water from deck drains fall directly into river. [1999] Truss bottom chord member L13/L14 has cracked tack welds at two interior stiffeners. [99/2002] Bottom chord gusset plate has section loss, flaking & pack rust. [2004] Bottom chord member L13/L14 has cracked tack weld @ diagram tab. Cracked tack weld at diagram tab member L13/U14. See photos. [2006] Bottom chord member L13/L14 has a missing bird cover.

Condition @ Bottom Chord Connection

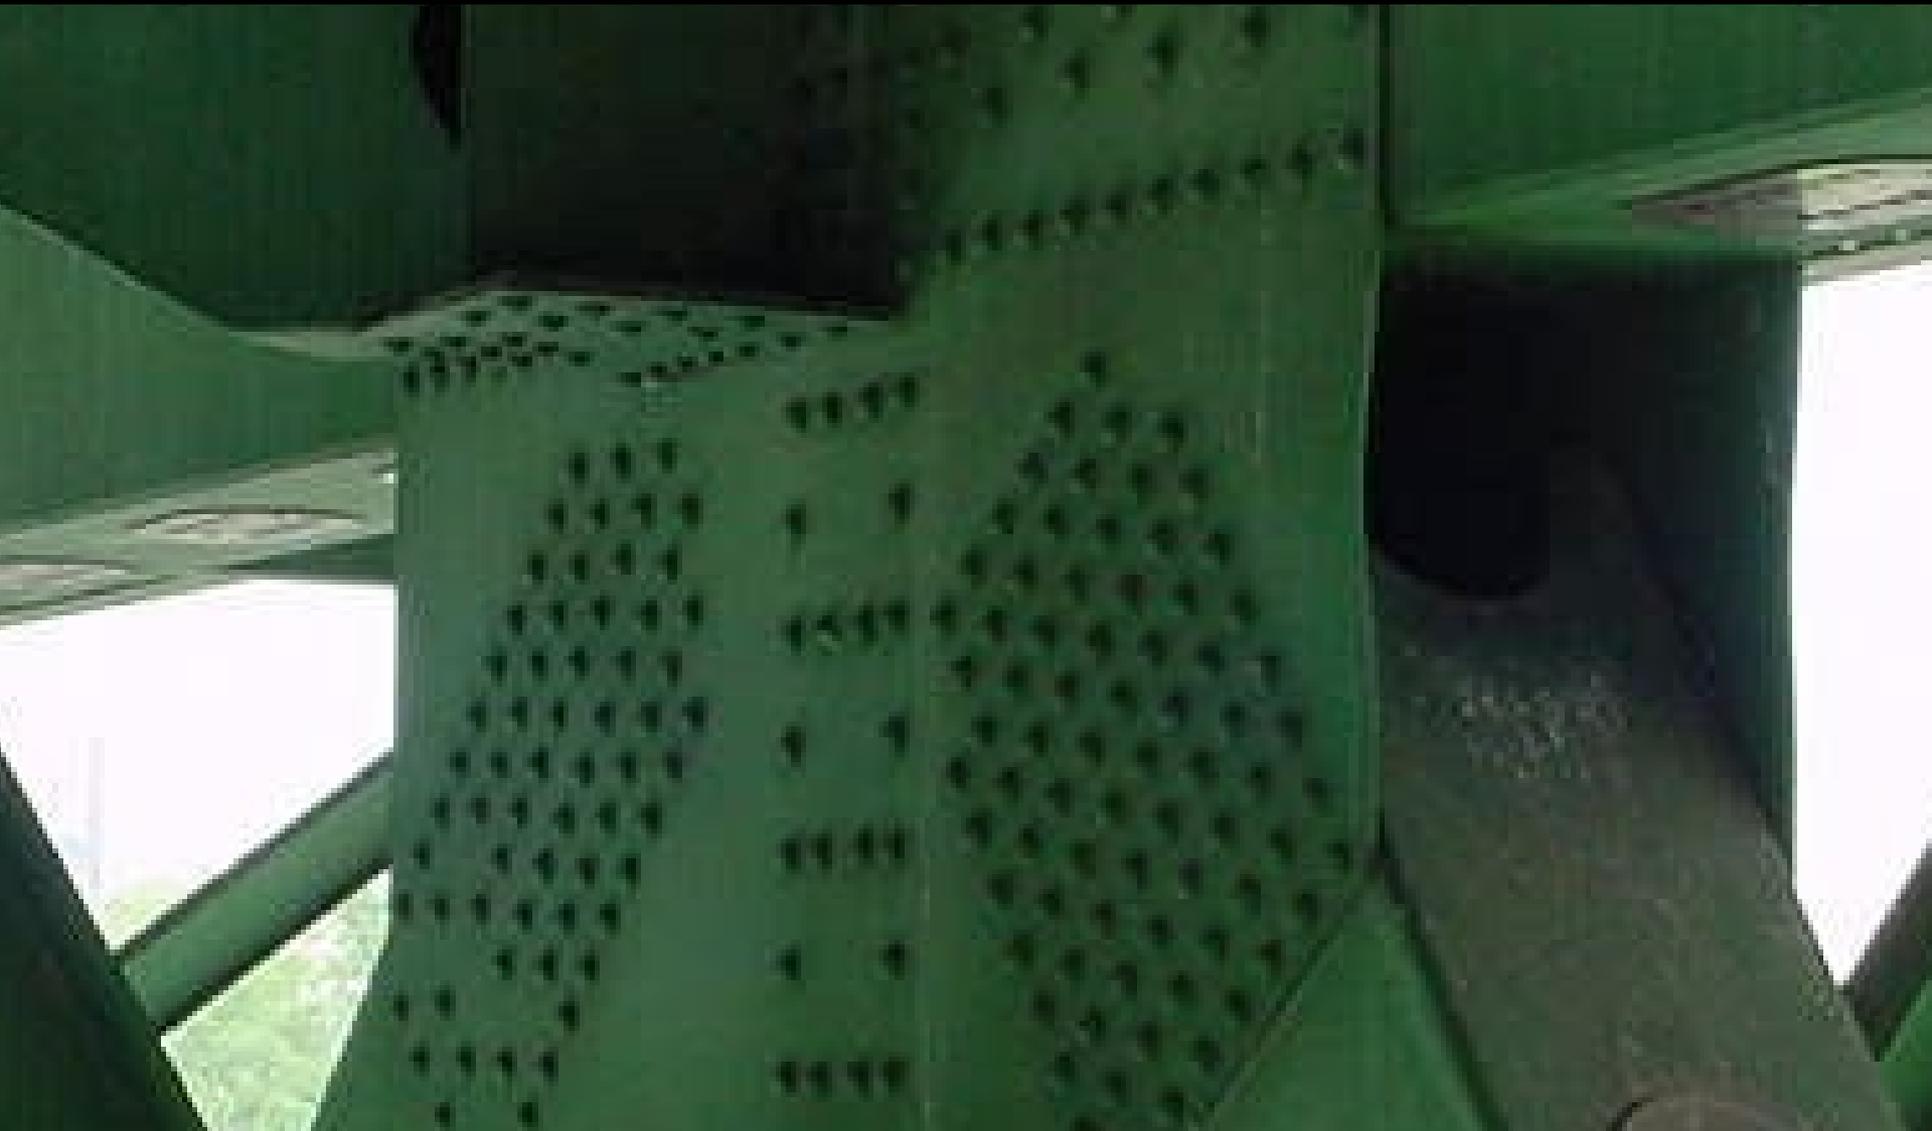
Gusset plate U10W - 2003

- inadequate load capacity of the gusset plates at the U10 nodes
- due to design error

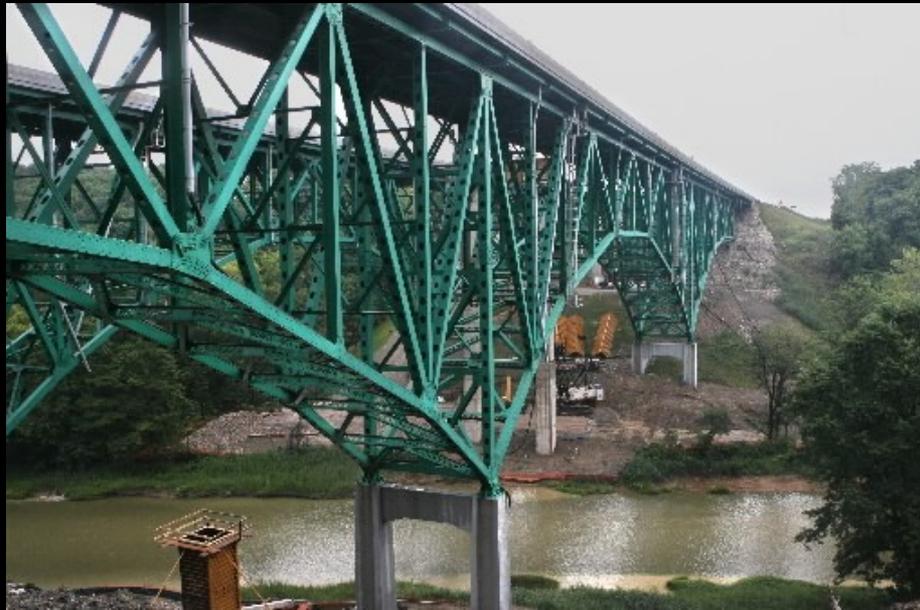
Grand River Bridge, Ohio

- Gusset plates buckled on 24 May 1996
- Construction traffic parked on bridge
- Gusset plate thickness inadequate

- Bridge repaired with thicker gusset plates
- Importance of inspecting gusset plates emphasised in Ohio bridge inspector training
- Article in Sept 1997 Civil Engineering magazine

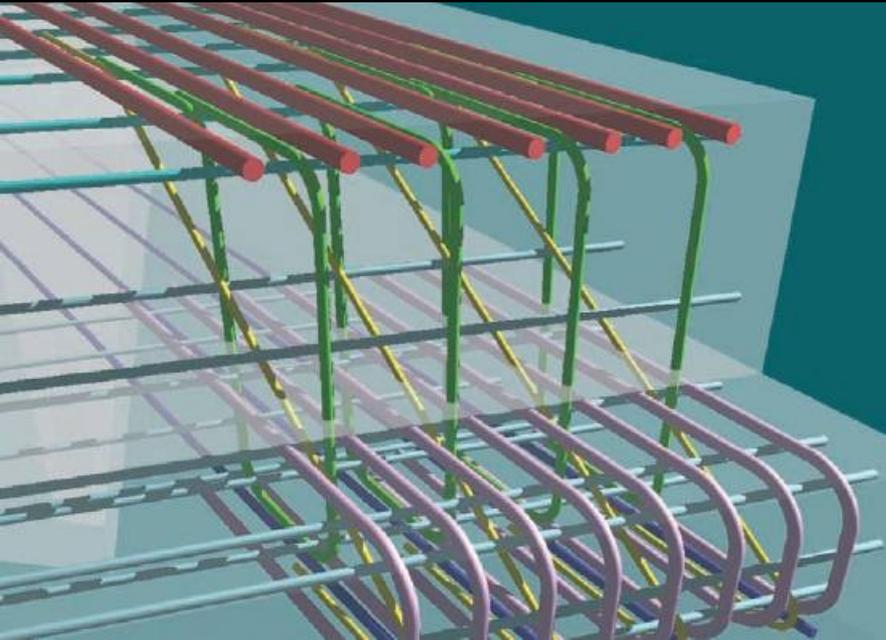
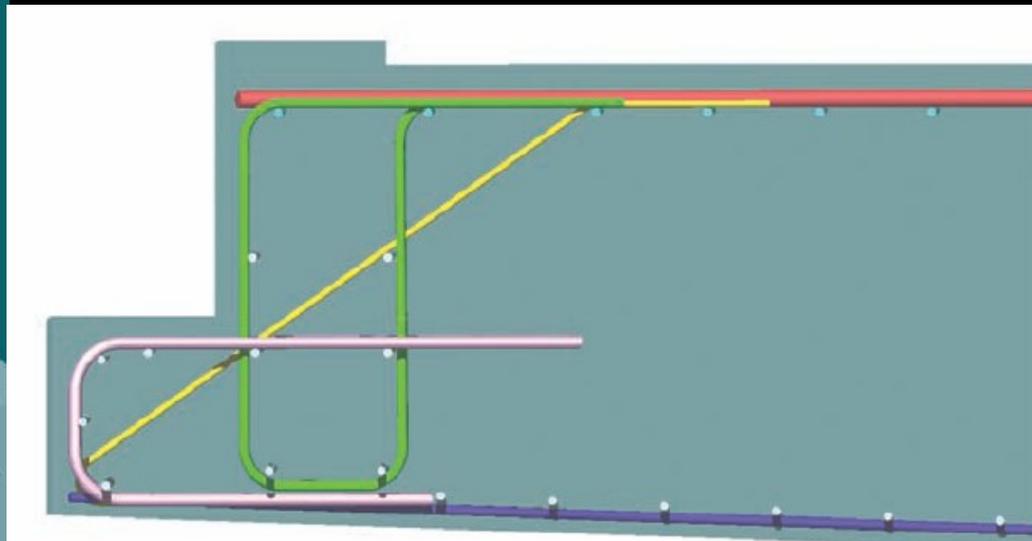
Causes - poor anchoring detail

- not in accordance with best practice
- inadequately anchored
- but did not contravene 1966 code

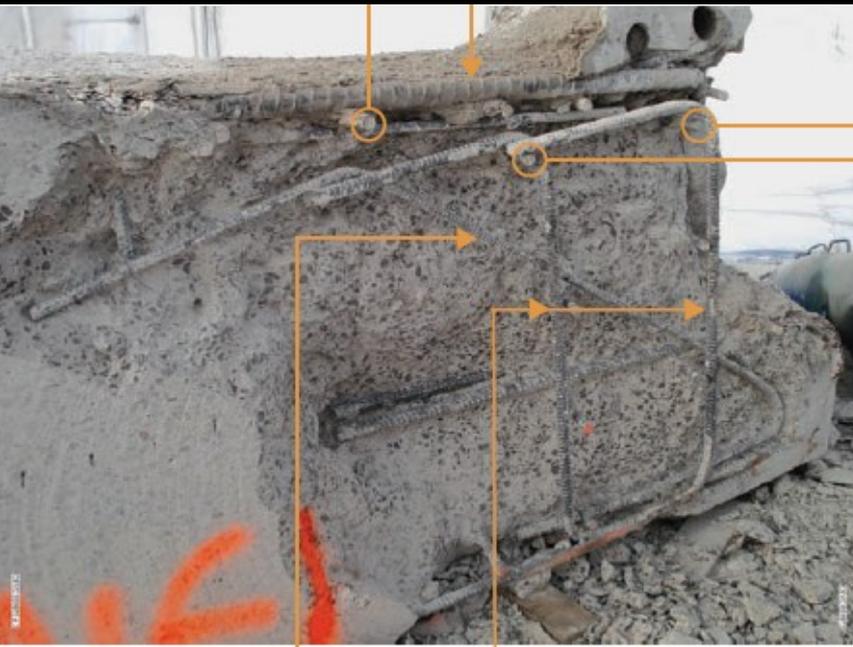
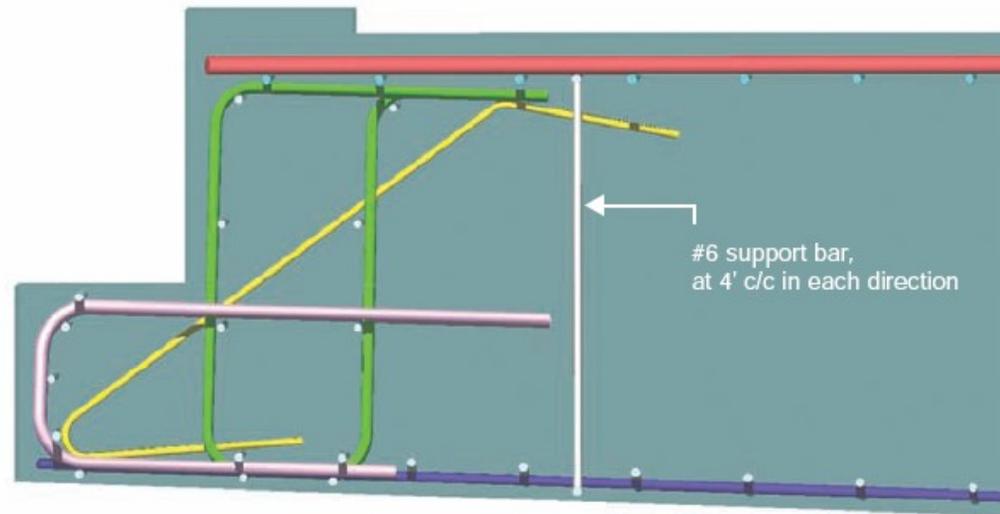
Causes - misplaced reinforcing bars

- hanger bars misplaced
- created unreinforced zone of weakness

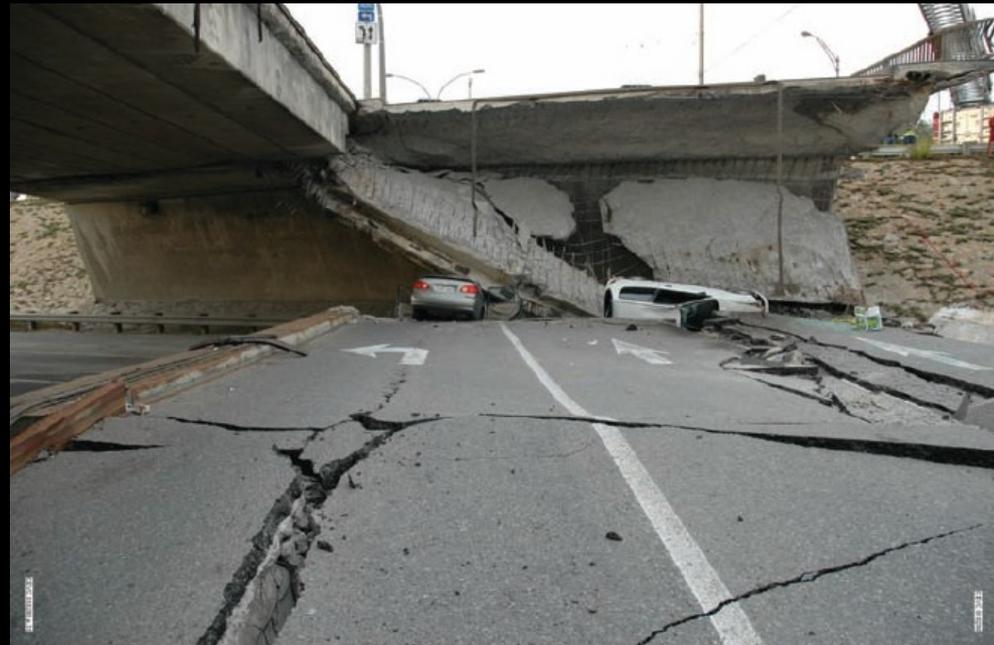
Contributory physical causes

- Absence of shear reinforcement in thick slab
- Absence of proper waterproofing
- Damages induced by repair work
