Investigations and Repairs of Boston Manor Viaduct

Prepared by Said EI-Belbol/Neil Loudon For Bridge Owner's Forum and Bridges Board September 2012

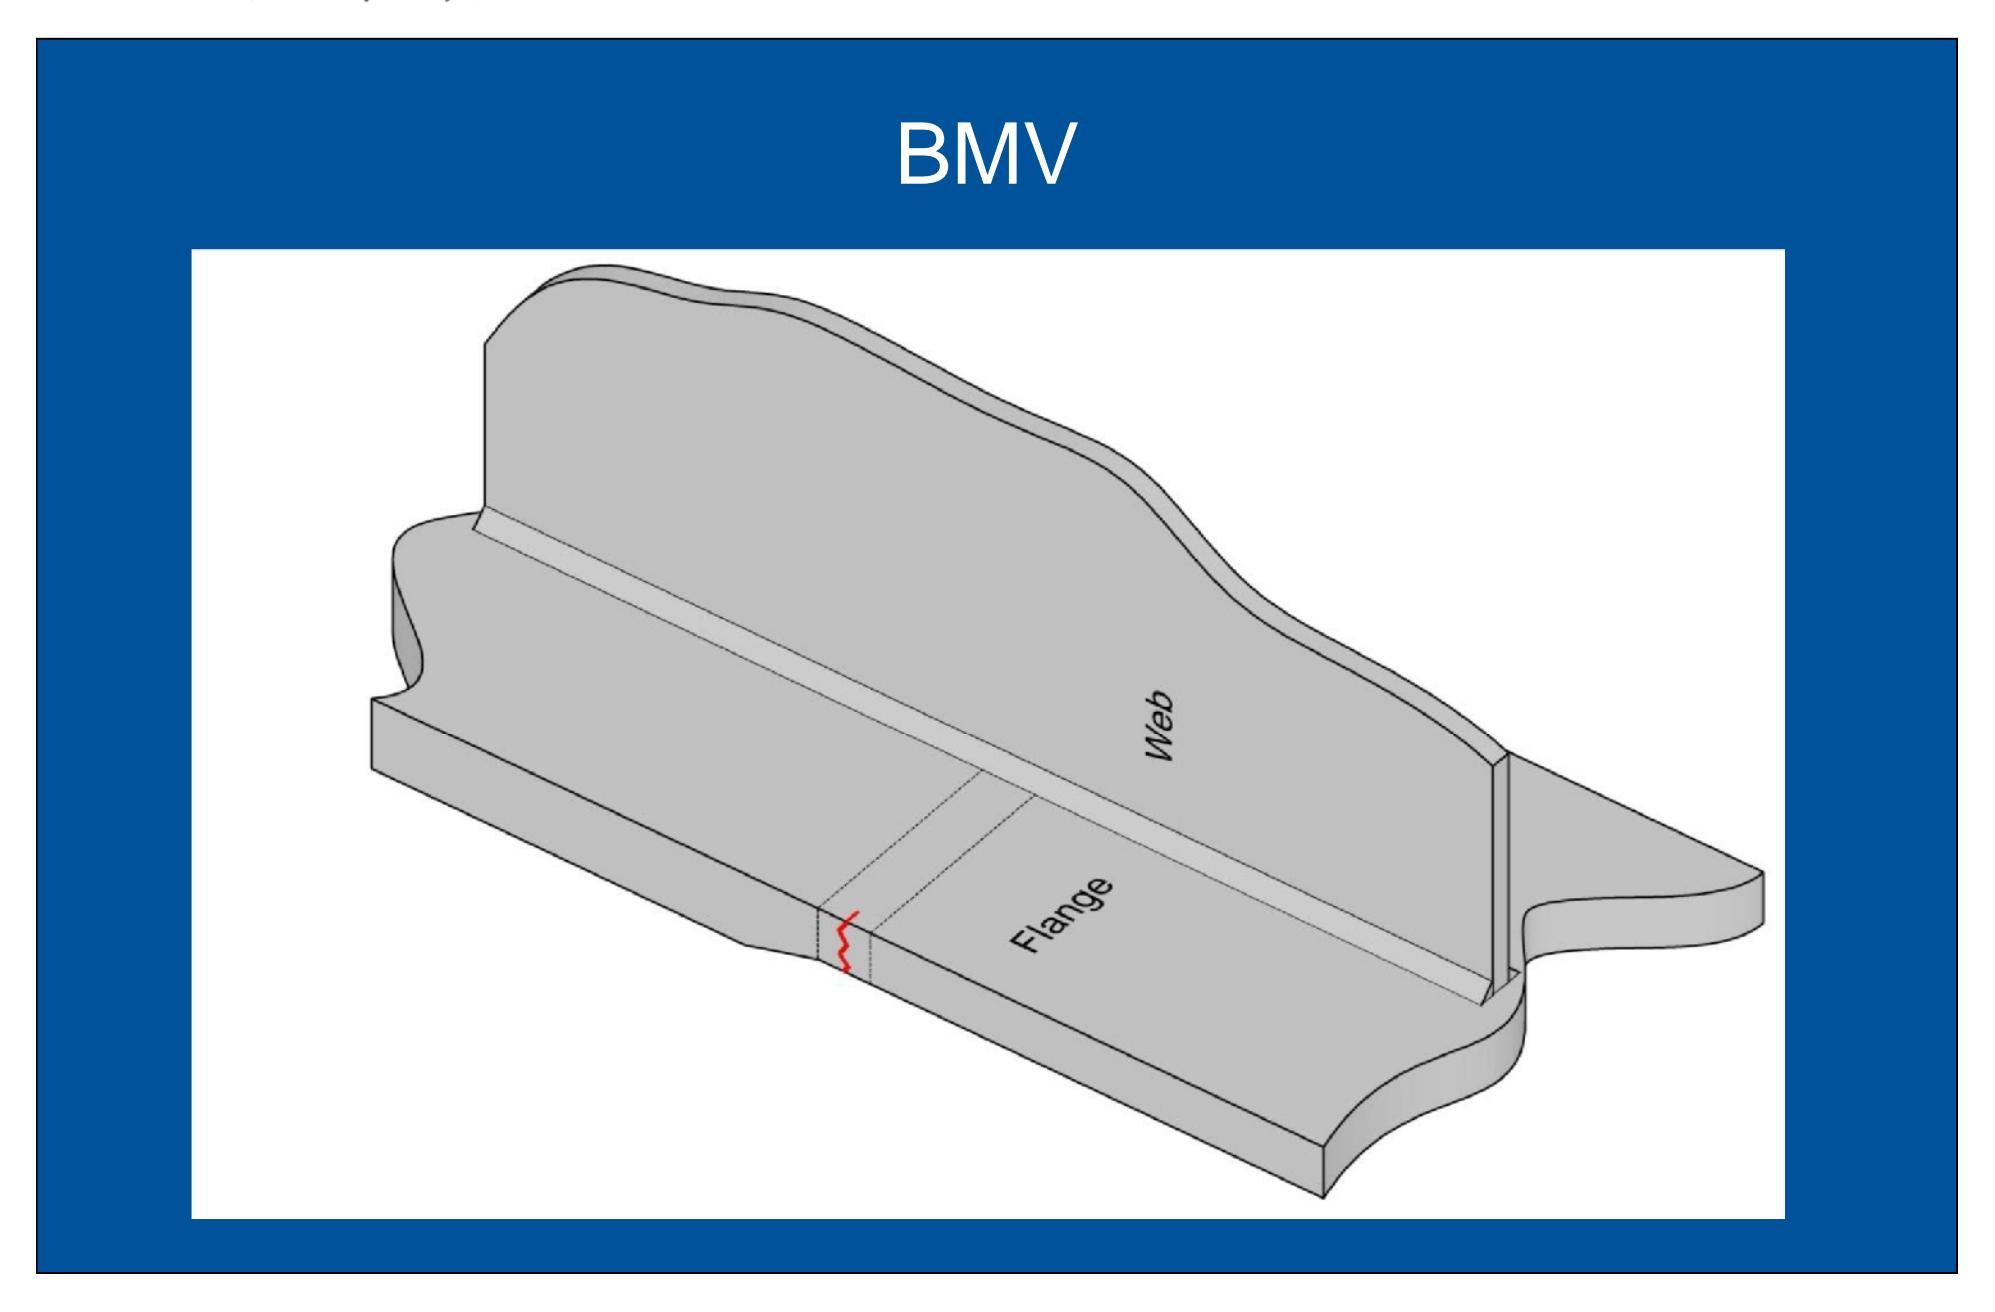
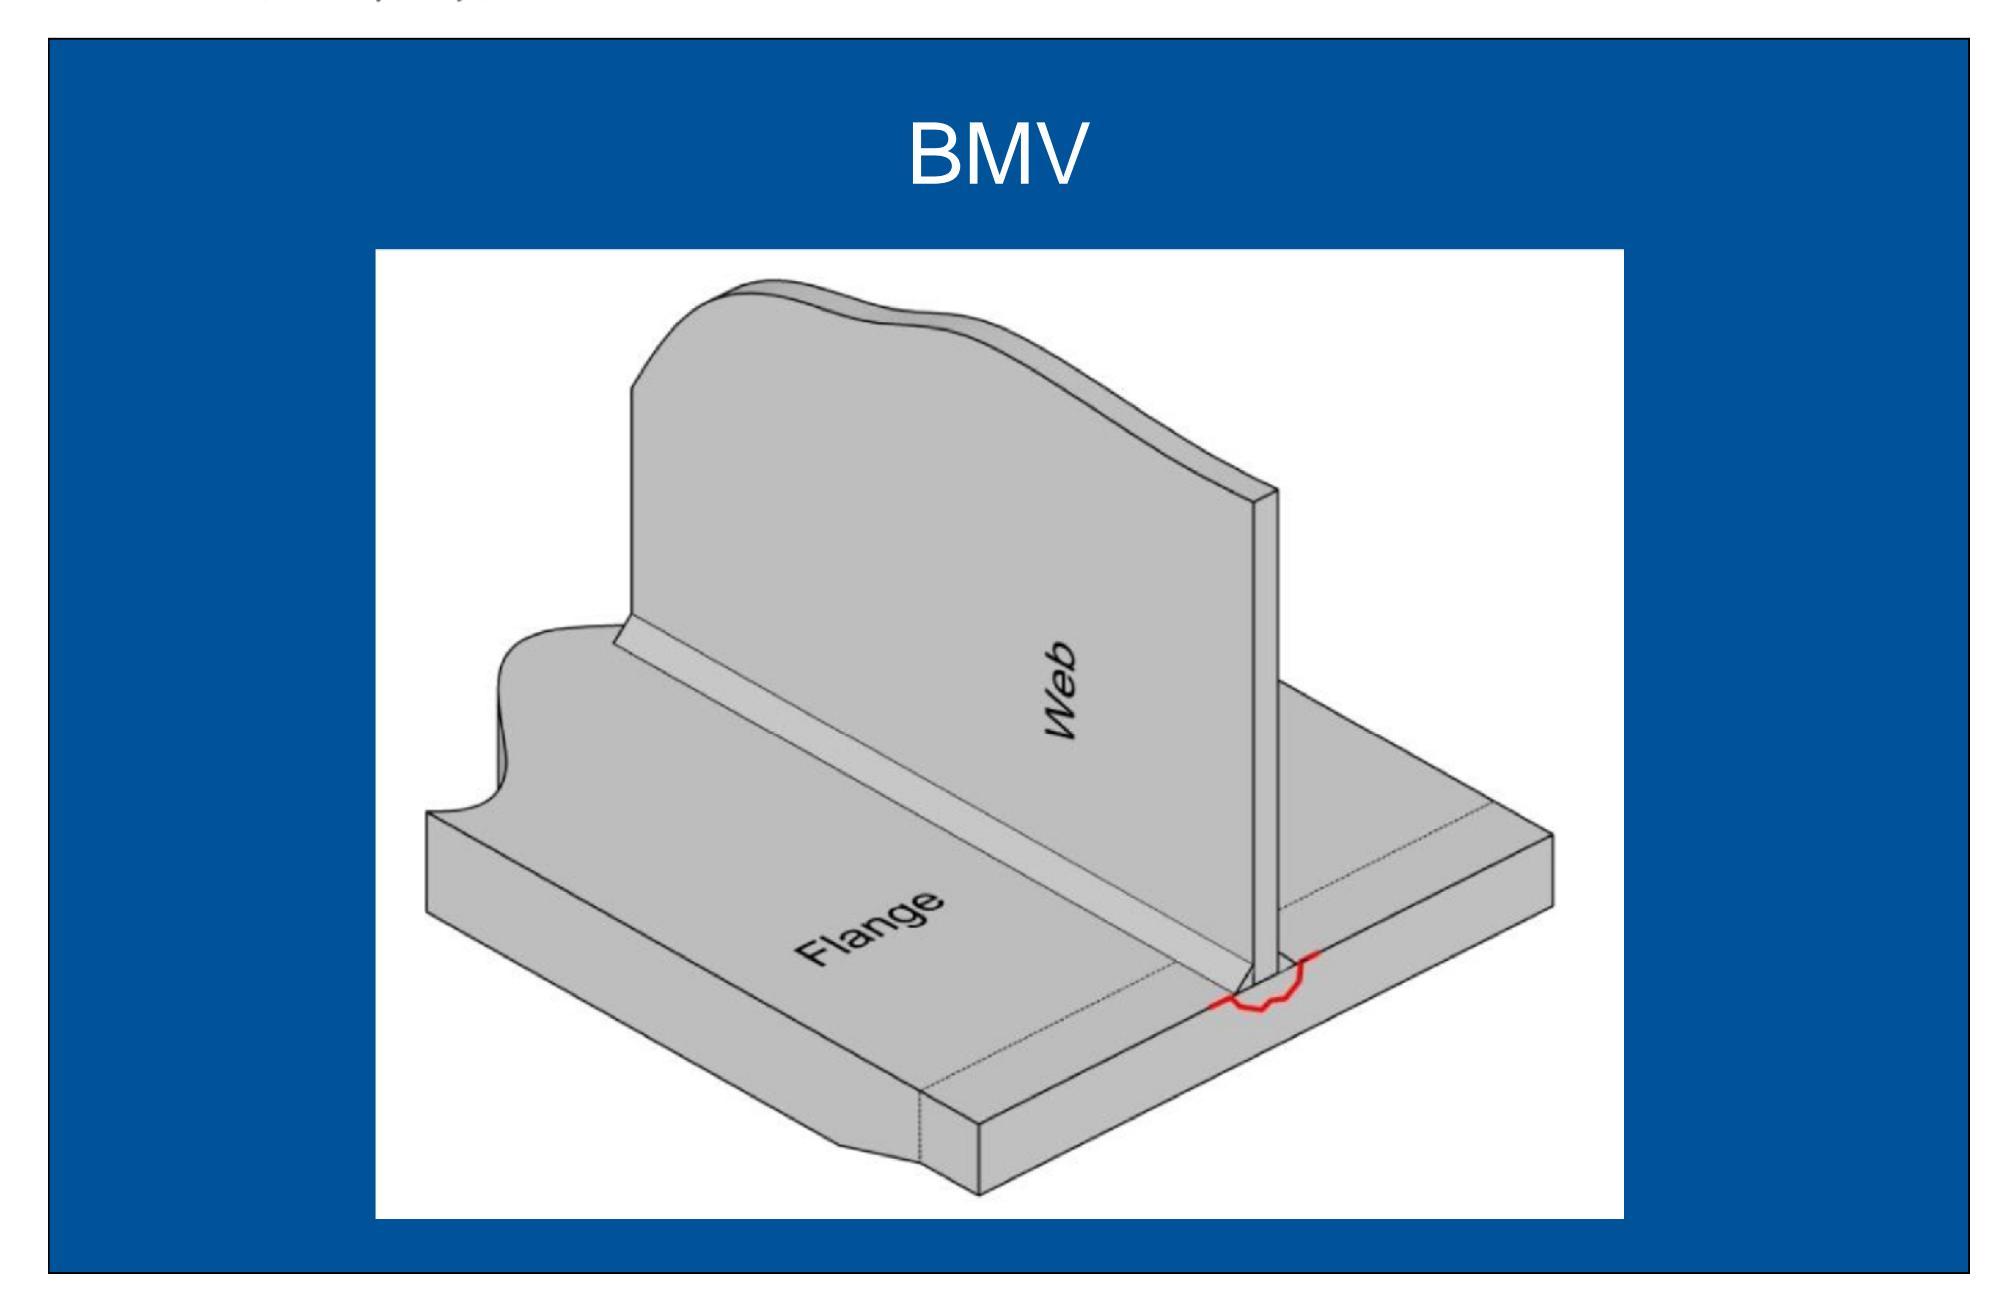
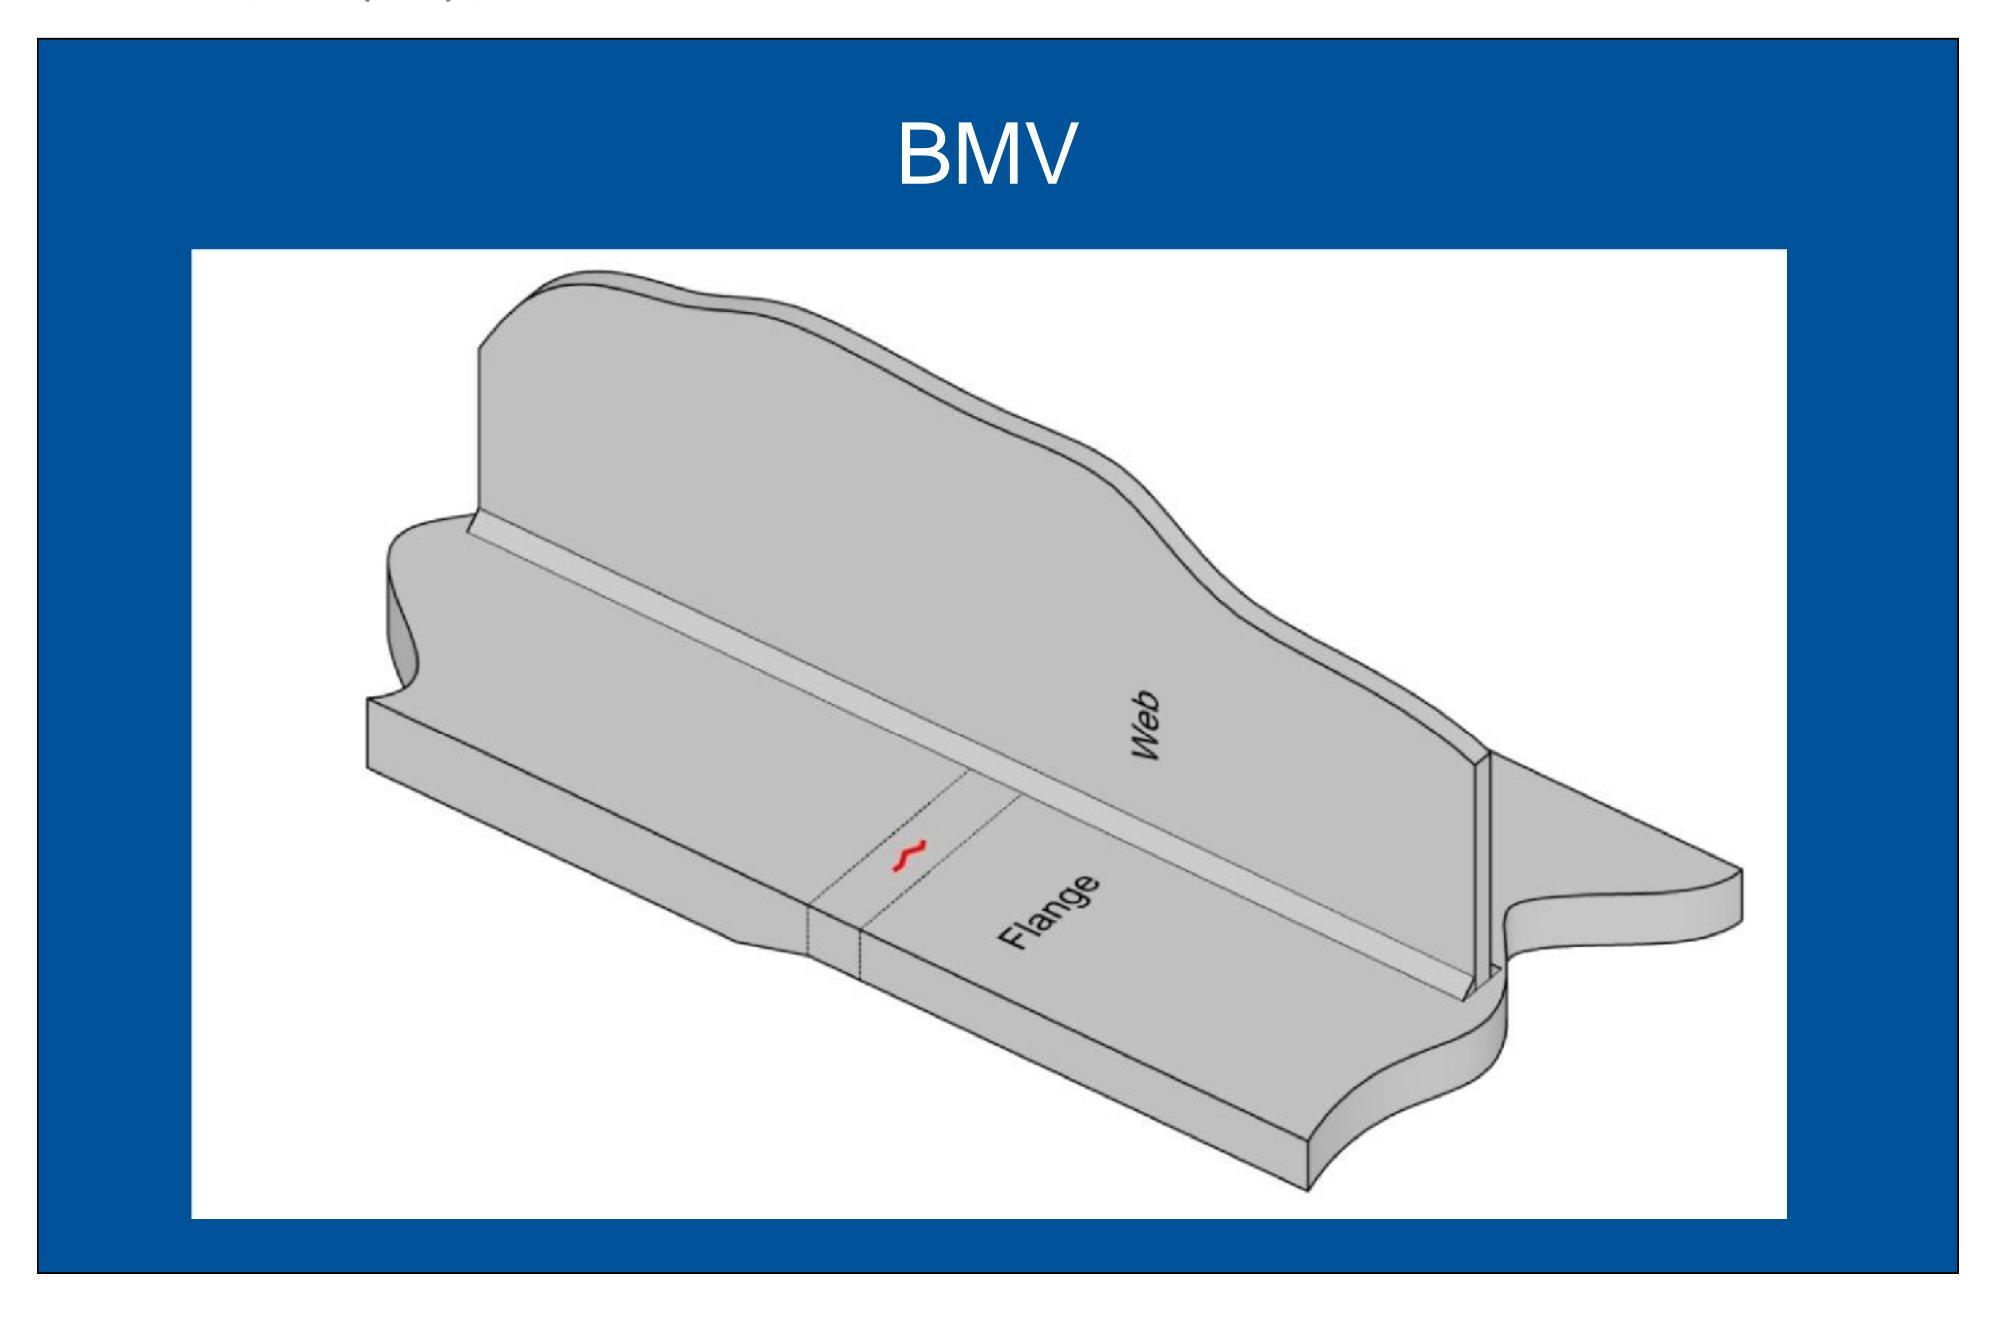
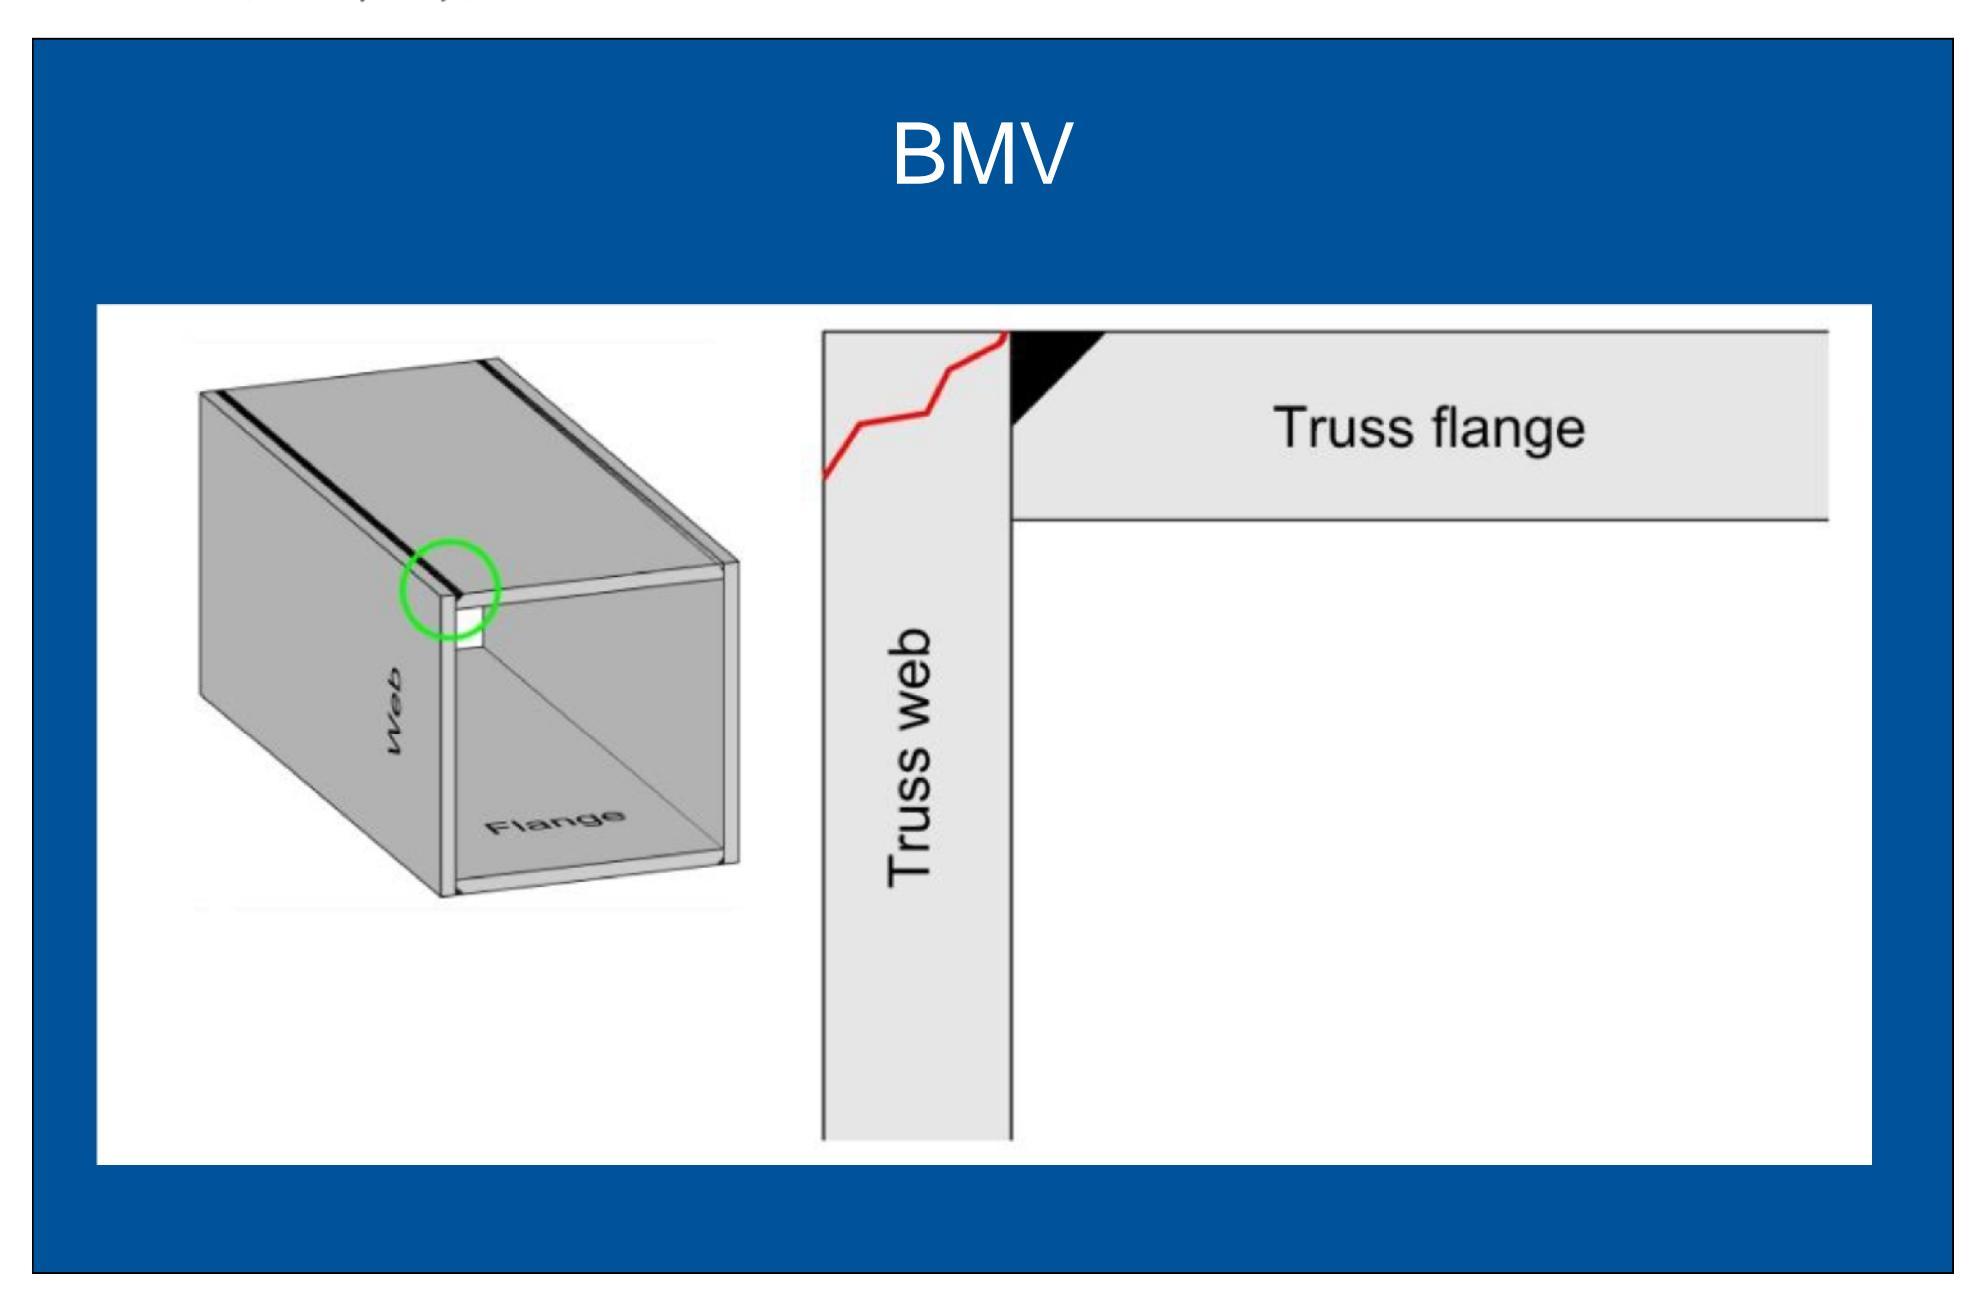
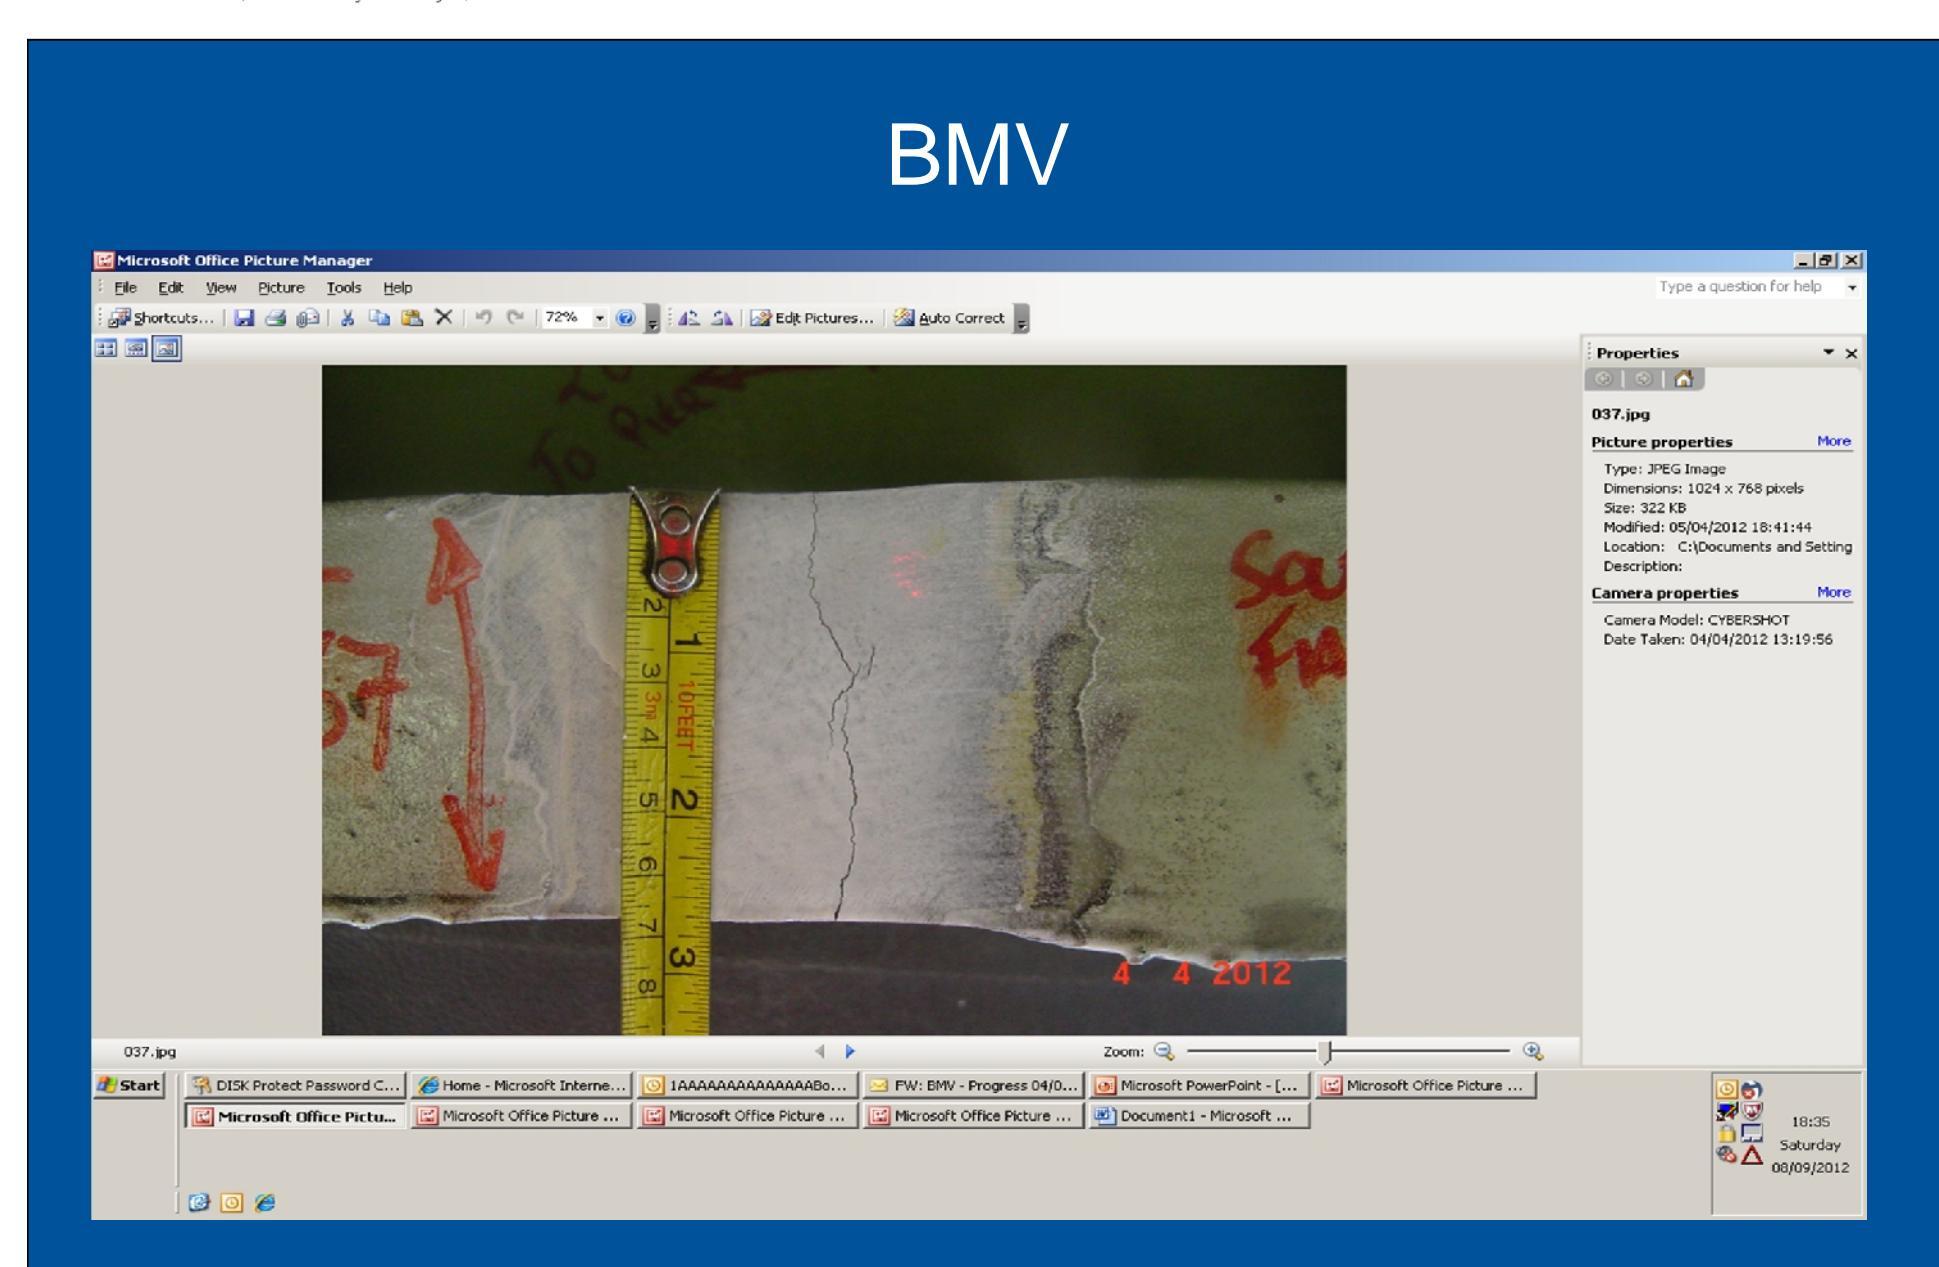
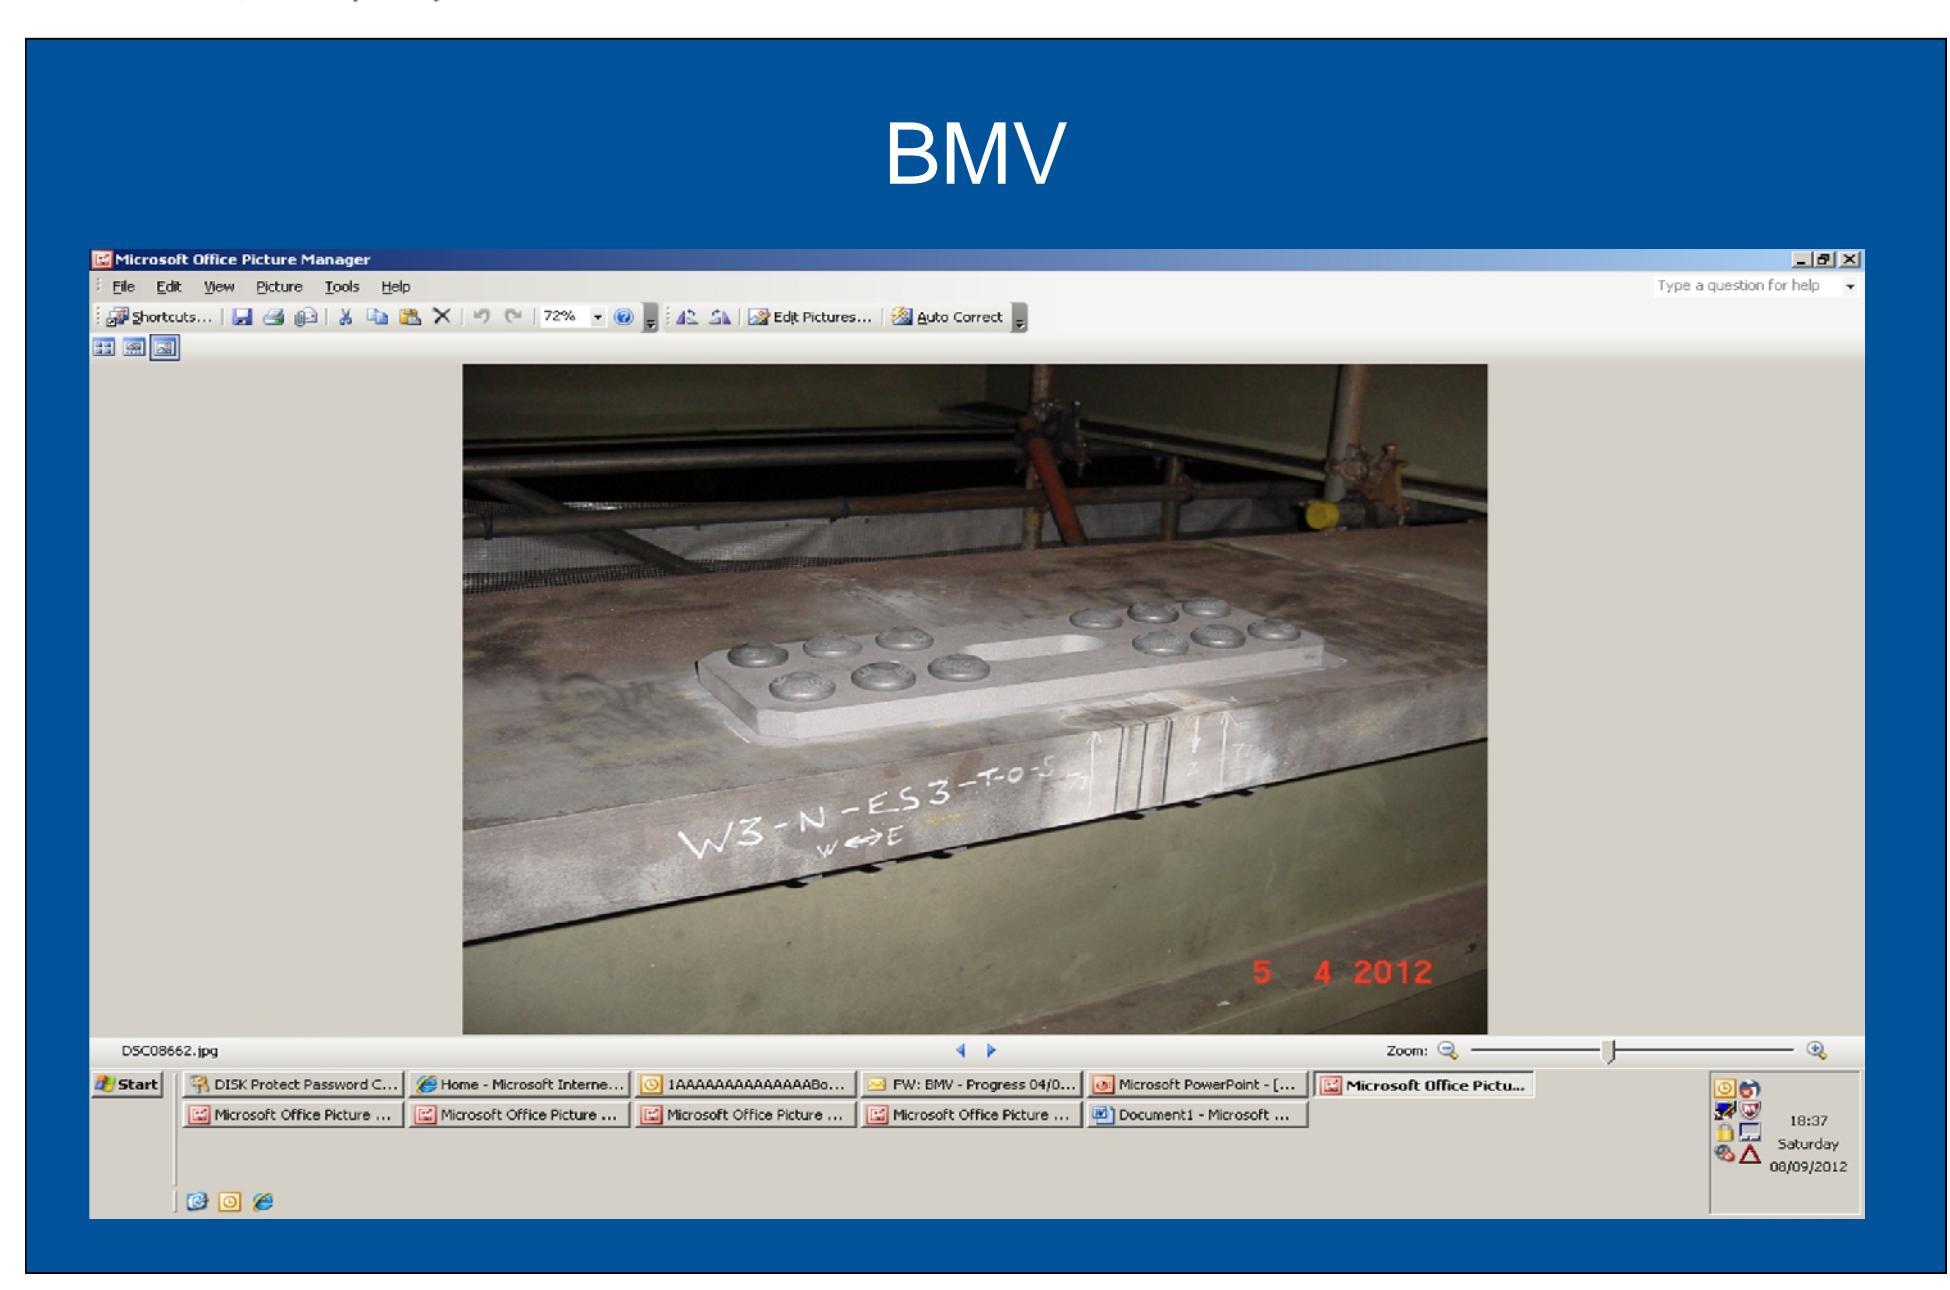
Findings

- Cracks identified at various locations
- At tension and compression zones
- Mostly in plate girders (at edges of flanges)
- Also directly under the web
- A combination of the above
- Limited number in the truss section
- Some "in board"
