Transport Wales Framework Lot 5

Task Order 5/2 BD 63/07 Risk Based Inspections

User Manual

Welsh Assembly Government Risk-based Principal Inspections

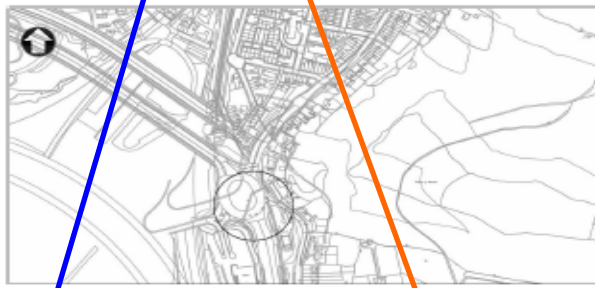
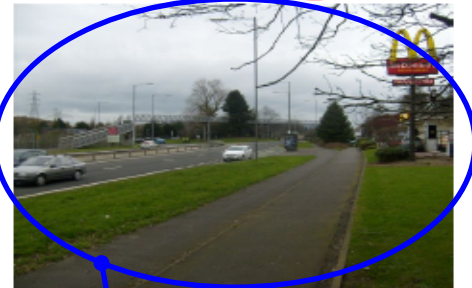
Figure 7.2 - Using the Roads 277 to risk assess footbridges or gantries (Page 1 of 2)

Construction Details:

Location Plan

Elevation
