# The Assessment of VIPP (beam and slab PC bridges) in France

**Bruno GODART**

International Bridge Forum, Cambridge, UK, 13 – 16 September, 2009

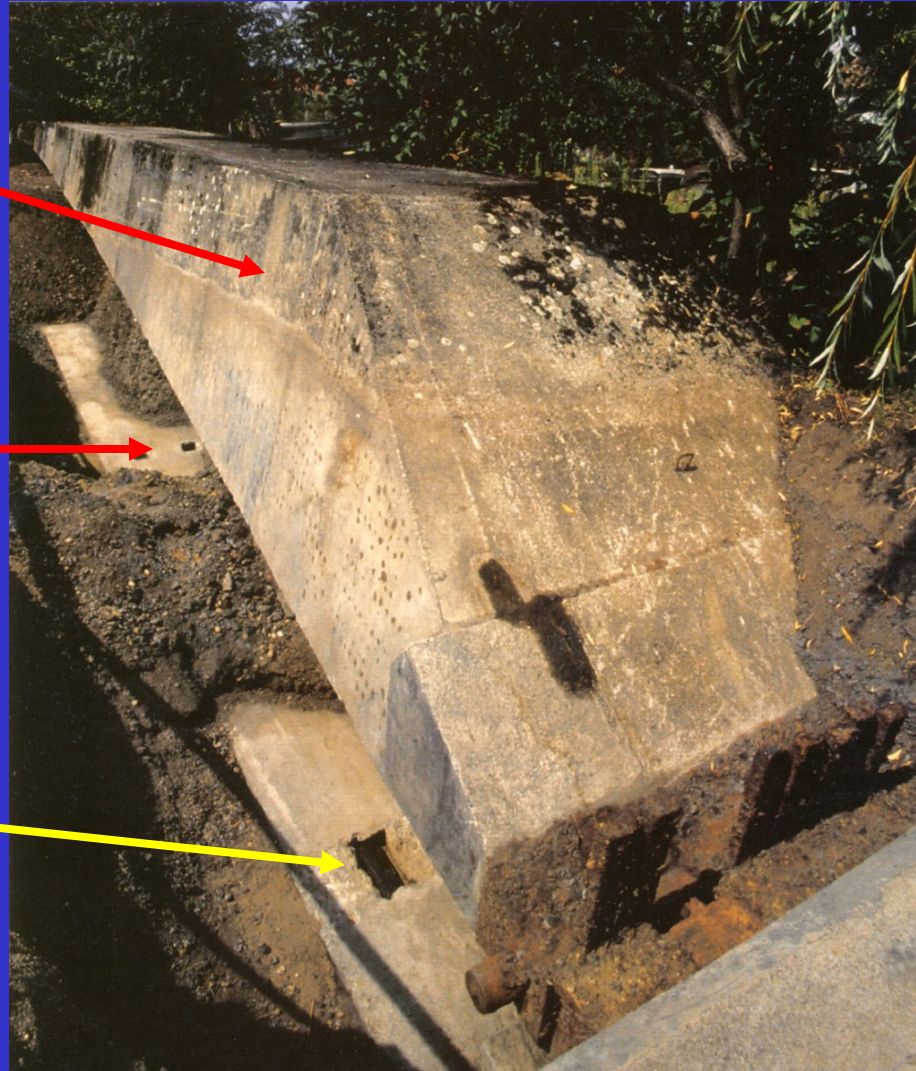
# Experimental arch of the Veurdre bridge (1907)

Arch

Prestressed  
Tie

Opening of  
window in  
1993...

# Experimental arch of the Veurdre bridge on Allier river

## Openings of windows operated in 1993:

- good behaviour of the tendons which were simply laid out in grooves filled with sand and sealed by a hydraulic mortar with care
- without any waterproofing on the surface of the tie and buried in soil for a long time

✂ → Experimental evidence that a prestressed structure may last more than 100 years...

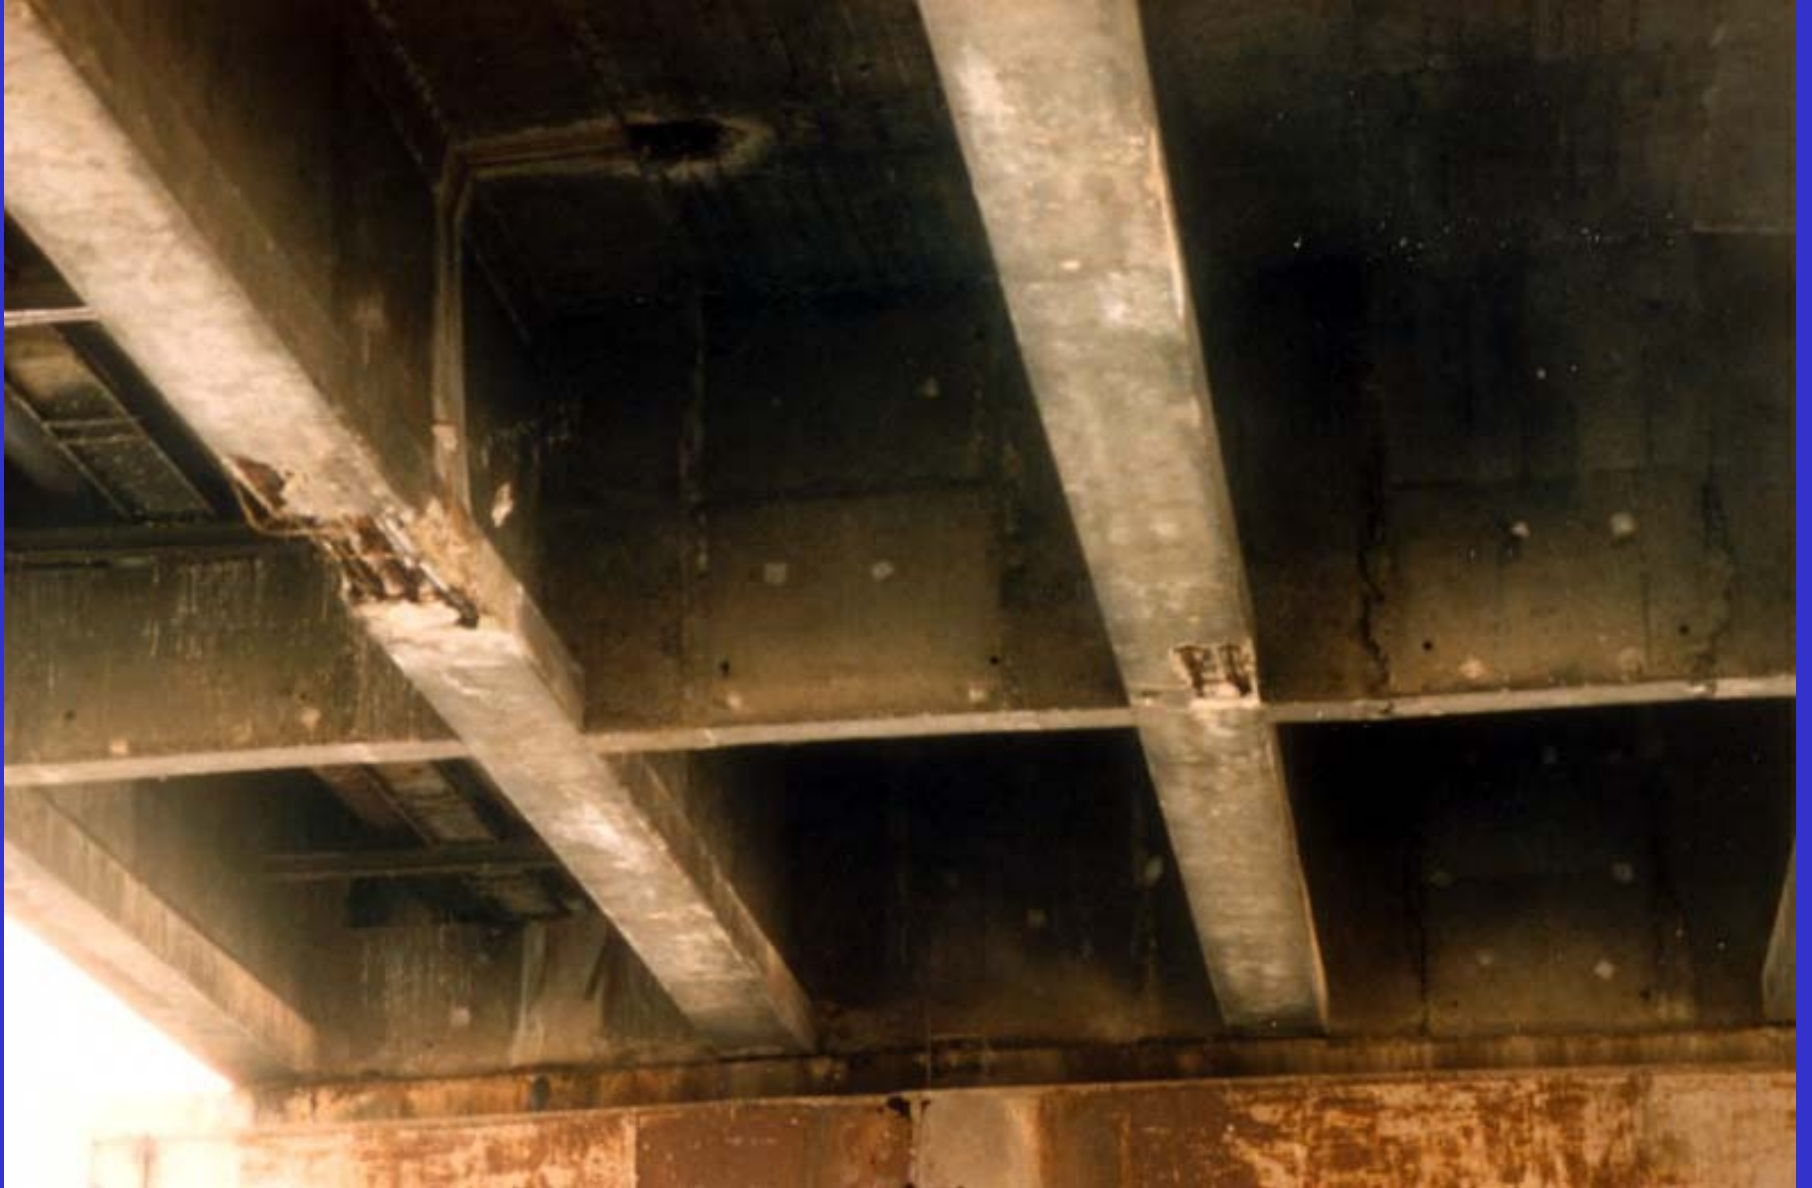
Example of a VIPP

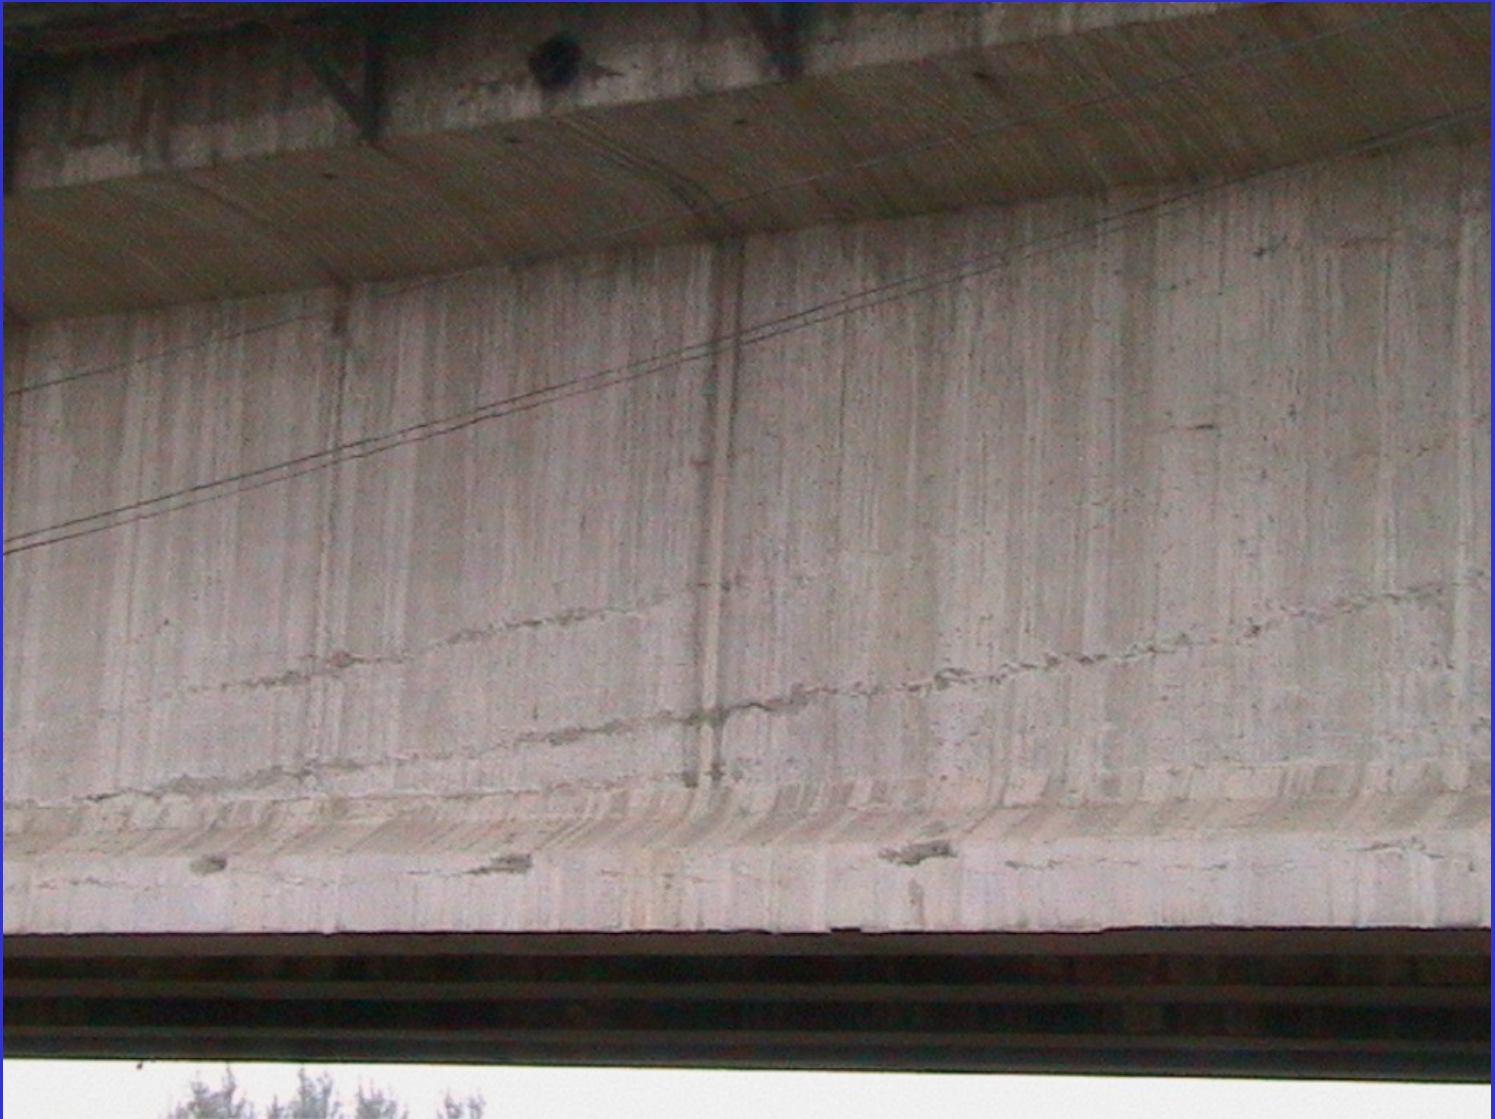
Example of cracks along the tendons in the webs

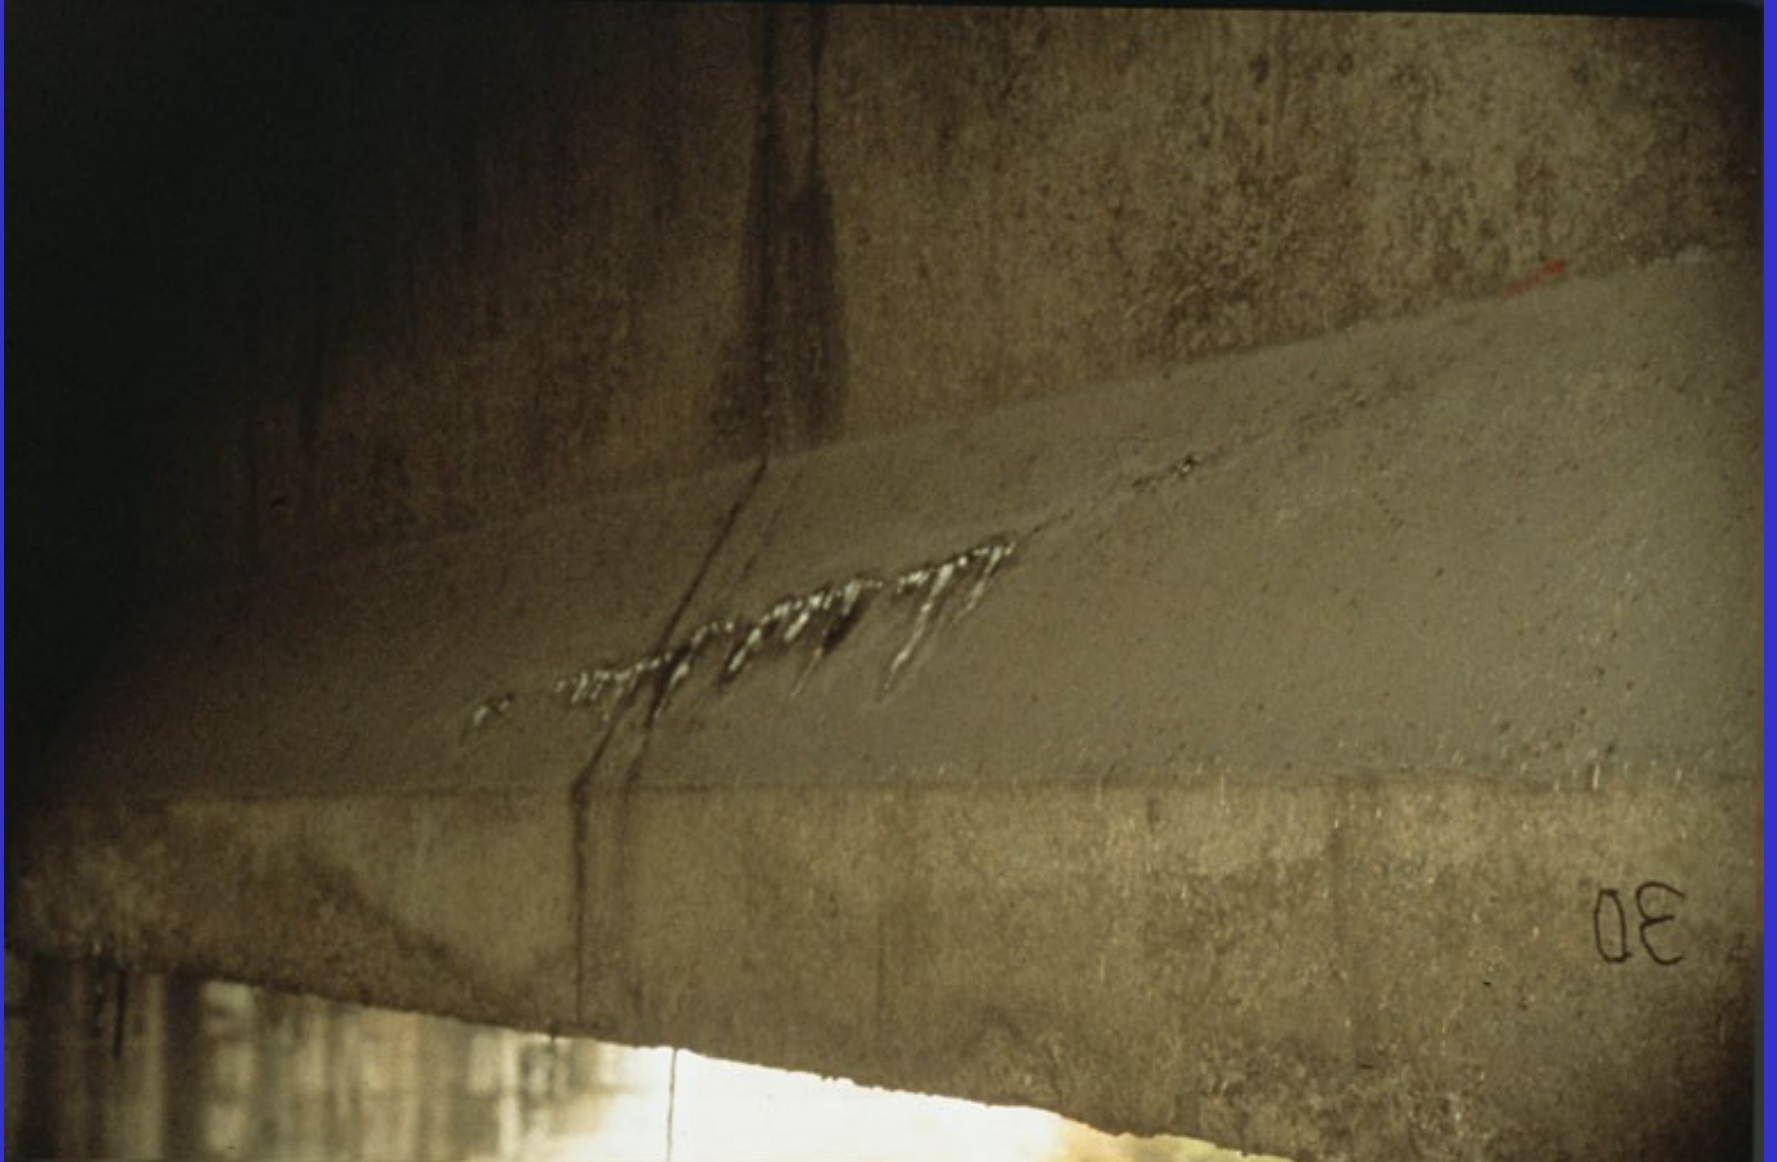
Active humidity in a crack on the toe of a beam...

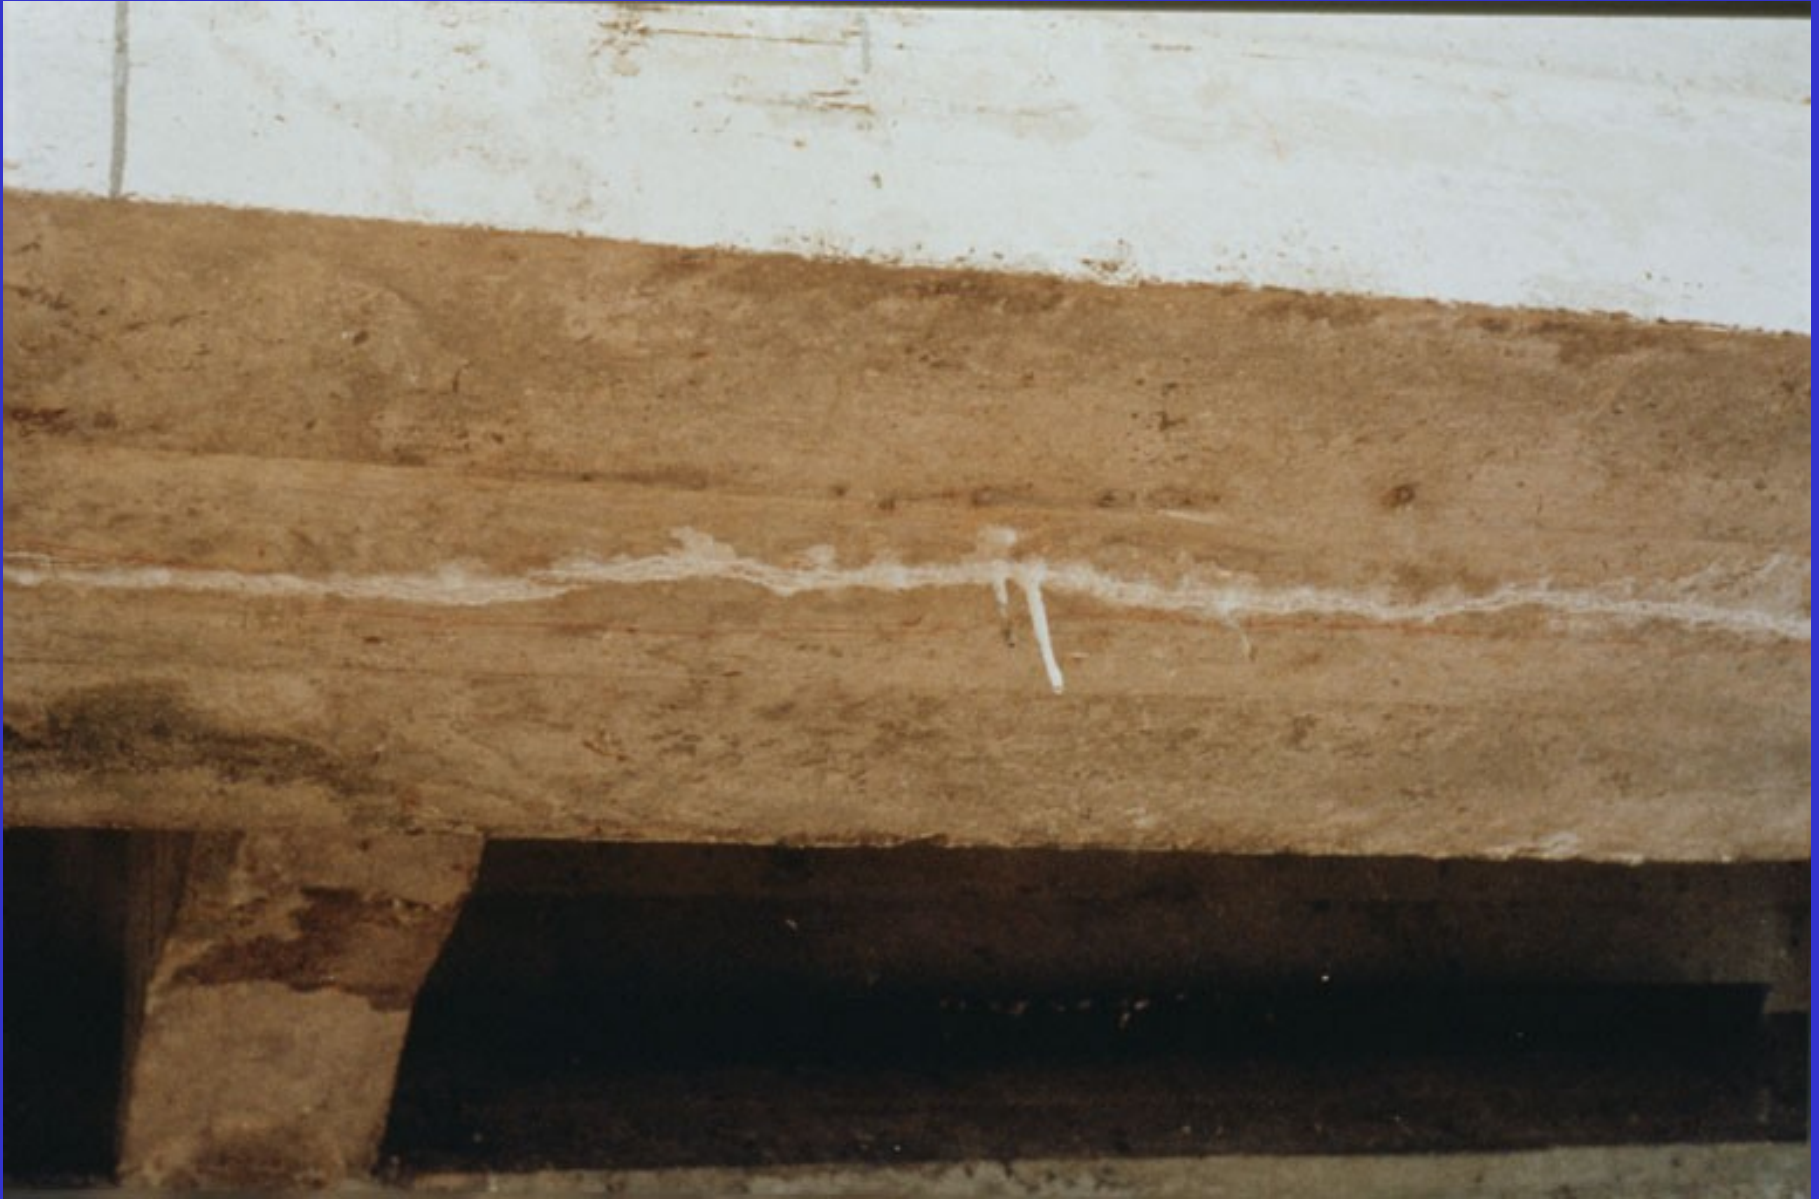
Crack with stalactite at the soffit of the toe of a beam

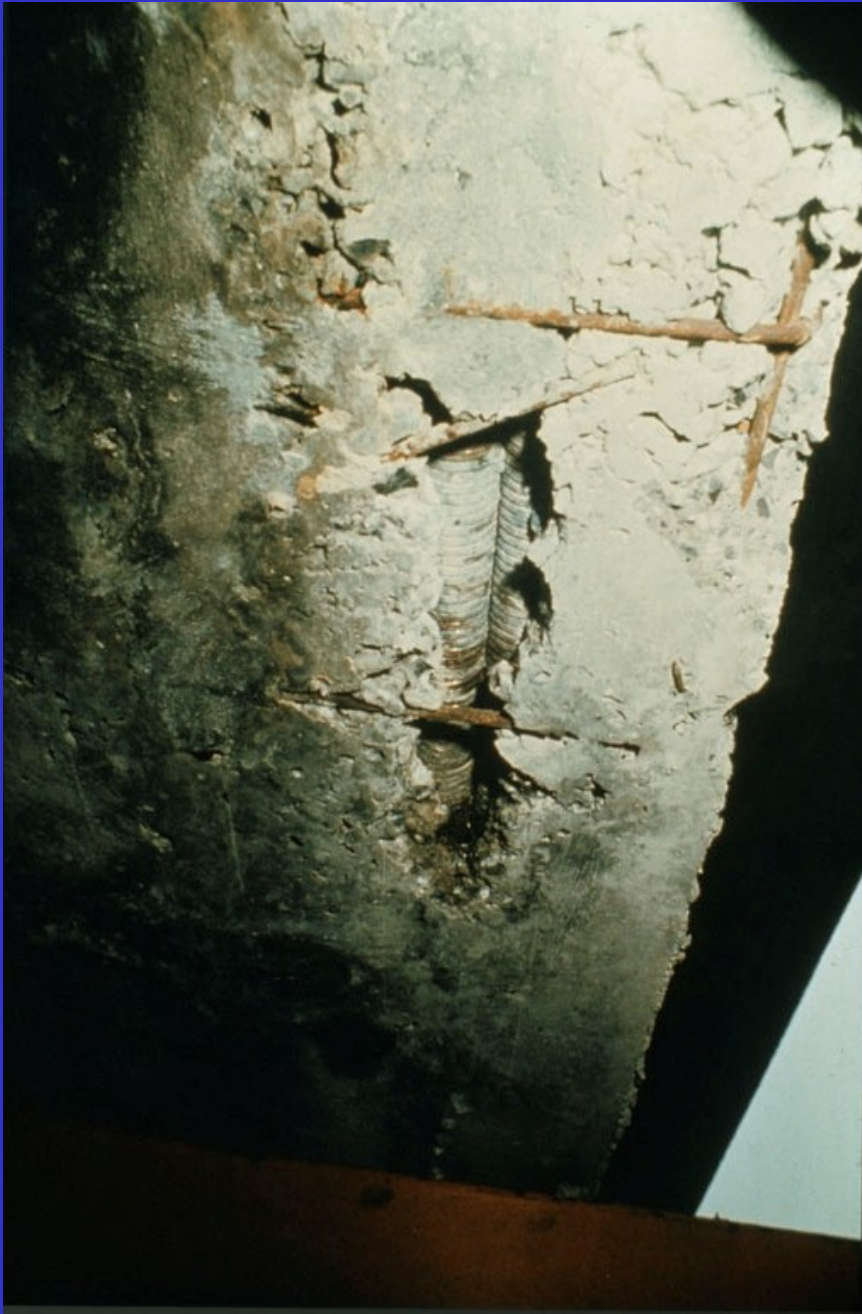
Typical defect at the soffit of a toe due to concreting difficulties

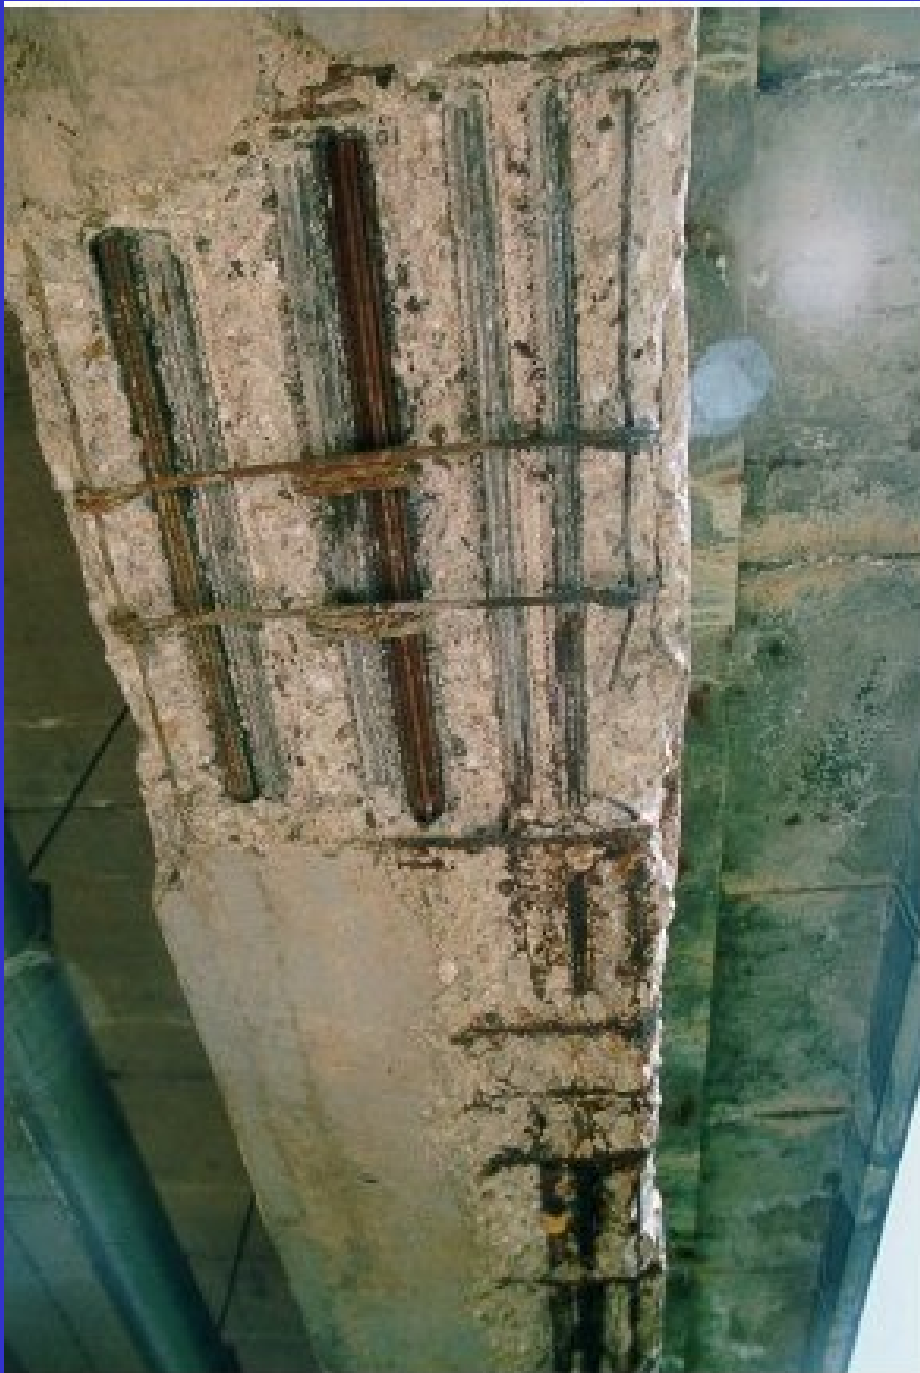
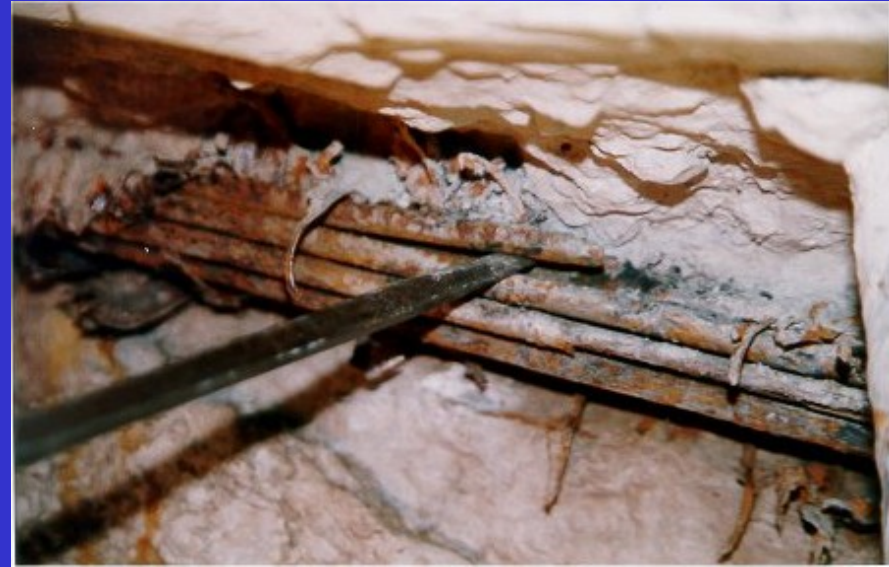
Example of the variability  
of corrosion

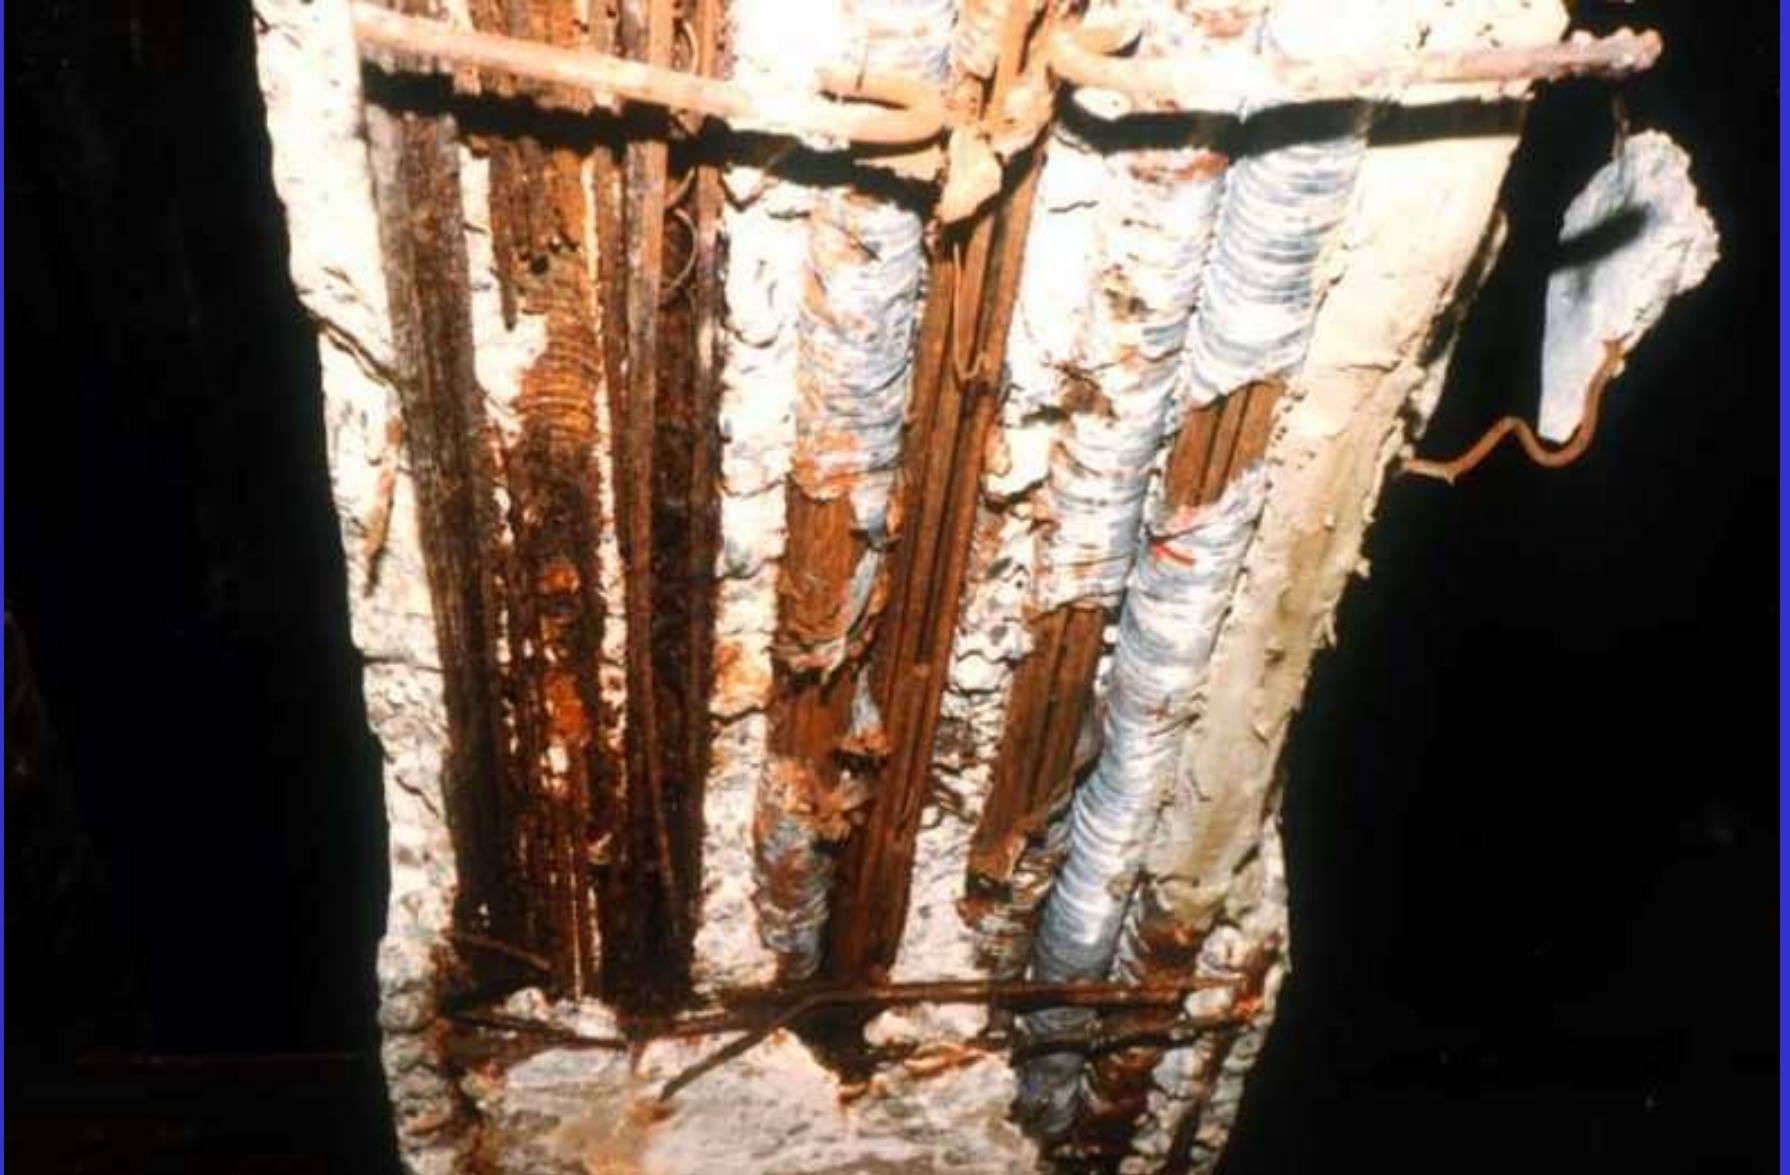
General corrosion of tendons

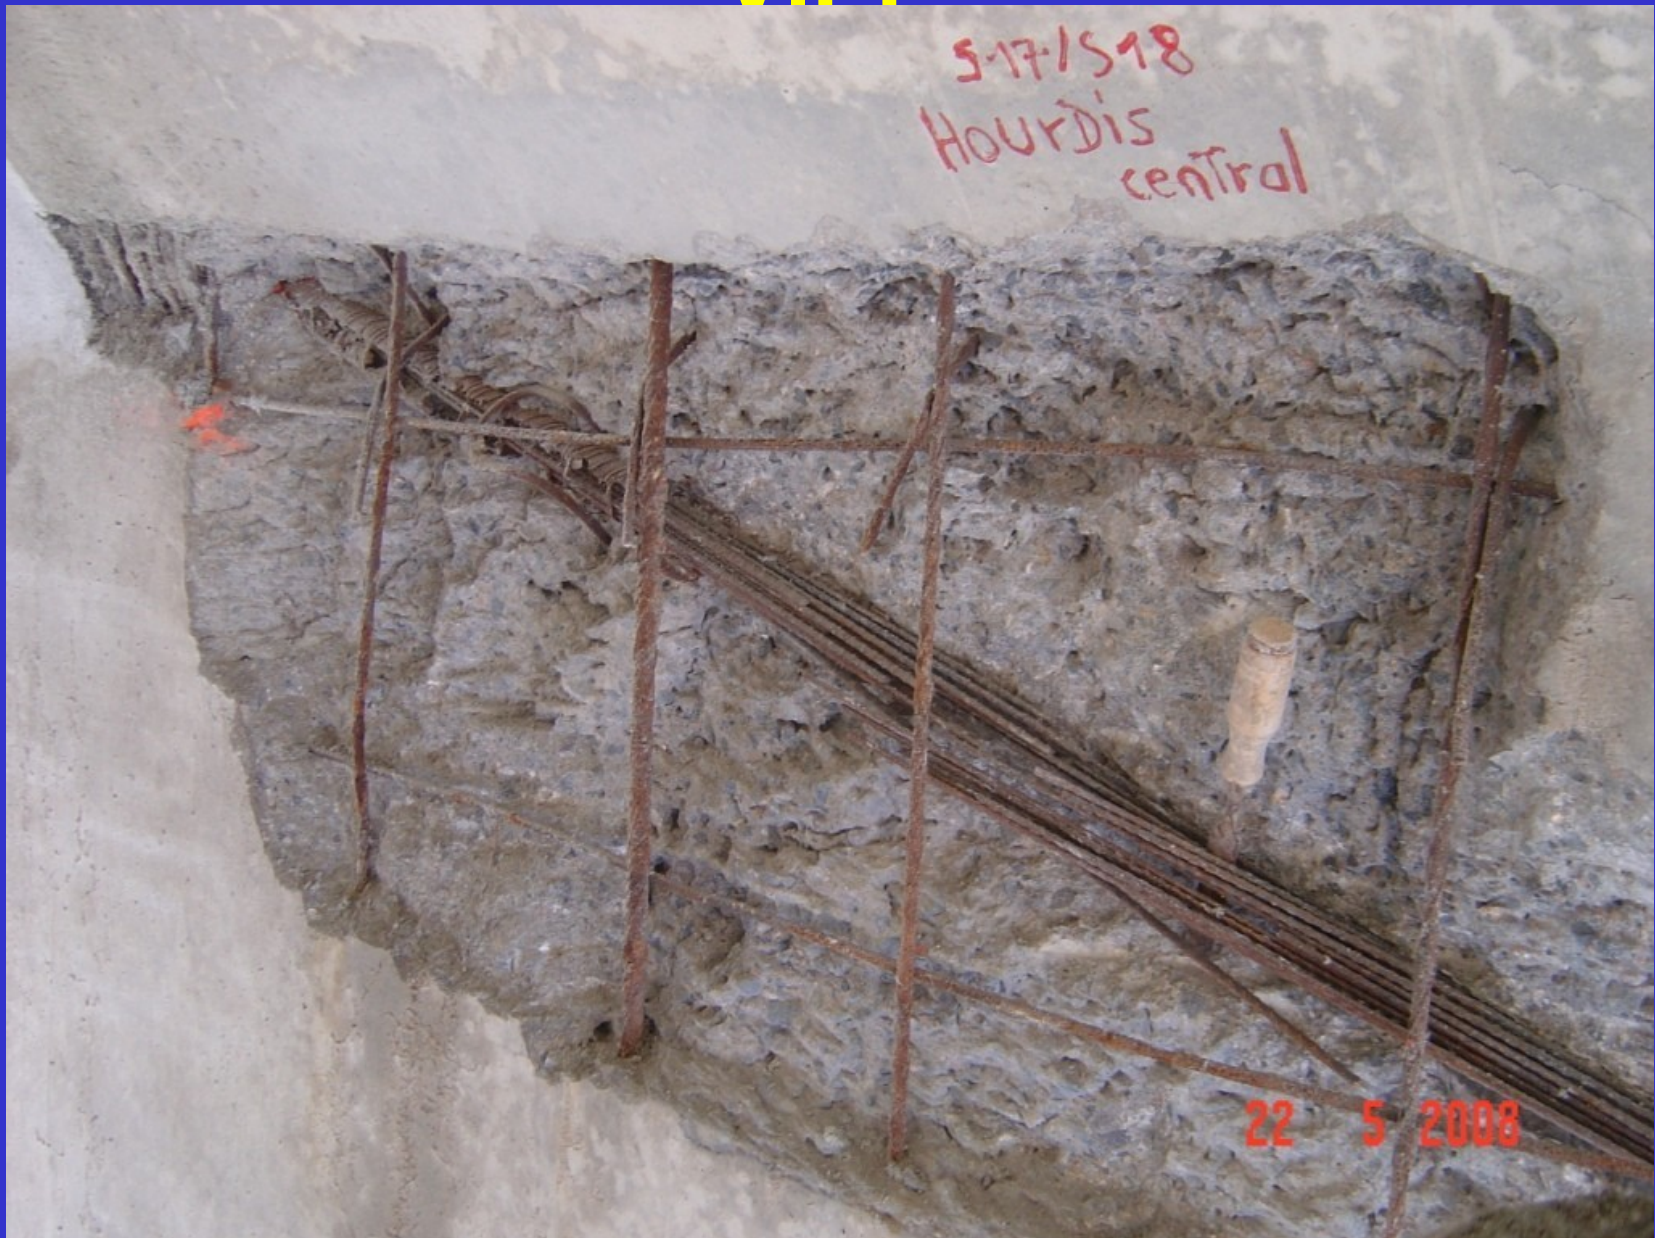
Example of broken wires due to SCC (KA system)

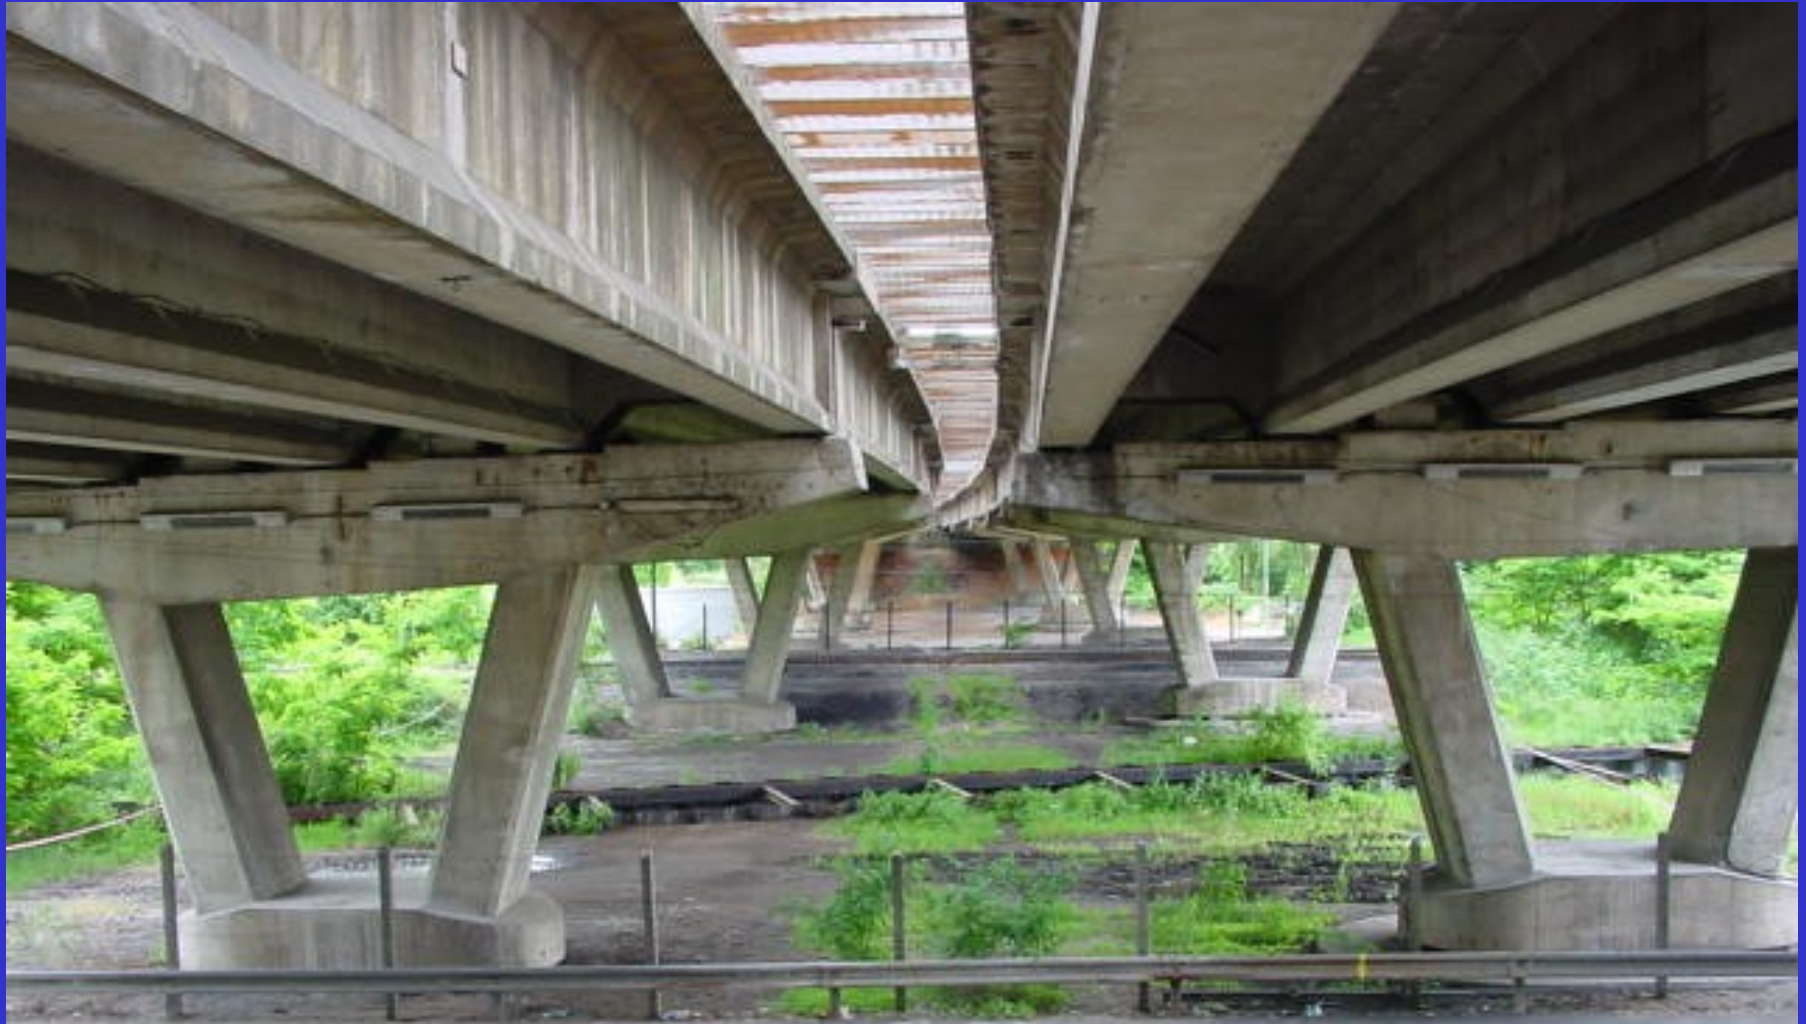
# Example of strengthening of a VIPP by prestress

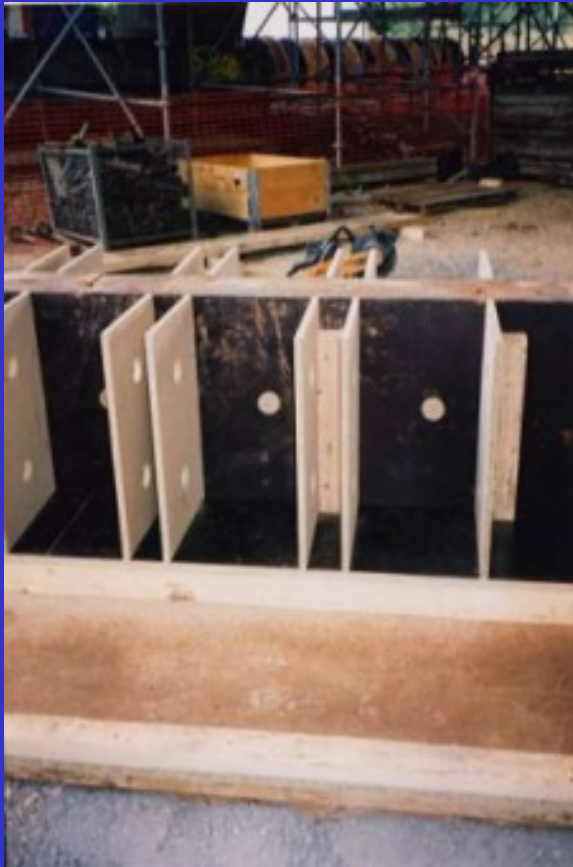
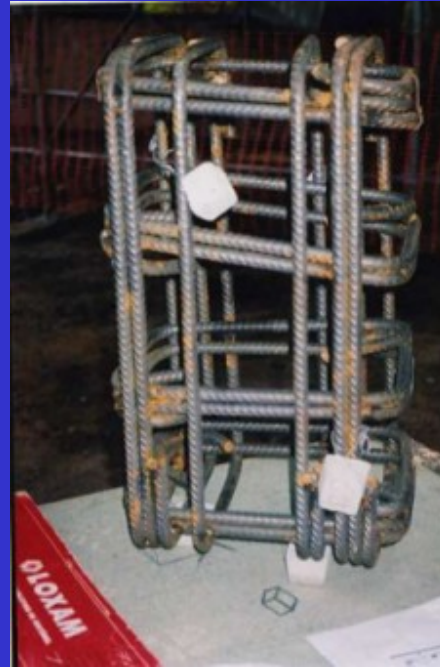
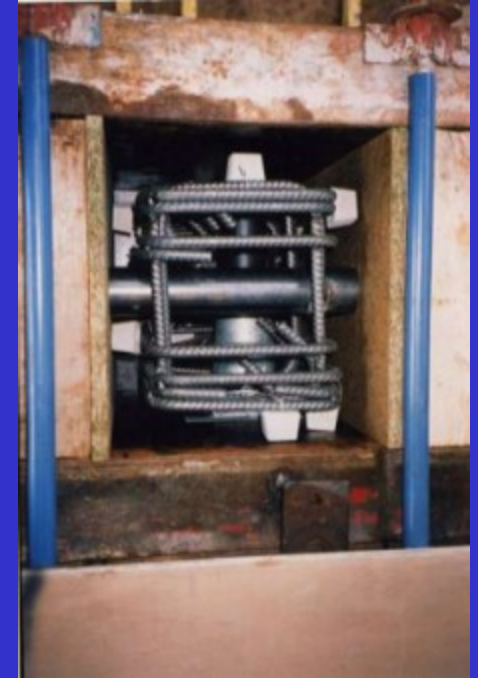
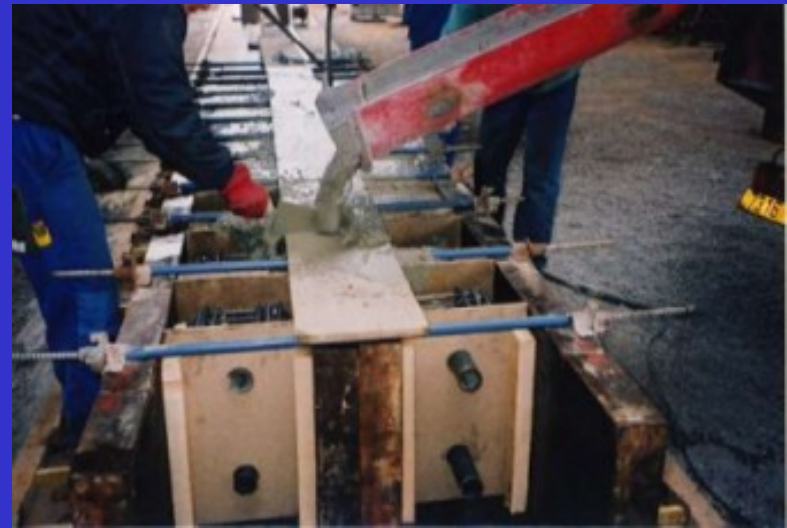
# Anchoring blocks

Precast on site

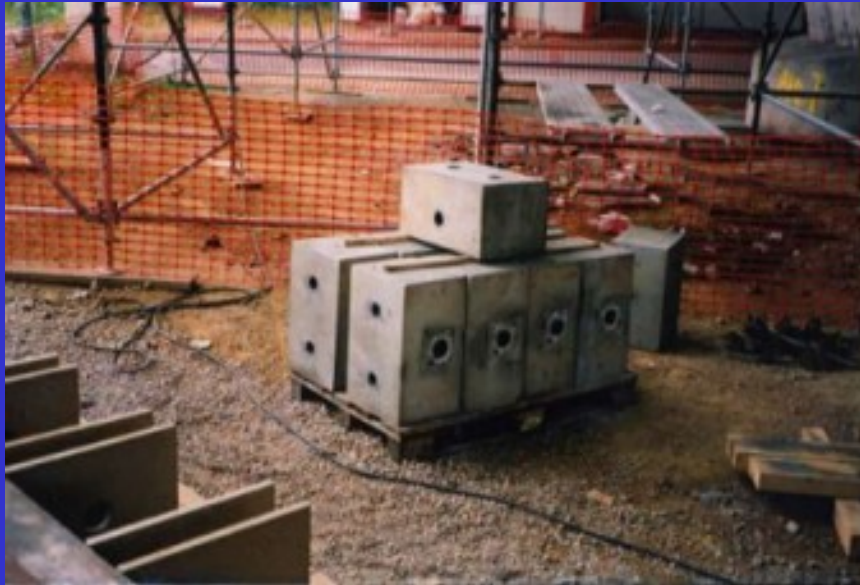
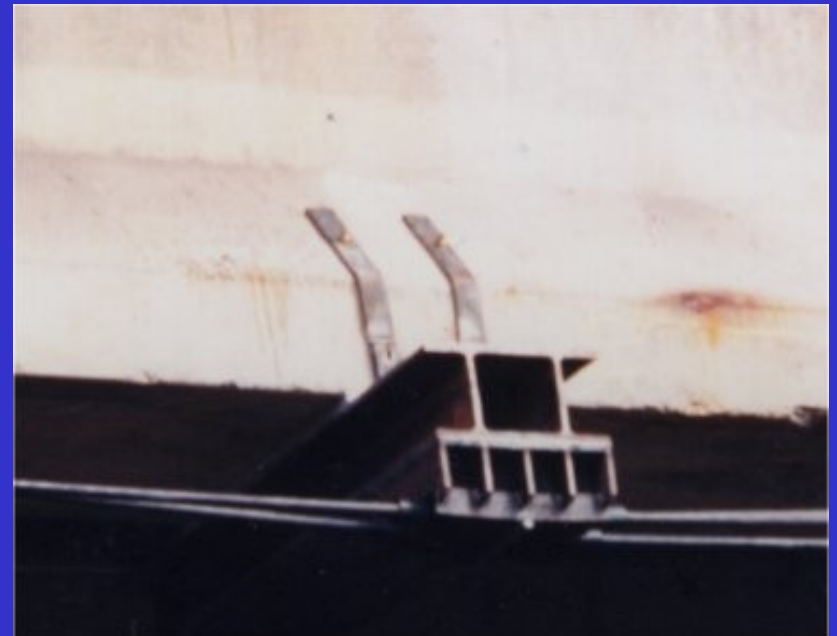
# Steel Deviators

## Prefabricated anchor blocks
