# Strengthening metallic bridges

## Network Rail's experiences

Brian Bell

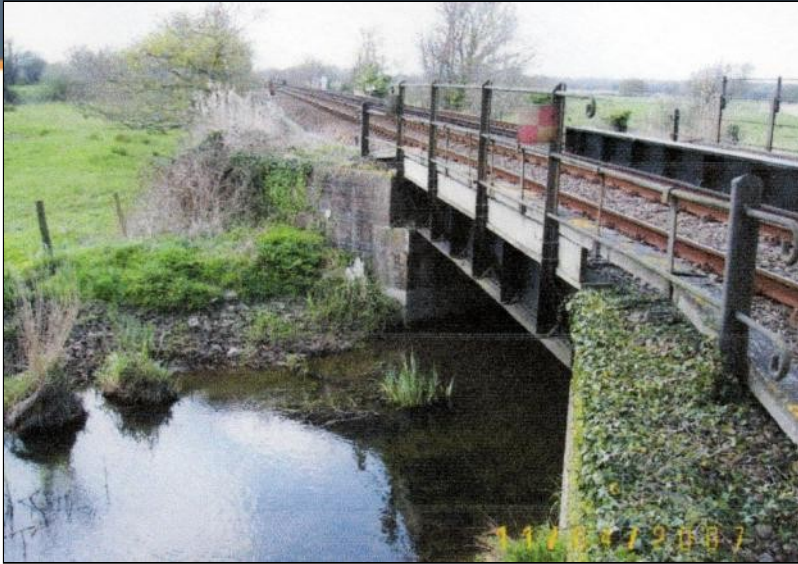
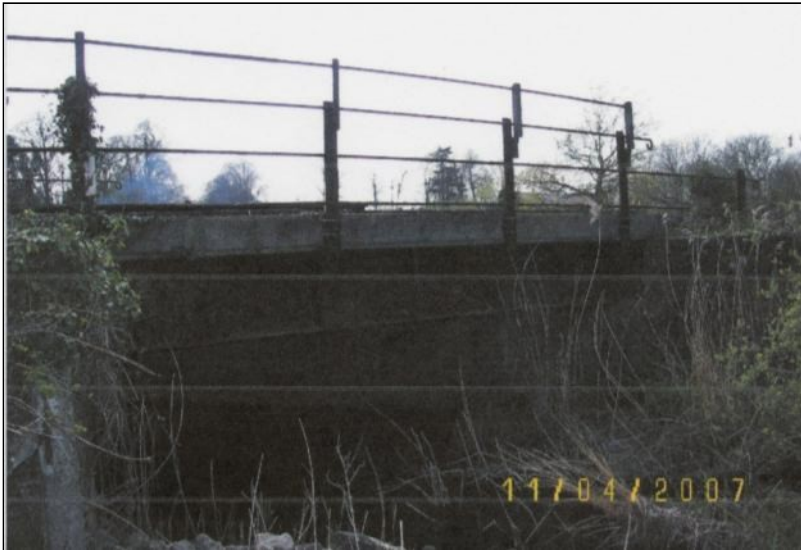
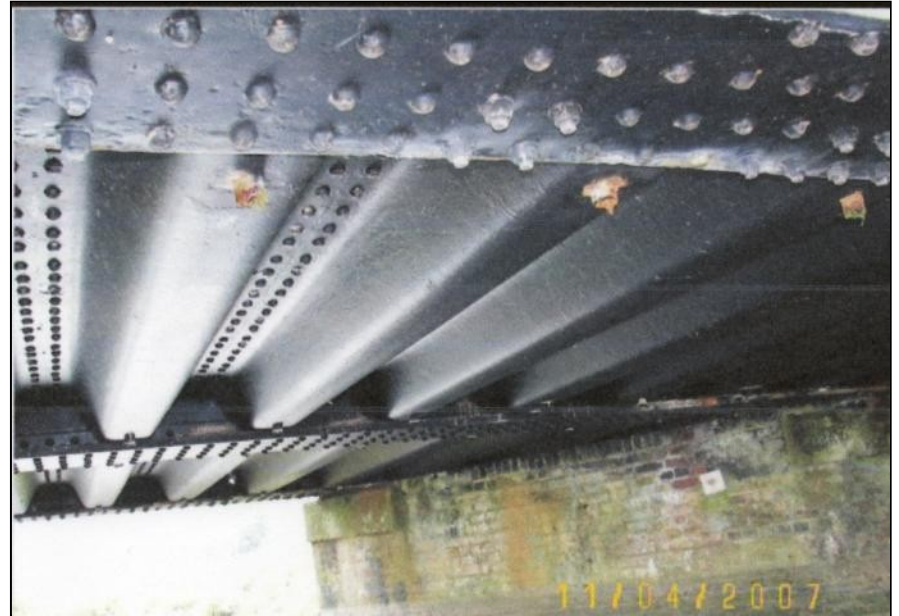
# Stoney Weir

- Typical small span steel or wrought iron bridge
  - Three equally dimensioned main girders and pressed steel trough decking
- Centre girder weak
  - Partly due to historic use by lightweight EMU traffic
- Standard “top hat” solution used
- Three similar bridges dealt with as one contract at a total cost around £300k

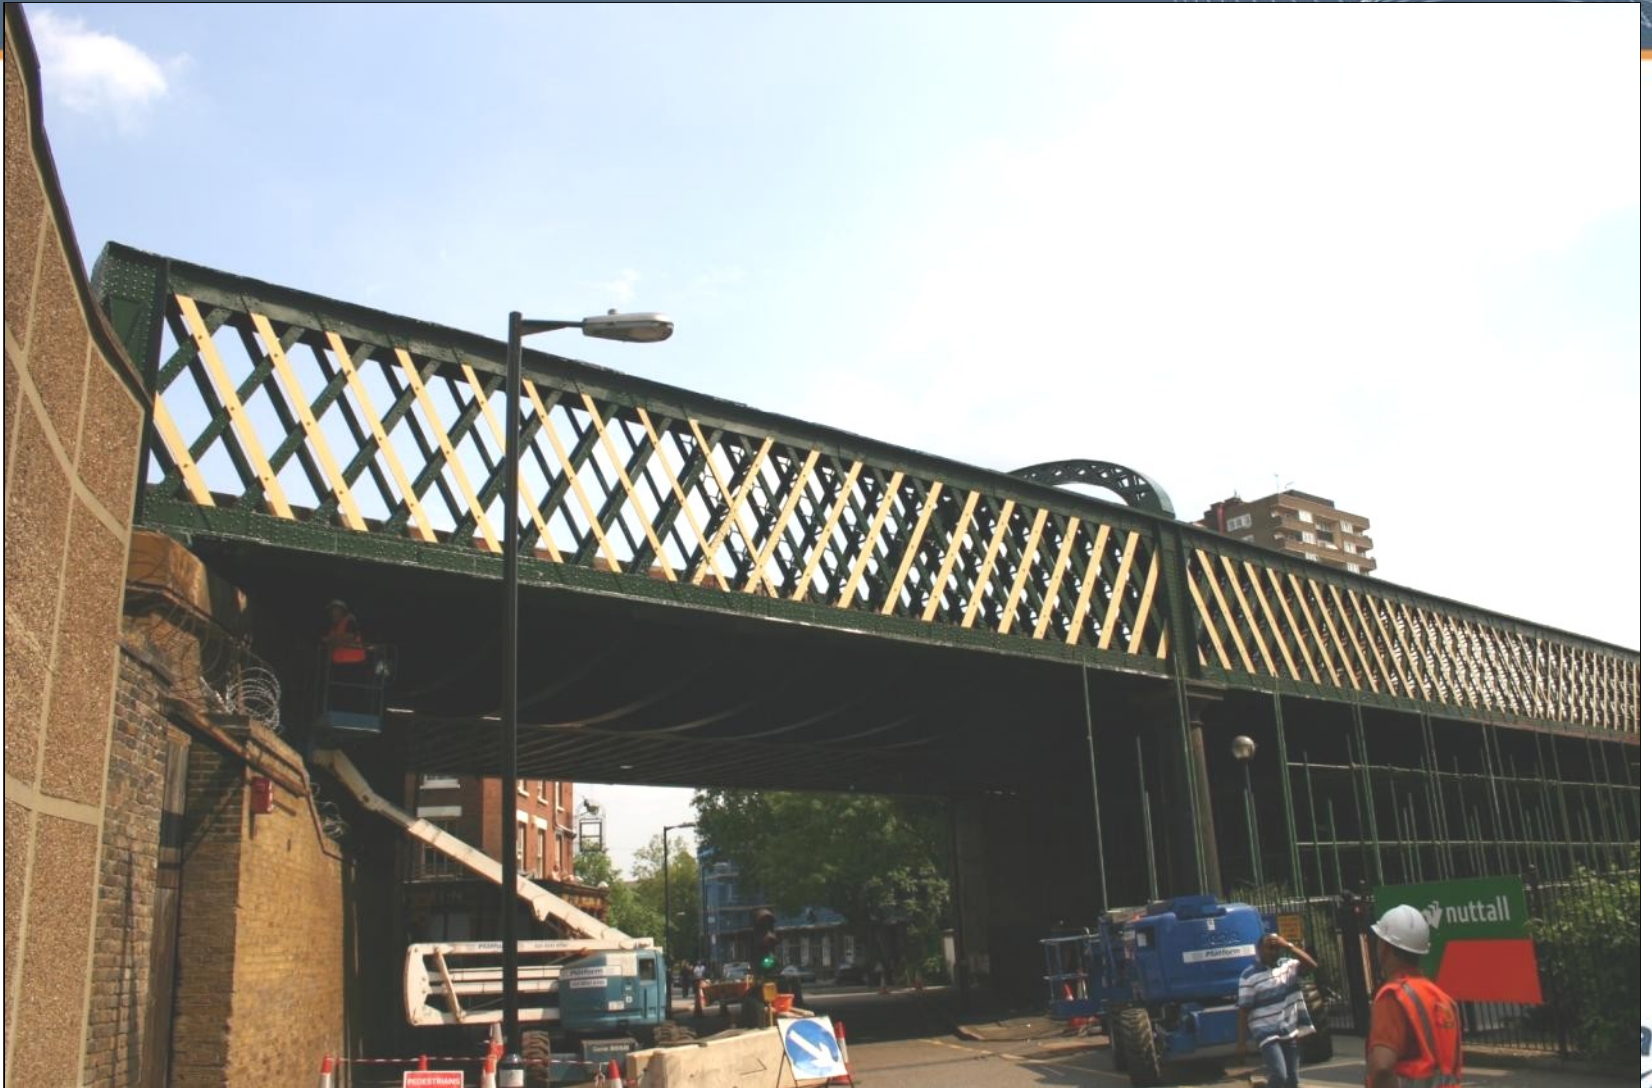
# Rockingham Street

- 1890s wrought iron bridge, carrying principally suburban EMUs and weekend engineering trains.
- Cross girders weak in shear and bending
- Reconstruction estimate £3.5m
- Modified “top hat” solution, known as a “bottom hat”, possible as adequate headroom available.
- Bridge now full strength, final contract cost around £1m.

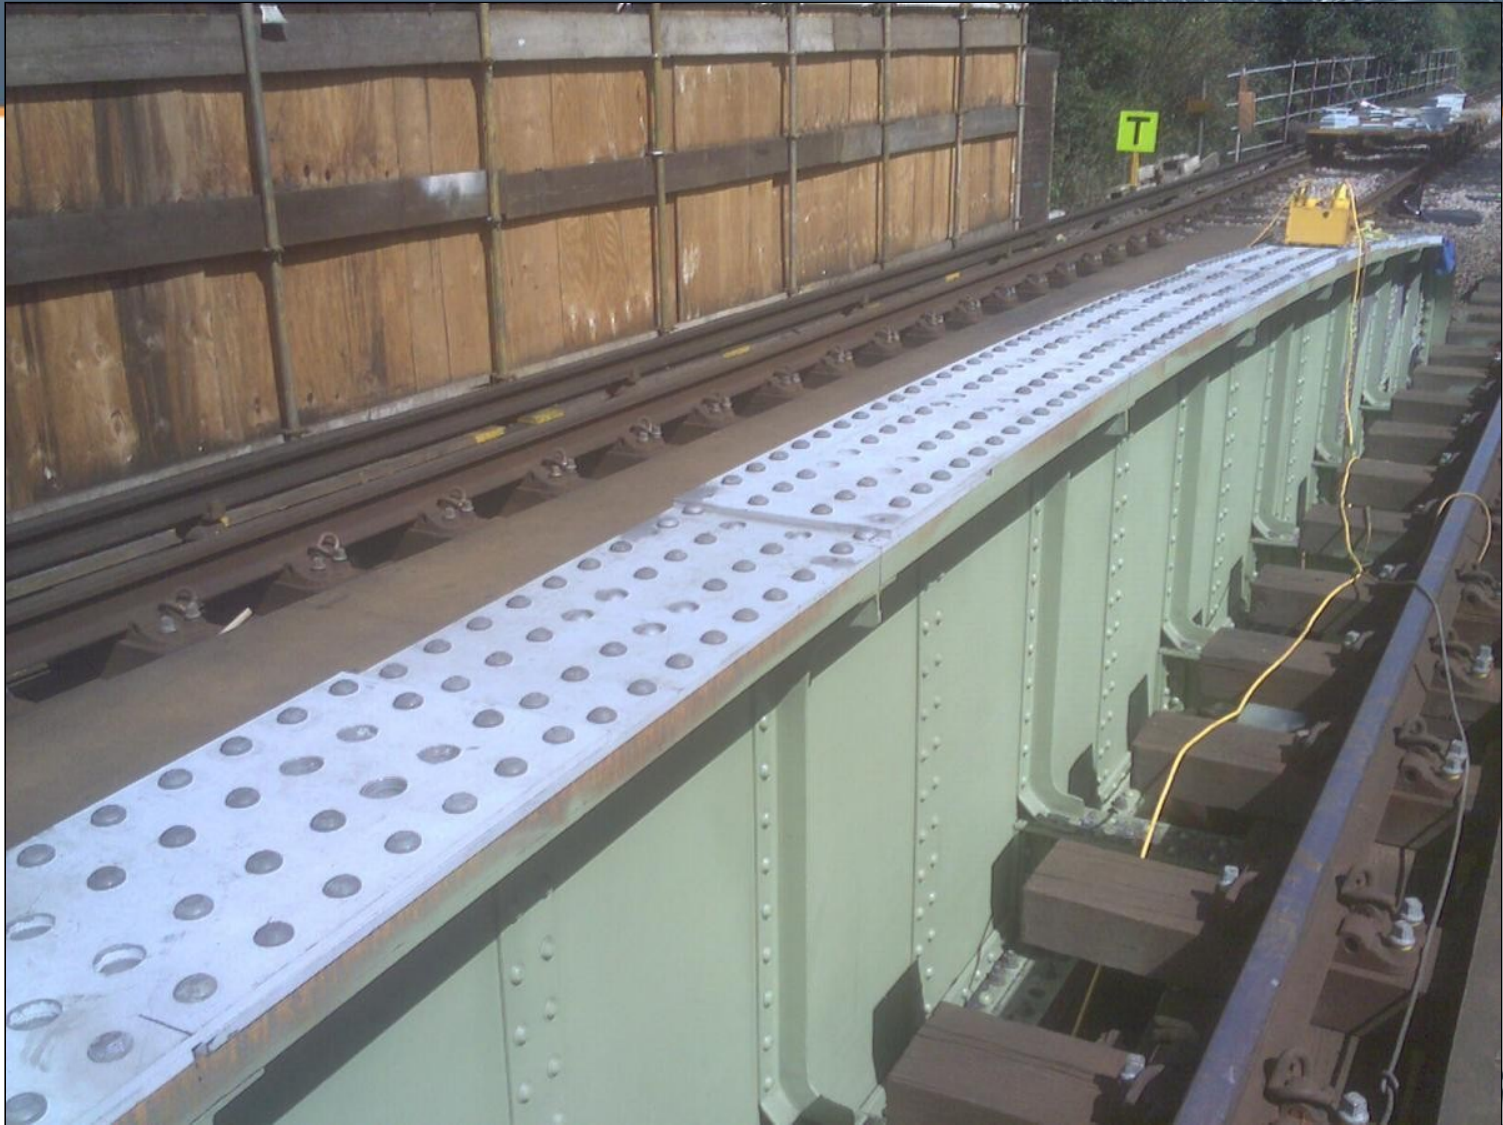
# River Mole

- 3 span wrought iron bridge built around 1880
  - External main girders trusses
    - Full strength
  - Inner main girders fish bellied plate construction
    - weak in compression and shear.
- Top flange strengthened with extra plates
- Web strengthened with discrete plates to resemble a truss.
- Total cost £800k

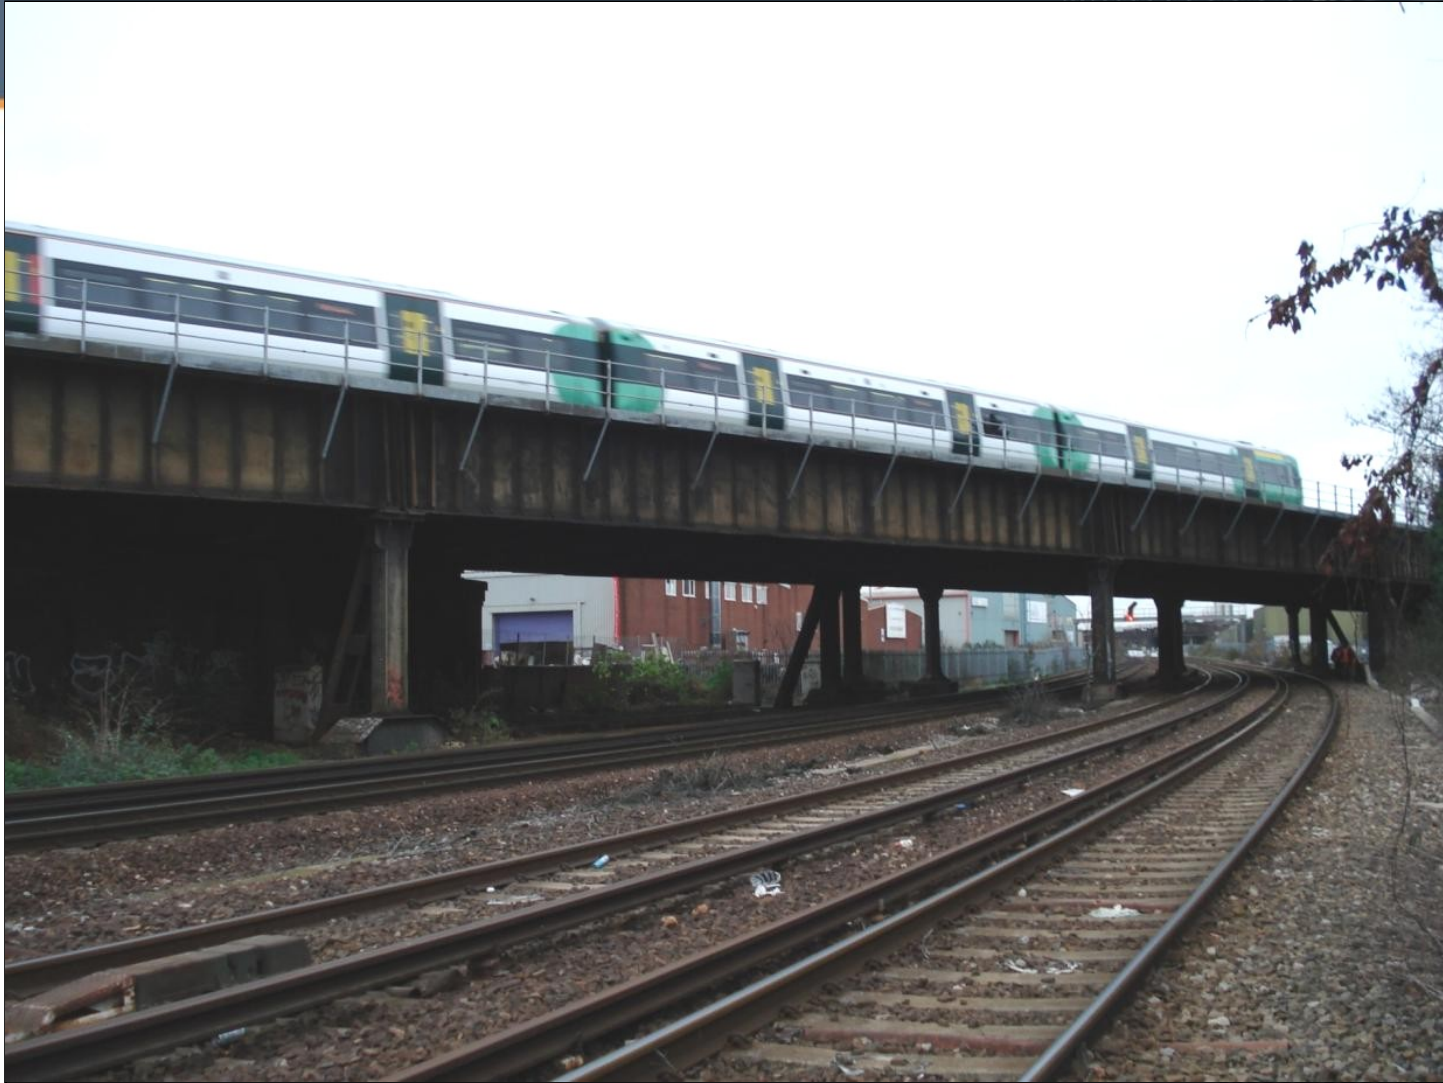
# Four Span

- Built 1866 using wrought iron plate girders
  - Carries 3 tracks of main London to Brighton line over a secondary route.
  - As name implies, 4 spans consisting of main girders, cross girders and rail bearers
- Cross girders weak
  - Additional cross girders fabricated to fit around main girders.
  - New cross girders installed during 54hr weekend closures of lower route
  - Bolted in position mid week with trains running on main line
- Had main line been lower tracks this option would have been feasible

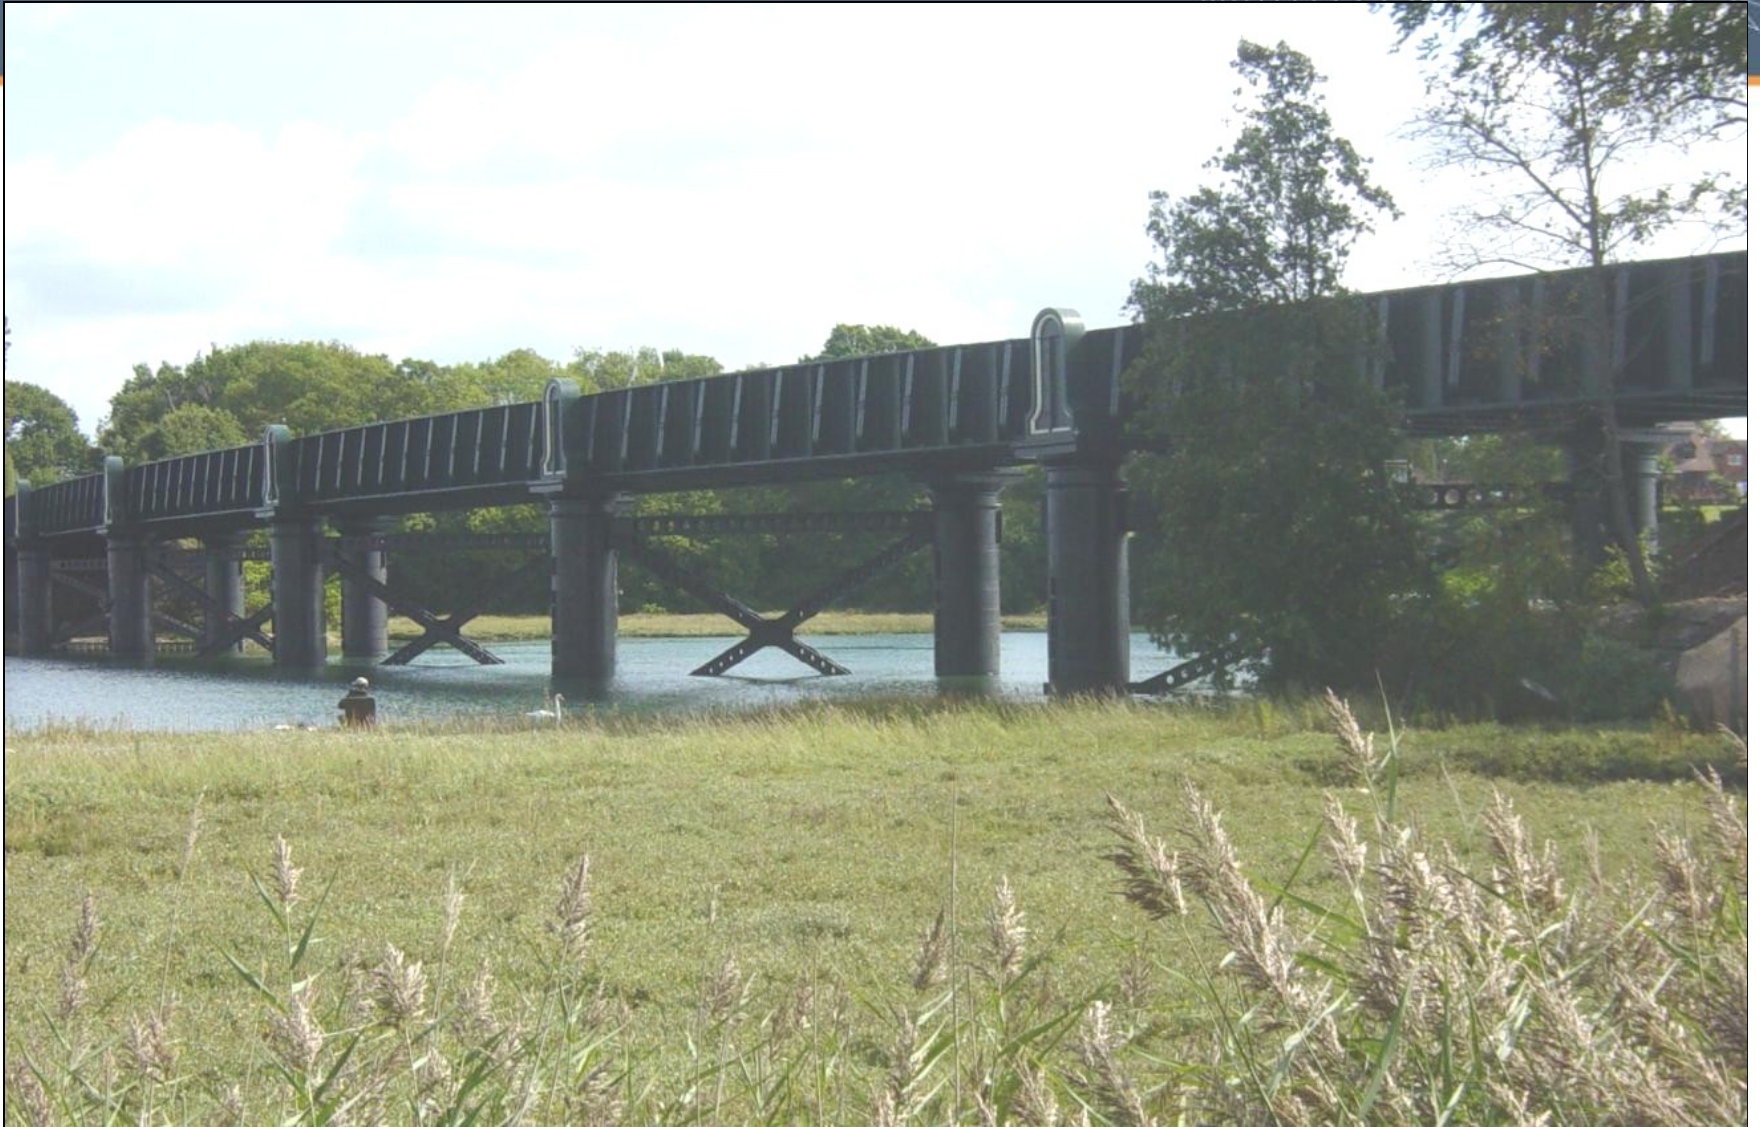
# River Hamble

- 1890s built 6 span wrought iron bridge over tidal river
  - Plate main girders, cross girders and pressed troughing flooring
  - Main girders theoretical zero live load capacity
    - Lateral torsion buckling of compression flange and web shear deficiencies
  - Cross girders not aligned with main girder stiffeners
- New stiffeners provided at each cross girder location
  - To provide “U” frame action
  - Each fabricated in 24 parts to facilitate man handling into position
  - Installed during standard 8hr overnight weekend line closures
- Over 350 tons of steel added and over 35,000 bolts utilised
- Final project cost (including repainting) £3.5m
  - Total time on site about a year

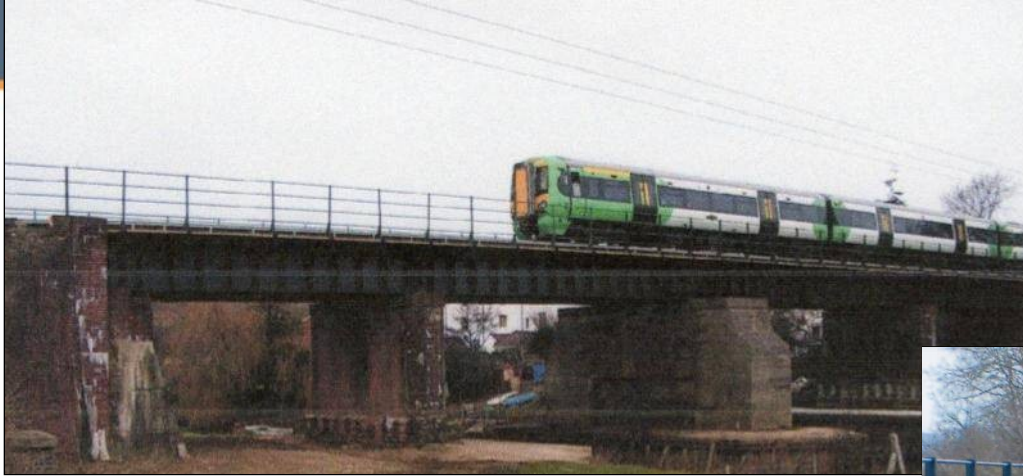
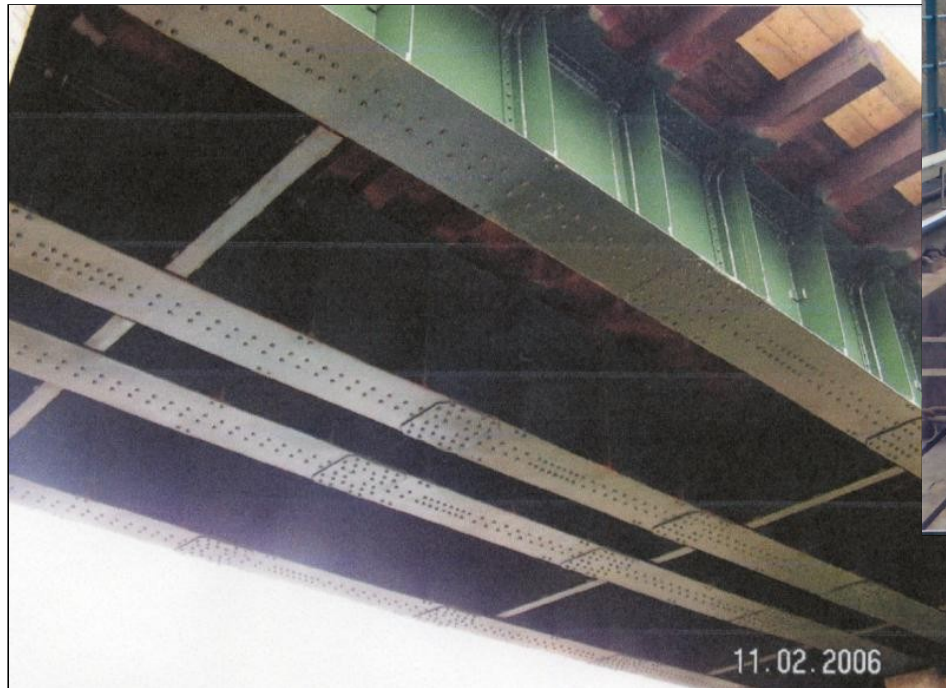
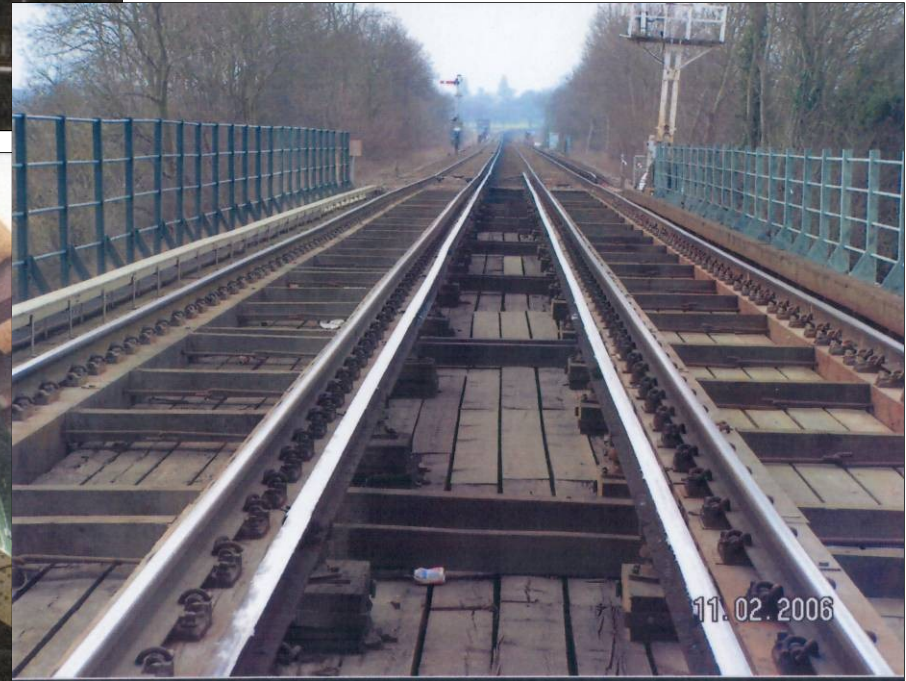
# Arun River

- Bridge dates from around 1860
  - 4 spans with four continuous main girders
  - Structural timber decking resting on top flanges spans between main girders
  - Track supported by longitudinal timbers
- Main girders weak in bending and shear at intermediate supports
- “Wing” horizontal stiffeners provided over piers

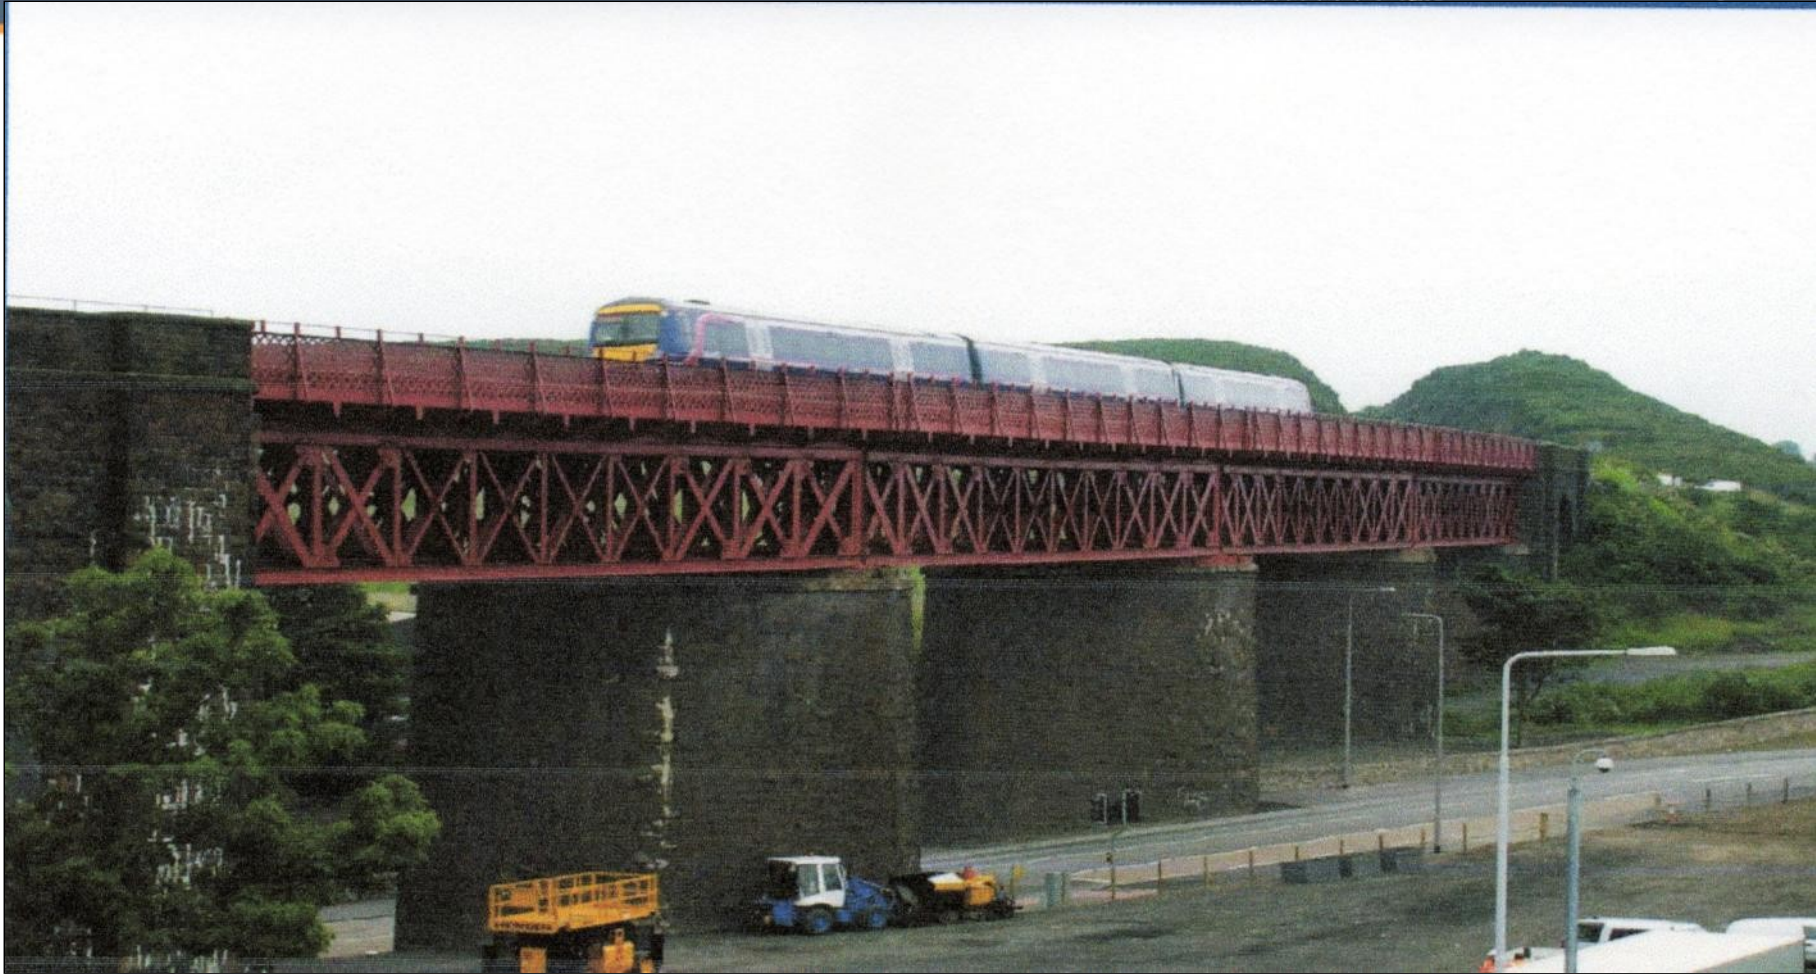
# Jamestown Viaduct

- Six span viaduct constructed 1887-1890 as part of Forth Bridge railway
- Four central spans steel
  - 2 truss main girders with cross girders and steel deck plates
  - 33.4m span at 70° skew angle
- Assessment results
  - Truss top and bottom booms weak in flexure
  - Truss ties weak in tension
  - Truss struts weak in compression
  - Cross girders weak in shear

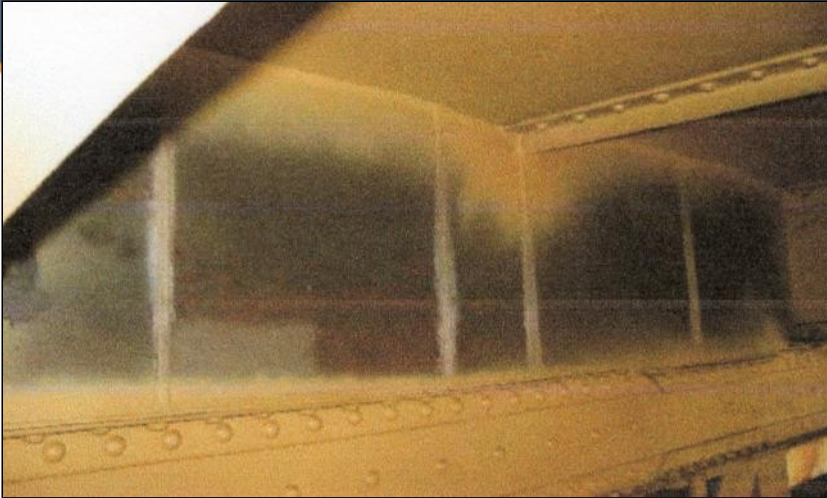
Diaphragm between main girder top boom and deck plates to transfer shear loads

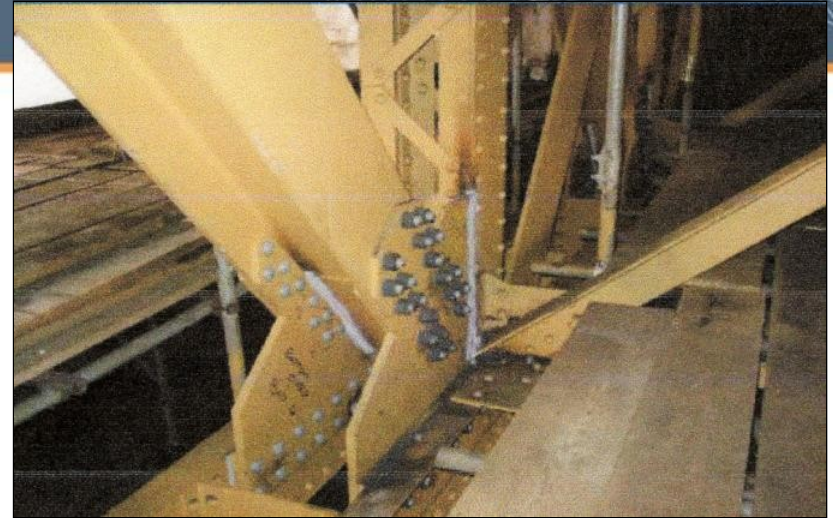
Strengthening of main truss ties with new "H" beams

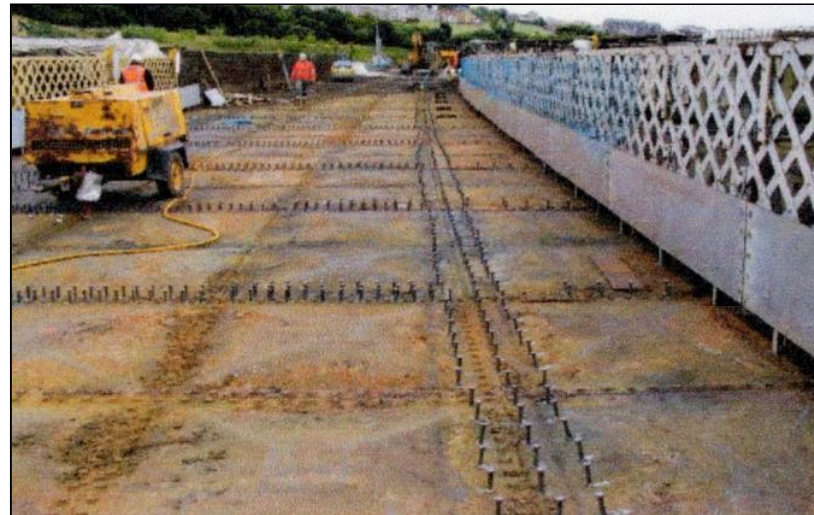
8,600 shear studs attached for new concrete deck

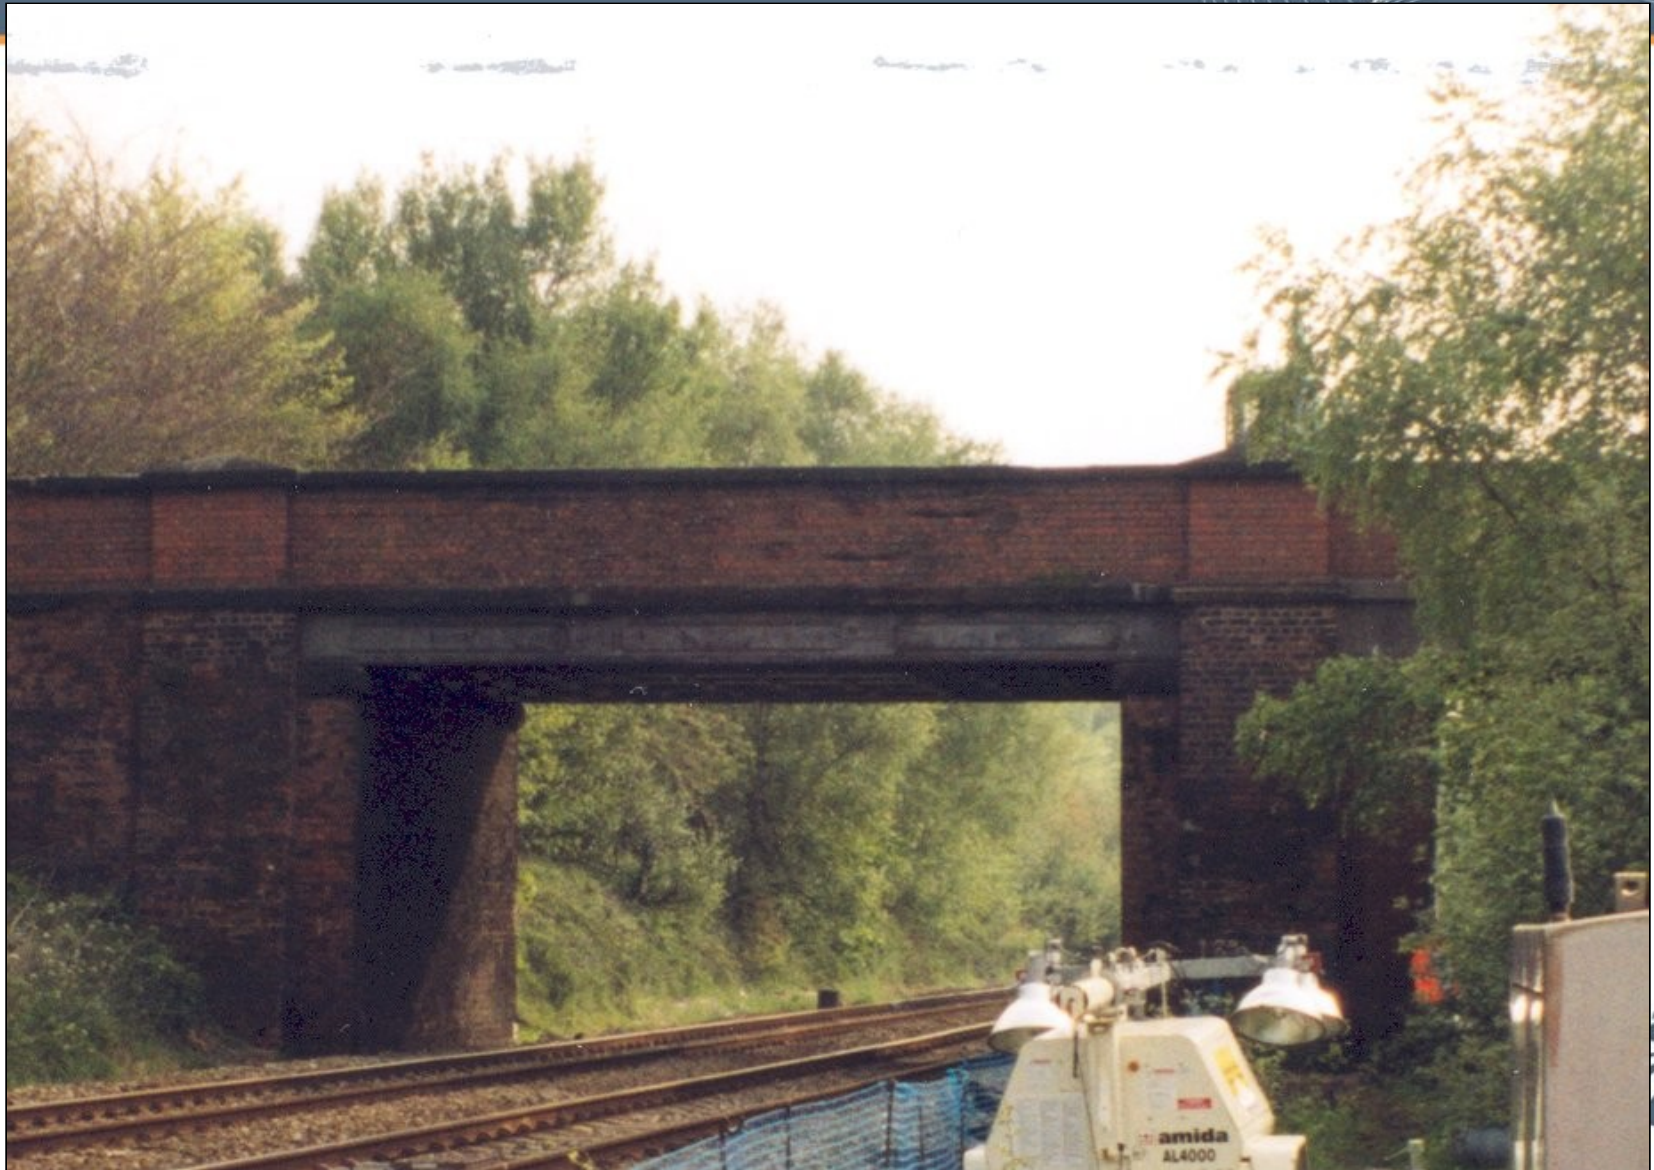
# New Moss Road

- Two span bridge carrying public road over railway
  - North span cast iron main girders and brick jack arches spanning open lines, built 1873
  - South span concrete slab spanning disused formation, built 1956
- North span capacity assessed as 17 tonne vehicle, local council wanted 40 tonne capability
  - Strengthened with 2No. 140mm wide UHM CFRP plates per beam with a maximum thickness of 24mm
- Final cost £450k, saving around 75% when compared to reconstruction

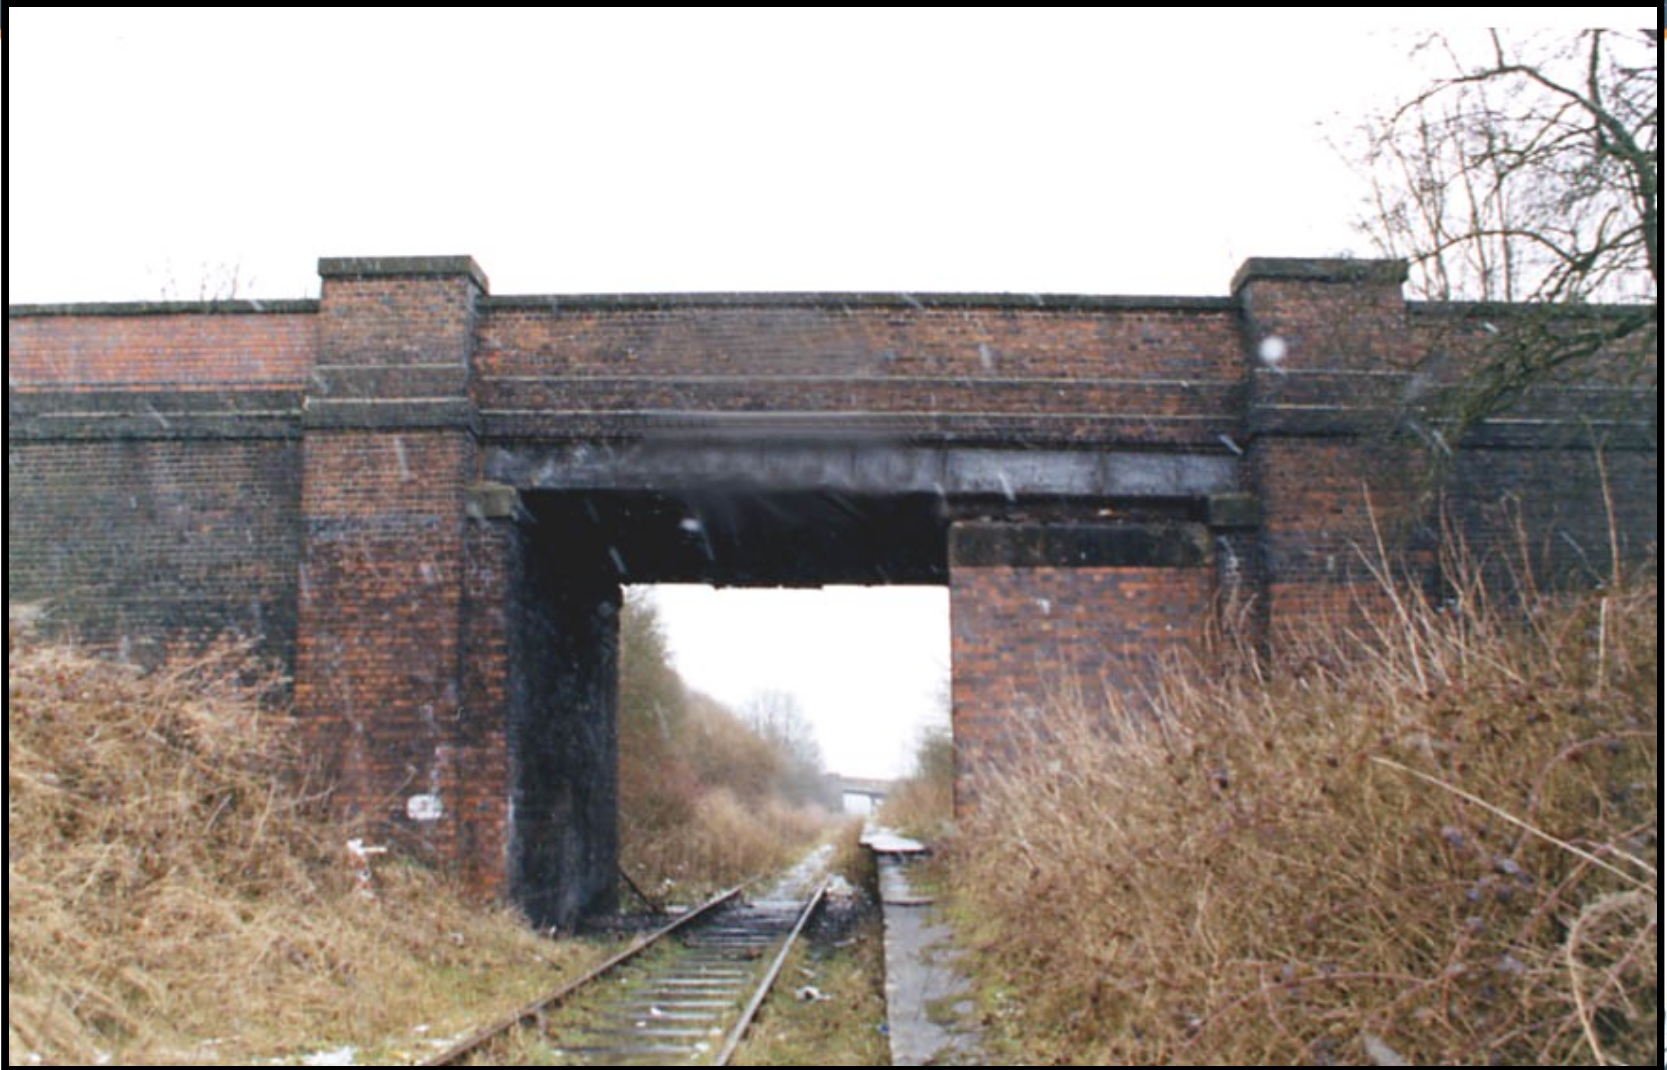
# Maunders Road

- Built around 1900, consisting of cast iron longitudinal main girders and jack arches
  - Capacity of edge girders assessed as 3 tonne vehicle and internal girders as 7.5 tonne vehicle
- Carries a local road over a mothballed railway
- Bridge provides only access to a nearby industrial area
  - Council required 40 tonne capability
- Novel design using UHM CFRP plates incorporating load relief
  - Edge beams required 2 plates 90mm wide x 32mm thick
  - Internal beams required 2 plates 140mm wide x 37mm thick
- Final cost £300k, saving around 50% when compared to reconstruction

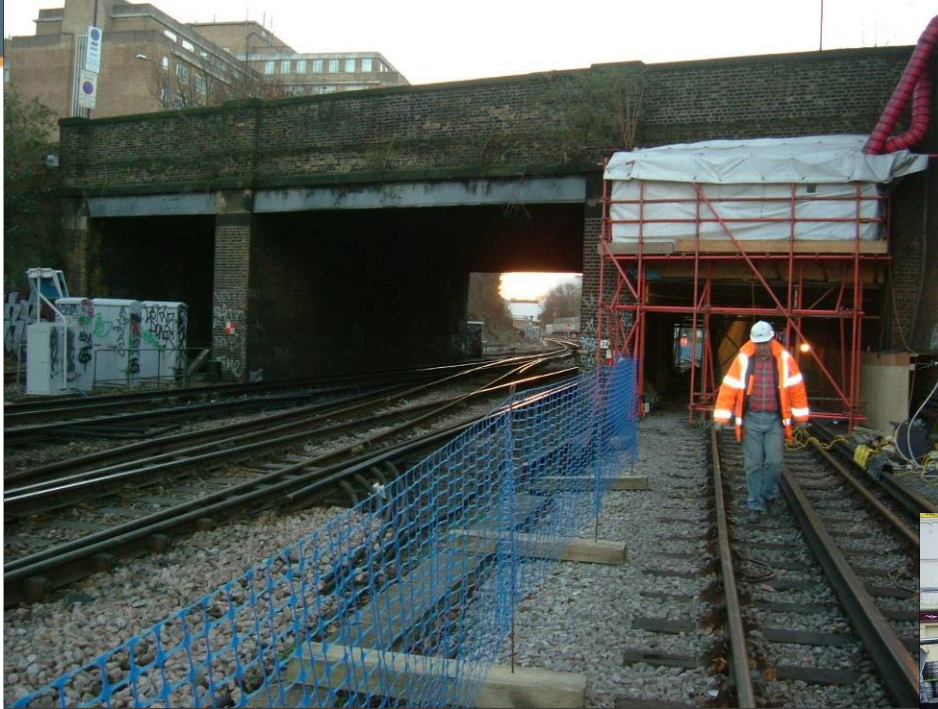
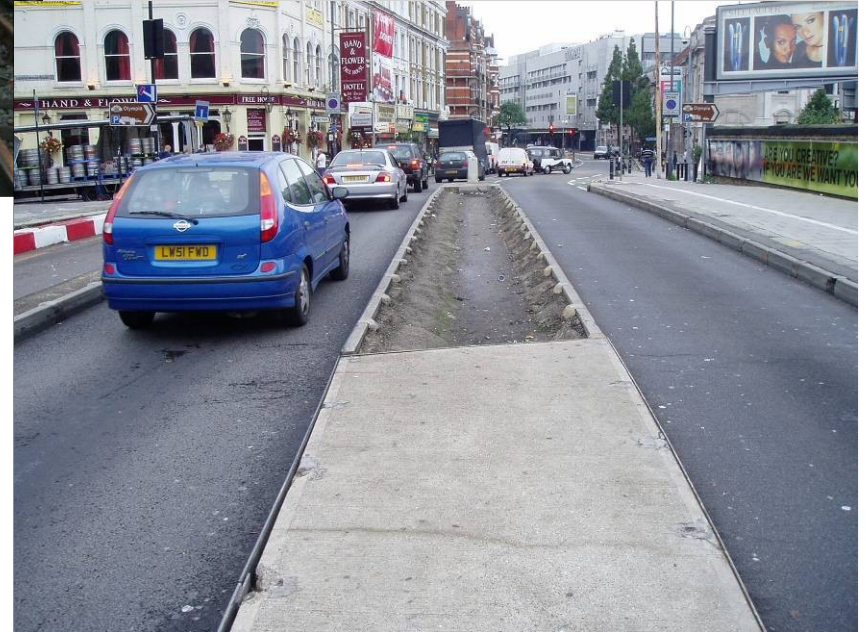
# Hammersmith Road

- 3 span bridge built in the around 1860 to carry a very busy main road in west London
  - Main span crosses the principal cross London freight route to the Channel Tunnel
  - One side span crosses the London Underground District Line branch to Olympia
- Each span consists of 13 cast iron longitudinal girders
  - Assessed capacity 18 tonne vehicle
  - 10 internal bays have brick jack arches
  - Remaining 2 internal bays have cast iron floor plates
    - These limit the assessed capacity to a 3 tonne vehicle
- 40 tonne capacity required
  - Main girders strengthened with UHM CFRP plates
  - CI deck plates strengthened with specially manufactured cruciform stiffening made from UHM CFRP
    - Insitu wet lay up not chosen due to short duration of available rail closures.

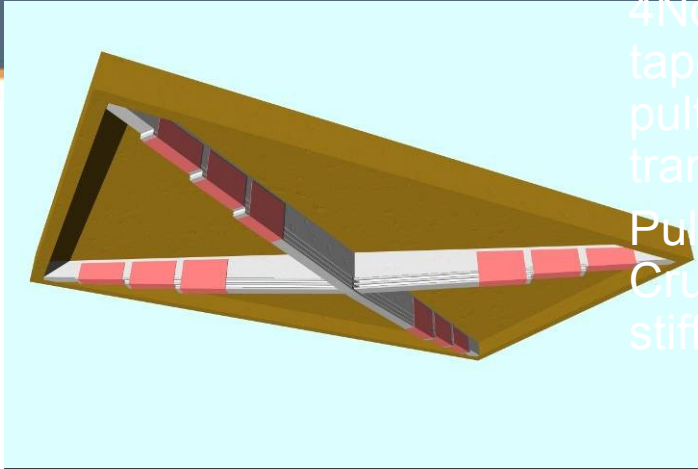
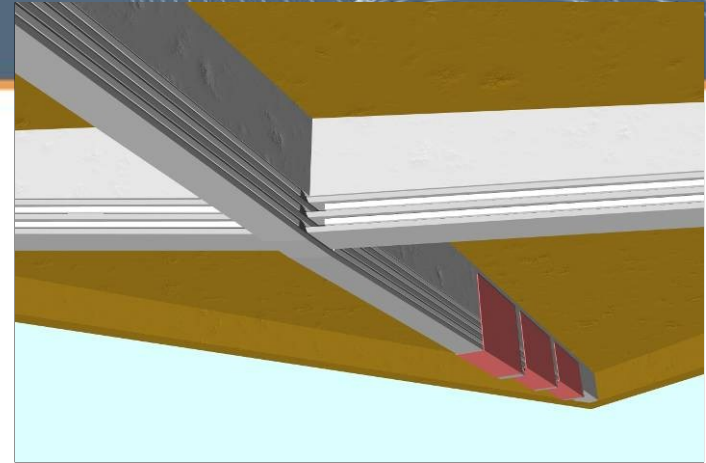
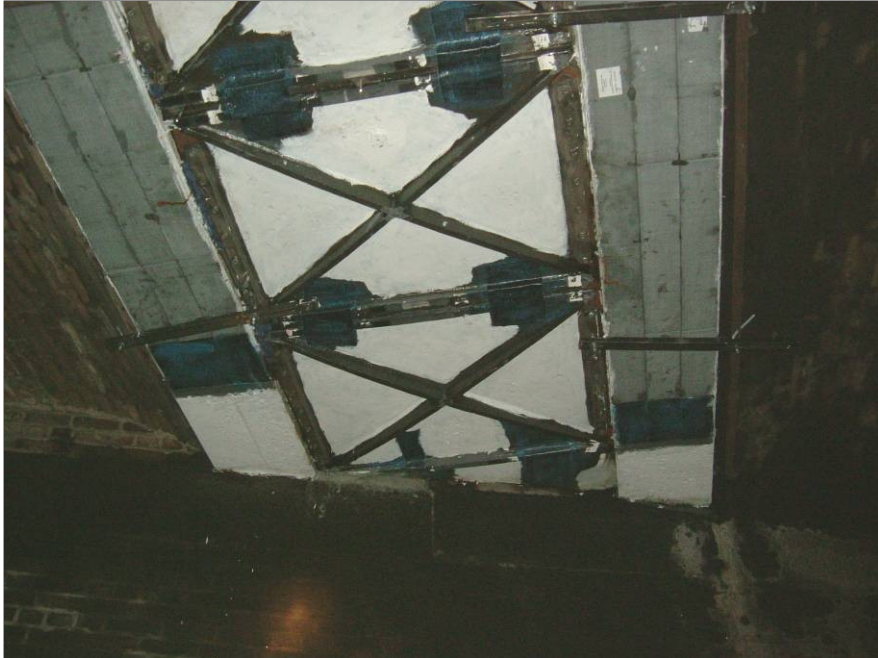
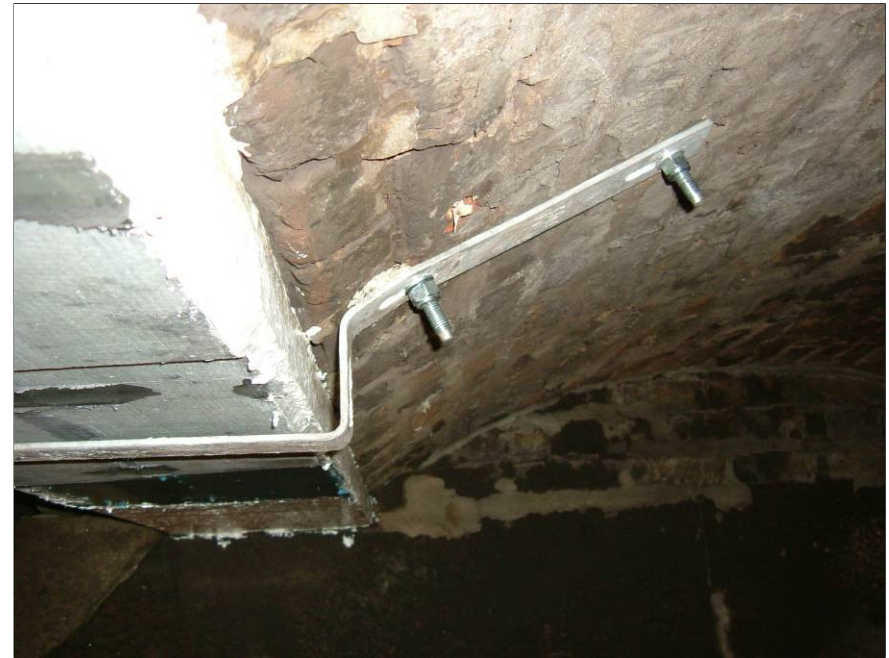
# Hammersmith Road

4No. 30mm wide  
tapered multi-layered  
pultruded FRP  
transverse stiffeners  
Pultruded FRP  
Cross stiffeners

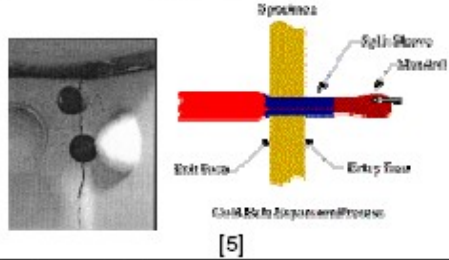
Hole drilling	Stops cracks by decreasing stress intensity factor. Method is almost only applicable at large visible cracks. Many cracks will relatively fast reinitiate crack growth.

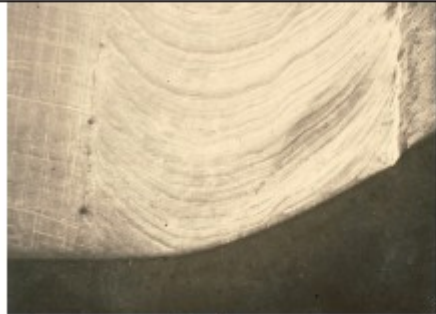
[6]	Laser/TIG remelting	Remelting the weld to eliminate defects and gaps within the weld. Best to do at a workshop with controlled conditions. Usable for up to 6mm defects. Picture is laser remelt
