Learning the lessons from bridge collapses around the world

Mungo Stacy

Principal Engineer, Parsons Brinckerhoff

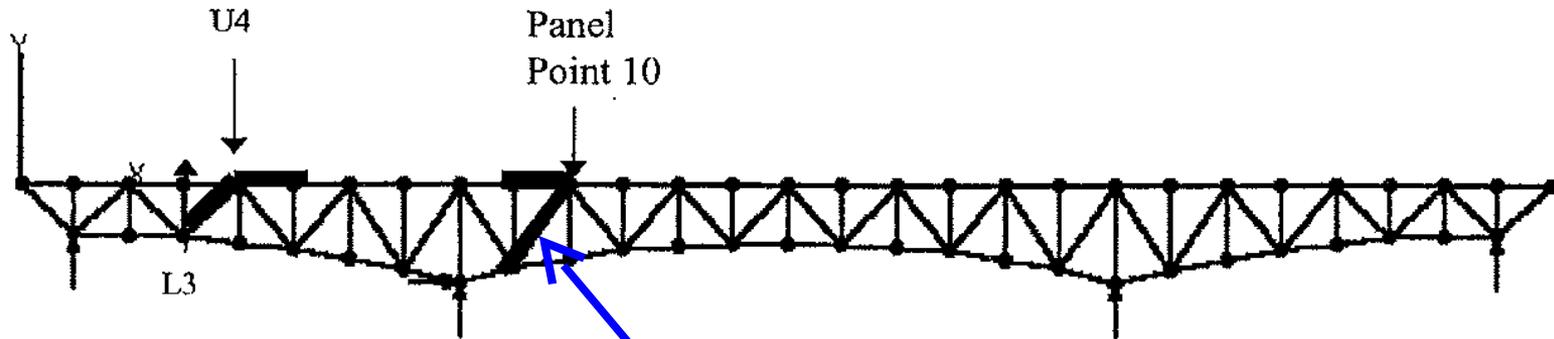
Figure 7: Gaged Locations on the Main Truss

Fatigue / redundancy studies

Physical testing and modelling conducted by University of Minnesota

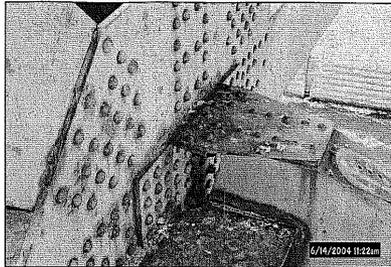
Bottom Chord Connection Condition

Panel Point #13 (East Truss):

Water from deck drains fall directly into river. [99/2002] Bottom chord gusset plate has section loss, flaking & pack rust. [1999] Truss bottom chord member L13/L14 has cracked tack welds at two interior stiffeners. [2004] Bottom chord member L13/L14 cracked tack weld @ diagram tab (diagram #1?). Cracked tack weld @ diagram tab member L13/U14 see photos.

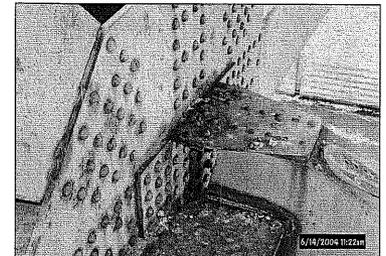
Water from deck drains fall directly into river. [9/9/2002] Bottom chord gusset plate has section loss, flaking & pack rust. [1999] Truss bottom chord member L13/L14 has cracked tack welds at two interior stiffeners. [2004] Bottom chord member L13/L14 cracked tack weld @ diagram tab (diagram #1?). Cracked tack weld @ diagram tab member L13/U14 see photos.

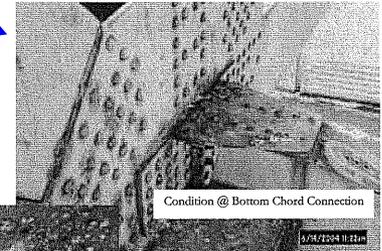
Water from deck drains fall directly into river. [1999] Truss bottom chord member L13/L14 has cracked tack welds at two interior stiffeners. [99/2002] Bottom chord gusset plate has section loss, flaking & pack rust. [2004] Bottom chord member L13/L14 has cracked tack weld @ diagram tab. Cracked tack weld at diagram tab member L13/U14. See photos. [2006] Bottom chord member L13/L14 has a missing bird cover.

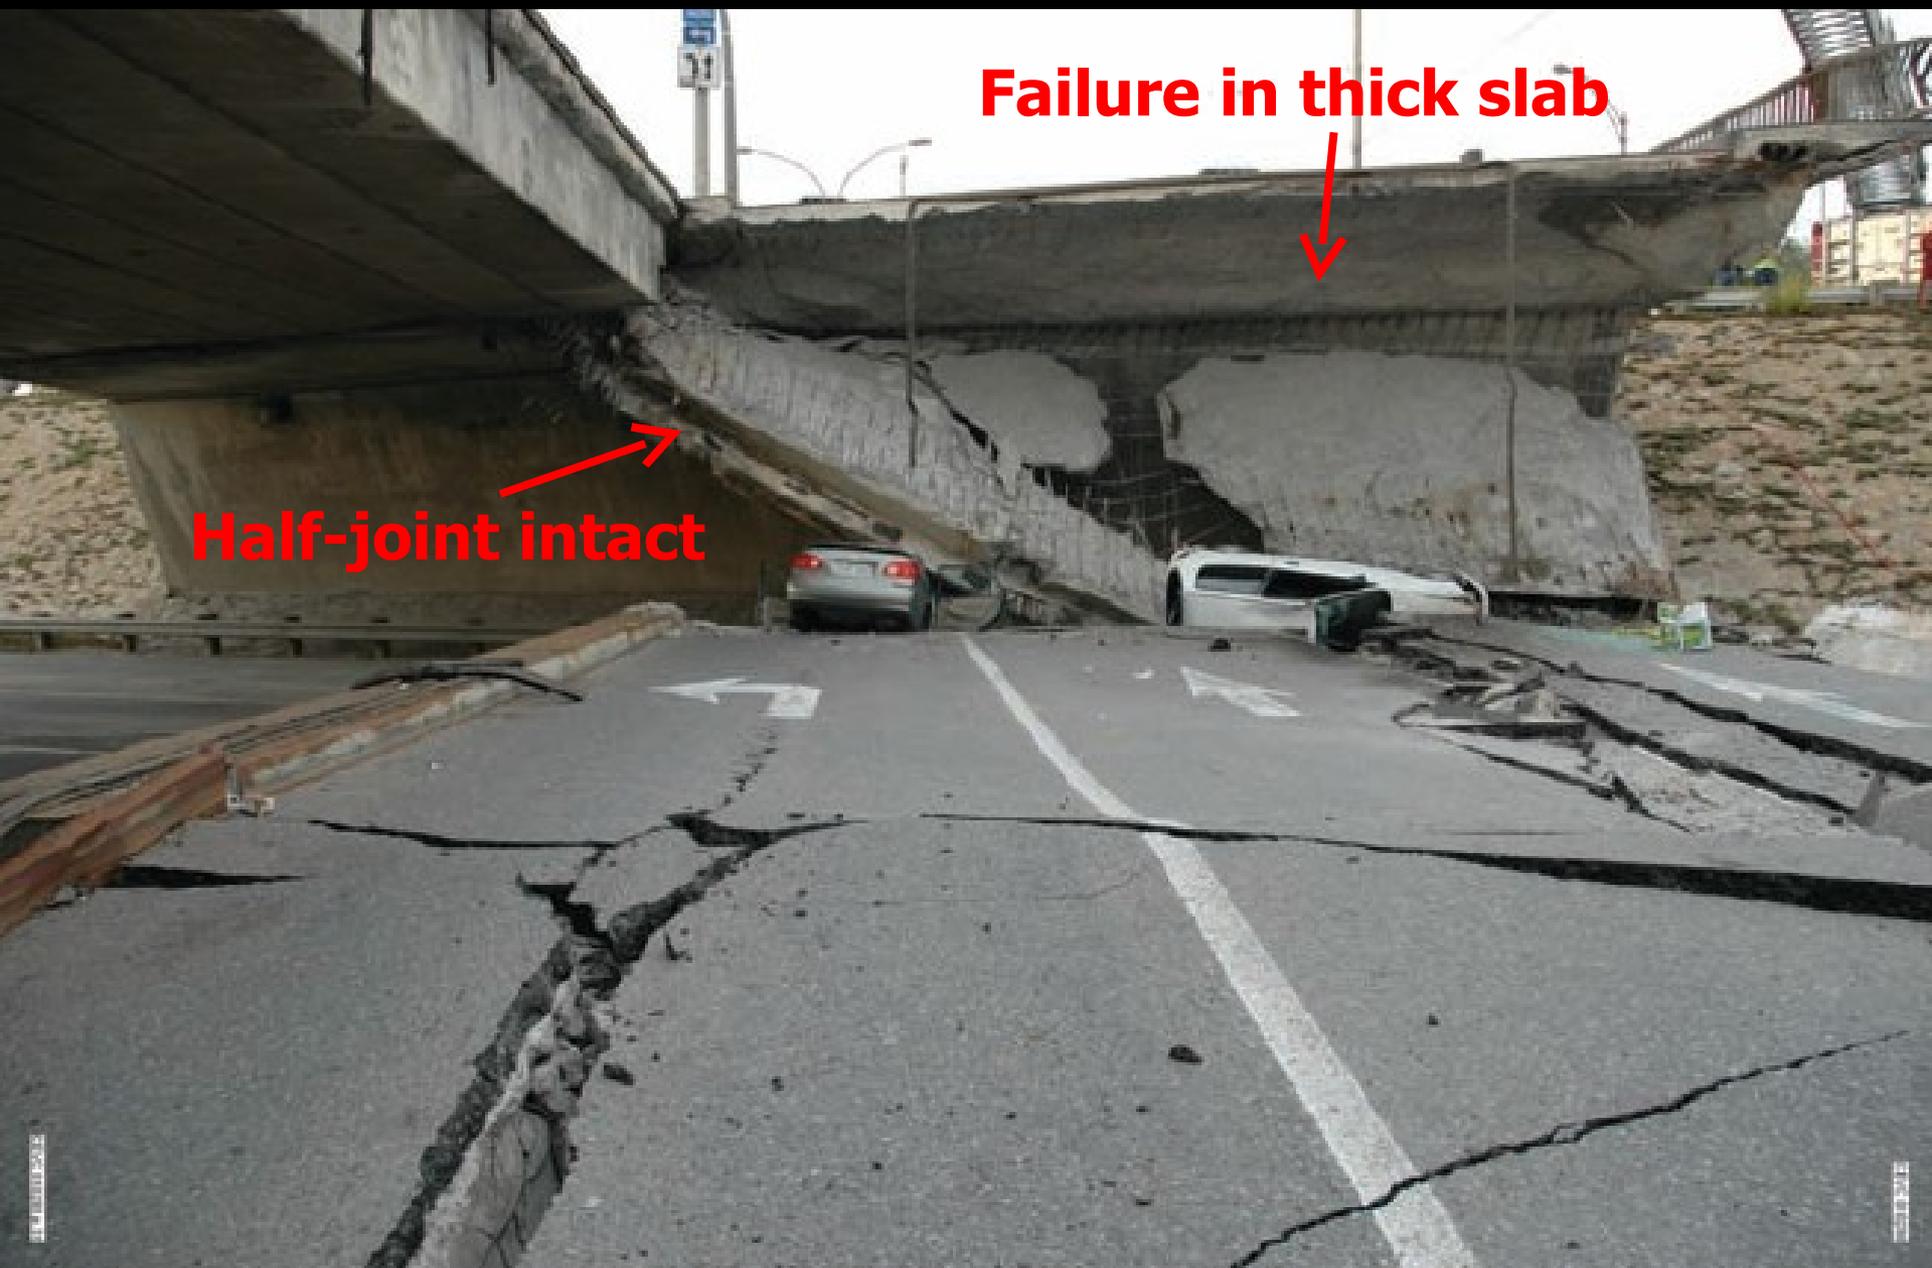
Failure in thick slab

Half-joint intact

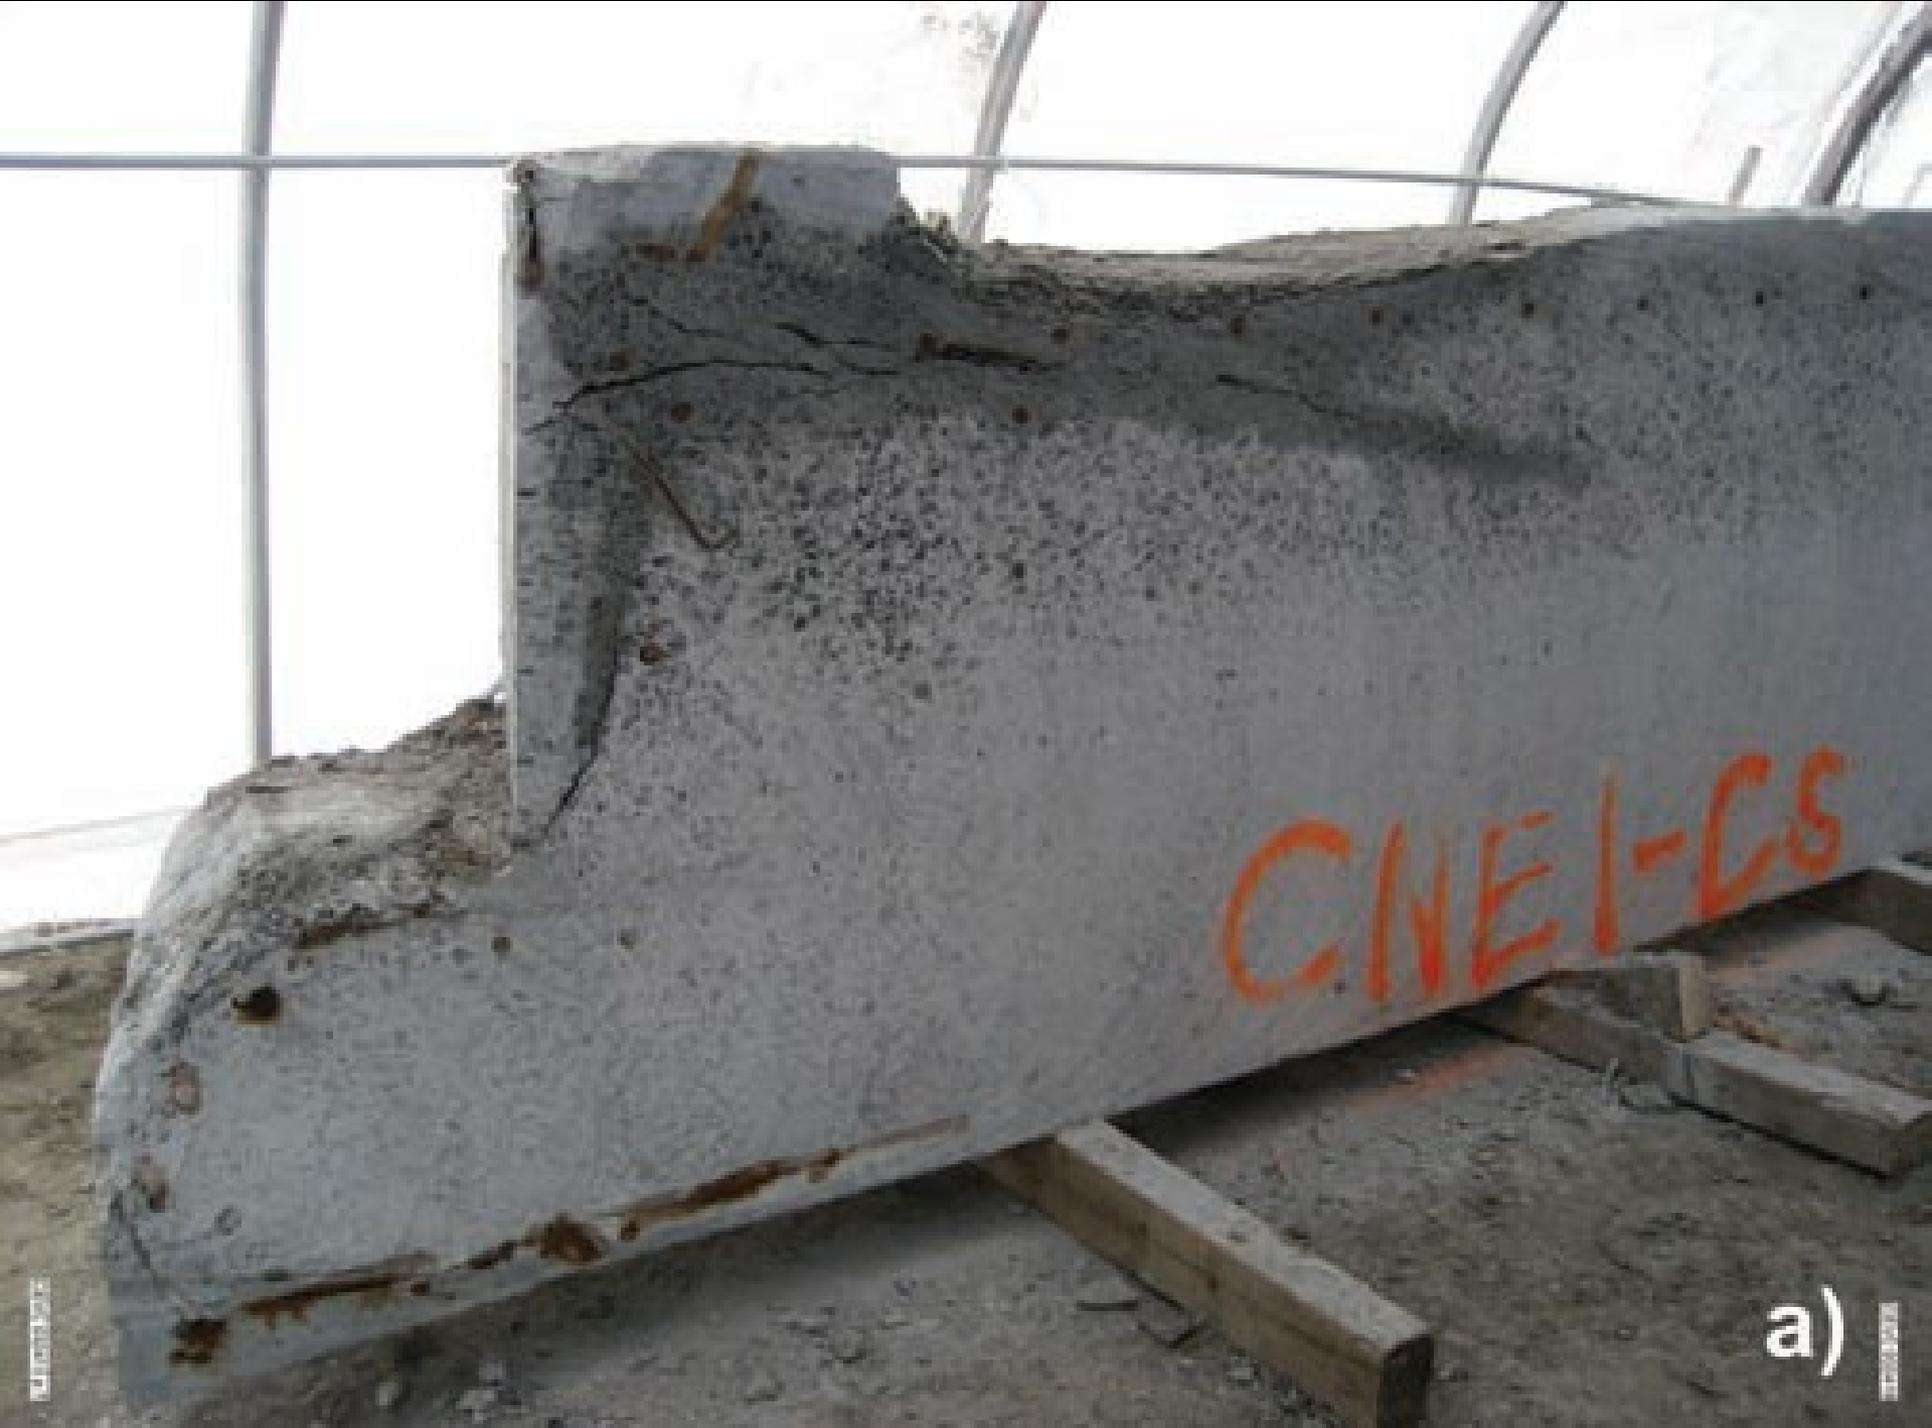
Causes - poor anchoring detail

- not in accordance with best practice
- inadequately anchored
- but did not contravene 1966 code
