Inspection guidance for bridge expansion joints

Part 1 – Reference guide

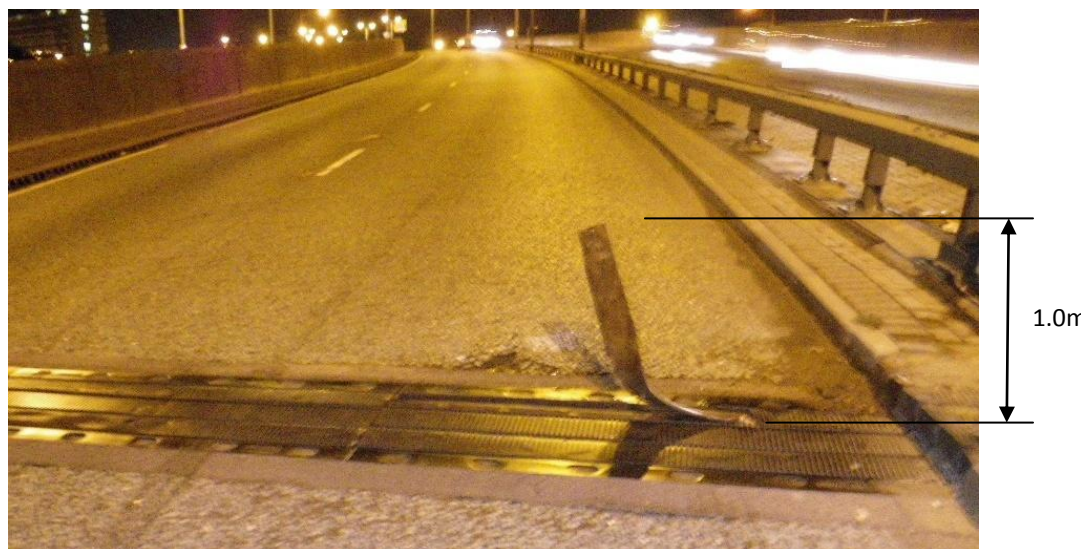
Photo 2.1 Failed elastomeric expansion joint on a major dual carriageway

The joint was only five years old. A recent principal inspection had given the joint a condition rating of 2B (early signs of deterioration, minor defect/damage, no reduction in functionality, along not more than 5% of the surface length). The inspection recommended that works to resolve leakage through the joint should take place within the next five years. Only eighteen months later, the joint failed spectacularly, leaving a dangerous obstruction in the carriageway. Luckily, the incident happened at night when traffic volume was low, damaging ten vehicles. There were no fatalities.

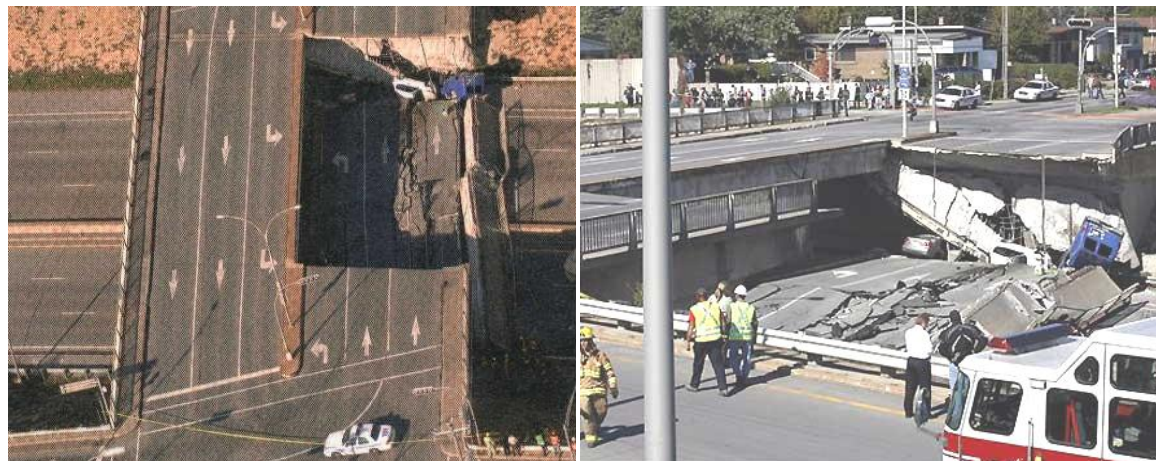
Photo 5.2 Collapse of Concorde Highway, Montreal, Canada (8)

This bridge, in Montreal, collapsed on 30th September 2006 about one hour after a bridge inspector had declared it safe, following reports of pieces of concrete falling from the bridge. Five people were killed when the cantilevered support to the central span failed, bringing the central span down onto the motorway below. The support that failed was located directly beneath an expansion joint, and had suffered extremely heavy corrosion, probably due to the road-salts used to keep the road ice-free during Canada’s cold winters. The expansion joint leaked. Had the road been busier, the number of fatalities could have been much higher.

The Montreal bridge collapse (see case study 5.3) demonstrated the effect of unmanaged water and highlighted the importance of the condition and watertightness of expansion joints. Joints are designed to be compatible with waterproofing systems, but it is almost inevitable that all joints will leak during their lifetime (9). Therefore, management of water is extremely important to reduce as much as possible the volume of water able to leak through a joint and affect primary deck elements. Possible causes of a loss of watertightness include

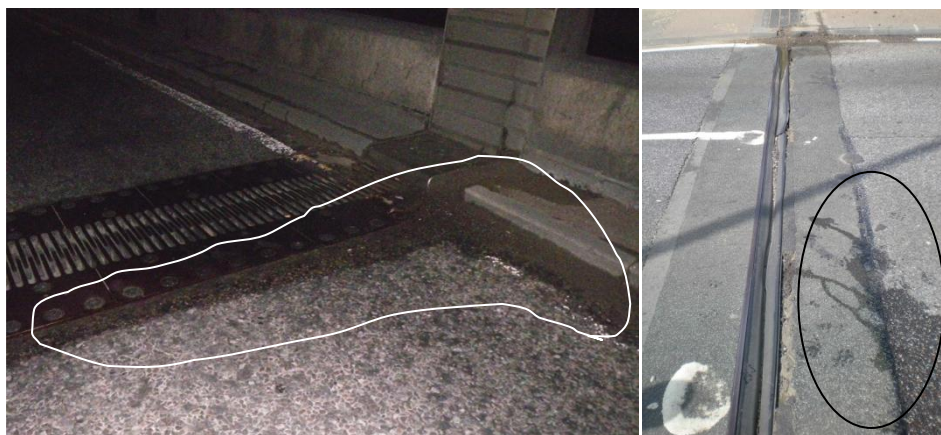
Photo 5.4 In both examples, the carriageway is wet on one side of the joint, showing that the surfacing is saturated.

The presence of sub-surface drainage is also important. Road surfacing is porous, and water will flow through the surfacing. However, an expansion joint will form a dam across the surfacing on the uphill side of an expansion joint, causing water to collect. This is called ponding. This, in turn, will cause the surfacing to break

up, as vehicle loading on the saturated surfacing will generate high internal hydraulic forces. Water inside the carriageway surfacing can cause it to deteriorate under freeze-thaw action. Damage to the surfacing adjacent to expansion joints will lead to the edges of the joint becoming exposed and subject to much greater forces from traffic loading.

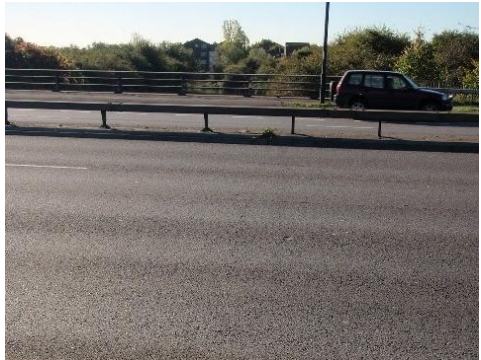
Crack inducer defects	Cracking can be managed by a crack inducer, typically a saw-cut across the surfacing, filled with flexible sealant. This allows some movement without generating stresses in the surfacing. The sealant in the crack can be pushed out, as the saw-cut will tend to close under traffic loading. The sealant will also deteriorate with time, cracking itself. A lack of seal in the saw-cut will allow the surfacing to break up as it will be unsupported at the saw-cut.	<p>Buried joint, appears in good condition as no sign on the surfacing of its existence. No crack inducer is evident in the carriageway. This could be because it is at the fixed end of the bridge.</p>

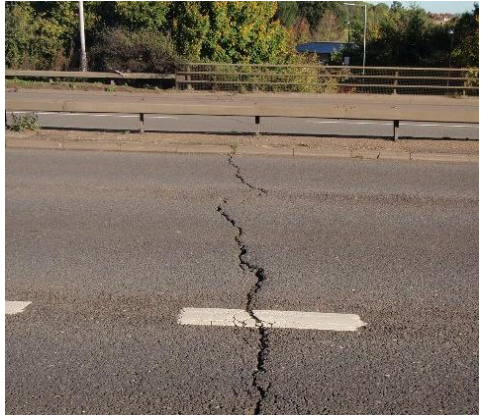
Leakage	Leakage is less likely in buried joints than most other joint types because the waterproofing is continuous. One possible cause of leakage is a discontinuous flashing across the deck.	<p>Wide crack across the full width of the carriageway, with no sealant.</p>

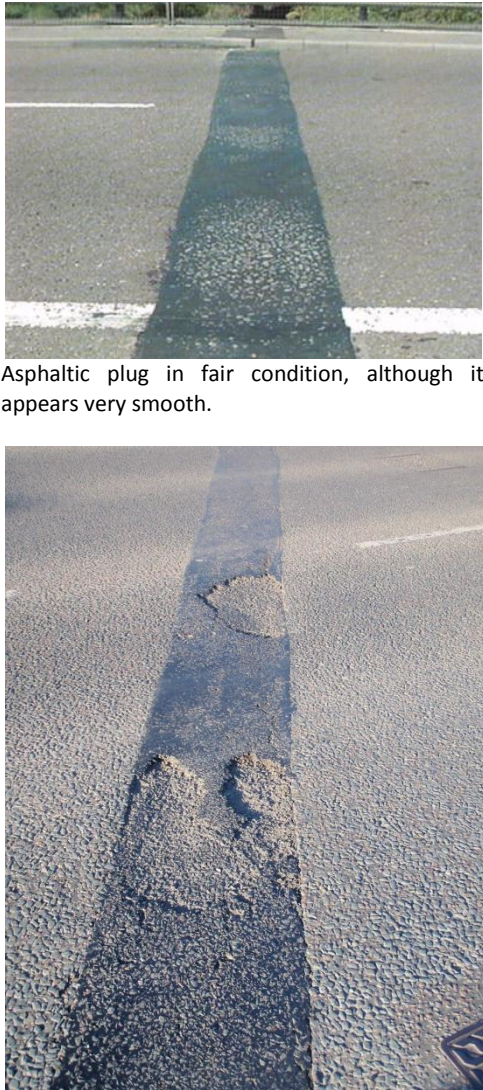
Tracking and flow of binder over adjacent road surface	<p>If the plug material is too soft, it will become depressed under tyre loading, and will also flow out of the joint and onto the adjacent surfacing. This is most likely under slow moving traffic or at higher temperatures. This usually happens at constant volume, with mounds of plug material forming at the edges.</p> <p>Tracking leads to breaking up of the plug and loss of support to the adjacent surfacing.</p>

Debonding between joint and road surfacing	<p>The watertight ability of the joint is dependent on a good bond between the plug and the deck and surfacing. Debonding allows water into the joint. A lack of bond will also lead to damage to the top edges of the plug and adjacent surfacing leading to break up of both plug and surfacing. Debonding is most likely where the plug material is stiff and the movement range is large.</p>	
Breaking up of road surface adjacent to joint	<p>When the joint becomes debonded, the edge of the surfacing becomes unsupported, which leads to break-up. It could also be caused by water underneath the surfacing being unable to dissipate due to blocked or no sub-surface drainage. It is most likely to occur on the higher side of the joint, where the water has drained to and then stopped as the joint forms a dam across the road. Break up of surfacing will expose the plug, leading to its break up, deteriorated ride quality and access for water to the joint.</p>

Cracking	<p>Cracks are most likely at a position coincident with the plate and in this case are probably caused by an uneven joint base causing the plate to bend. Cracks are also possible when the movement range is large.</p>	
Breaking up of plug material	<p>As well as the causes above, break up can be caused by water saturating the plug, usually after debonding from the surfacing. Hydraulic forces then lead to break up.</p> <p>Poor workmanship at installation may cause break up of the plug, due to a lack of binder in lower levels or the binder and aggregate becoming detached.</p> <p>Break up leads to deterioration of ride quality, damage to surfacing and water access.</p>	
Leakage	<p>Leakage caused by the defects described above will affect the durability of the structure.</p>	<p>Plug material is missing and pot holes are forming.</p>

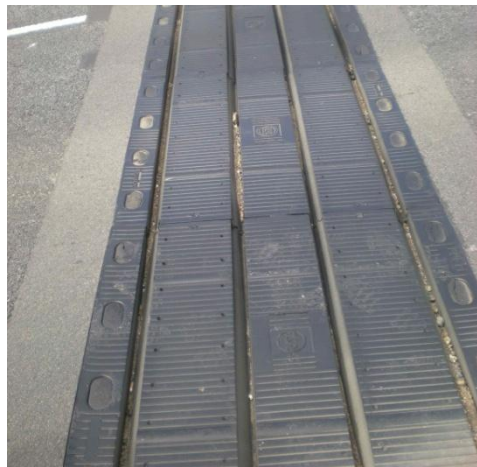
<p>Wide joint, in fair condition. Note debris in grooves.</p>
Breaking up or cracking of transition strips	This is generally caused by the transition strip becoming debonded, either from the surfacing or from the deck or abutment. Once debonded, the edge will be unsupported, and start to break up. This can happen to the transition strip and adjacent surfacing. Tracking of the adjacent surface can lead to the transition strip becoming exposed, and therefore subject to much greater forces from traffic loading, causing break up.

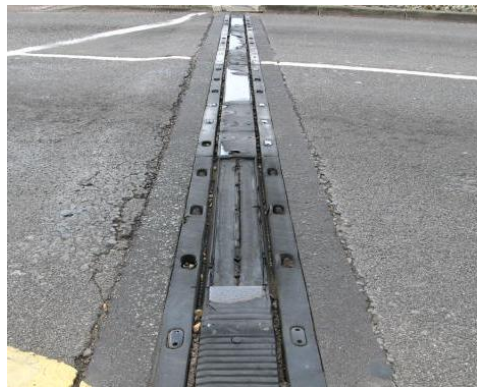
<p>Narrower version, but in poor condition. Note missing resin plugs, top plate and rubber. Also note depression in carriageway to left of joint, and cracks to the surfacing adjacent to transition strip, which is beginning to break up.</p>
Bolt failures causing joint to lift	Sufficient bolt failures will cause the joint to move under traffic. This will lead to impact damage to the deck below the joint.	
Debris in grooves	Debris in grooves will restrict movement and under vehicle pressure will wear the rubber.	
Wear of rubber ribs on top of joint.	Wear will reduce the skid resistance. Significant wear will expose the steel plates beneath the rubber, leading to delamination.

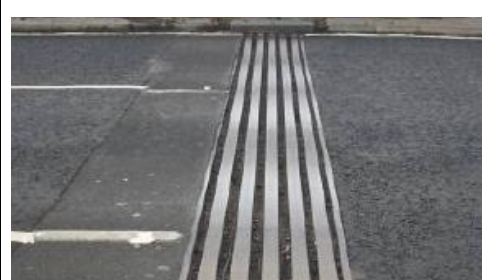
<p>Several central rails configuration</p>
Elastomeric seal breaks up or pulls out	<p>Siltation and debris will enable forces from passing vehicles to exert forces on the seal, leading to failure. This will then cause leakage. Debris can be left following resurfacing works.</p> <p>The seals on resin encapsulated joints are wider, and so larger and more debris can collect, leaving this seal more vulnerable.</p> <p>Excessive movement may cause the seal to pull out.</p>

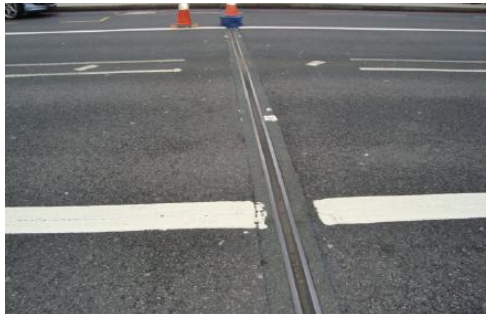
<p>Resin encapsulated (resin visible either side of rails).</p>
Worn metal rails	Worn runners will be polished and a hazard to vehicles, particularly motorcyclists and particularly if located on a skew or at a curve in the road.	
Distorted metal rails	<p>Tracking of the adjacent surfacing, or of the resin, will leave the leading rail exposed to lateral traffic forces. This will cause that rail to twist or rotate. This can also be caused by resurfacing works not being completed to the correct level.</p> <p>Distorted runners can be caught by trailing elements of vehicles or snow-ploughs, pulling them out.</p>

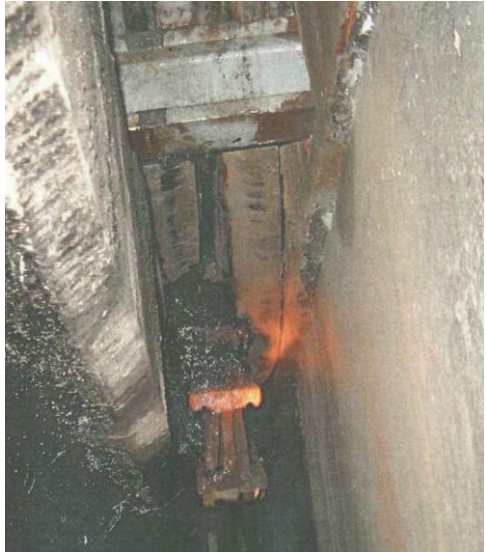
<p>Rail has dropped, visible from underneath.</p>

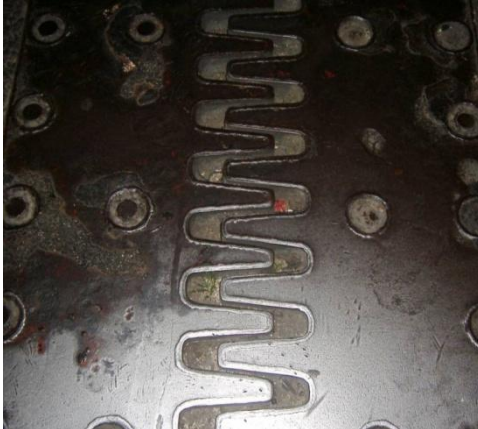
<p>Gaps in teeth need cleaning and metal surface appears polished.</p>
Loosening of securing bolts/failure of concrete anchorage	Initially this will cause movement of the plates, causing noise and increasing the probability of further bolt failures. This could lead to misaligned teeth or damage to adjacent surfacing or bedding material through impact.

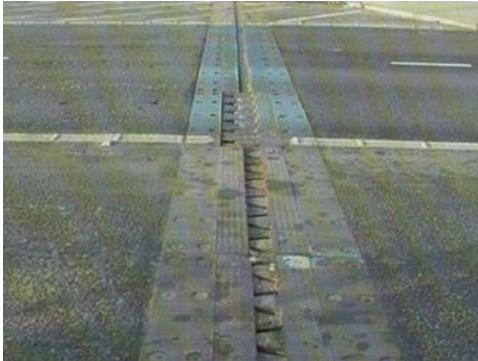
<p>Plate missing in centre of photograph.</p>
Debris / Corrosion	A build up of debris will may cause the joint to seize up, restricting movement and imposing undesired forces on the bridge structure. The debris will also hold water, and the combined effect of wear caused by the debris and the moisture will lead to corrosion of the components. Corrosion will lead to loss of section of the teeth, thus loss of load capacity, and will also lead to a loss of ductility. These two factors may lead to teeth breaking.

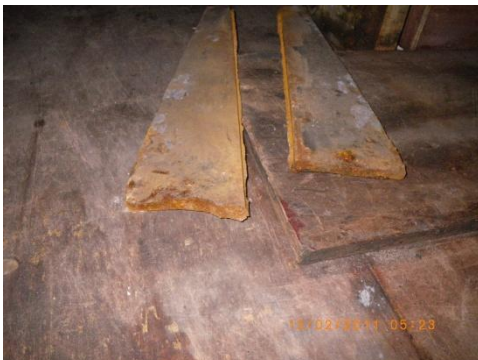
<p>Teeth, broken from the main component.</p>

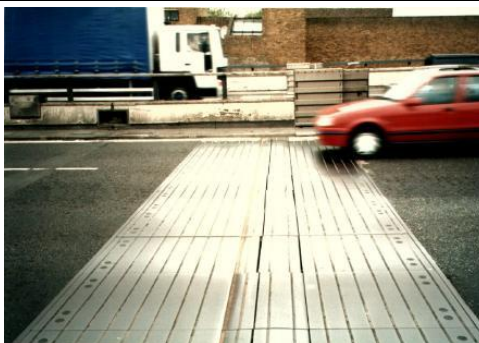
<p>The scale of these joints is demonstrated by the size of the car to the right.</p>

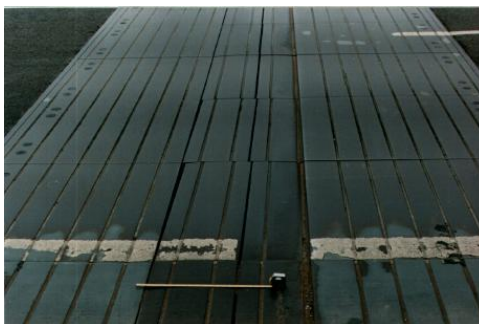
<p>In this photograph, the plates are not well aligned.</p>

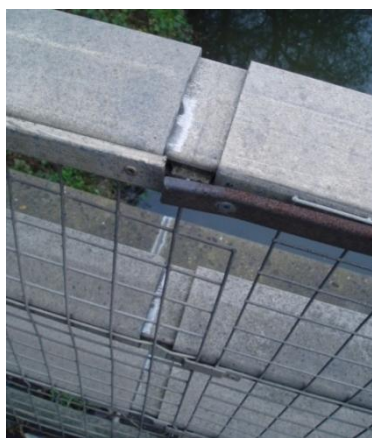
Photo 7.3 Parapet expansion joint

There is clear evidence of movement in this photograph, taken in winter. However, in summer, when the bridge has expanded, this evidence may be hidden.

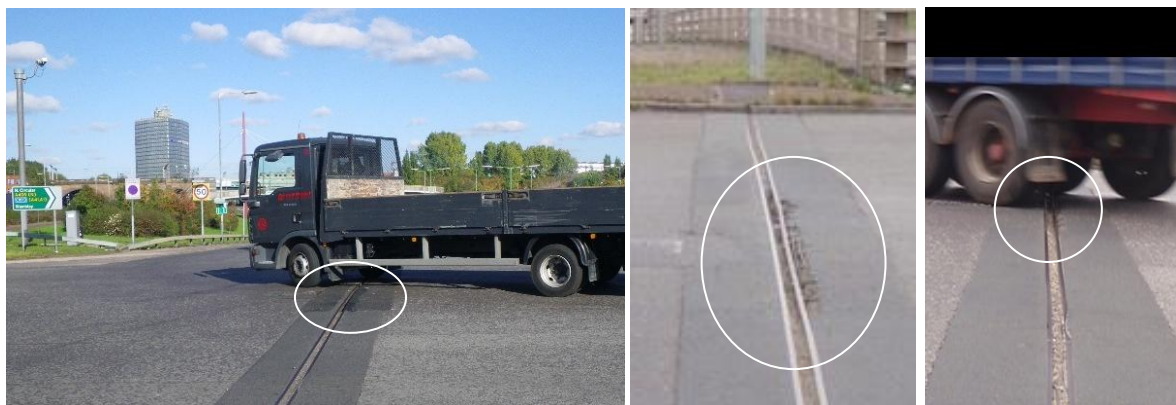
Photo 7.5 Expansion joint at a turning point

This expansion joint is located where vehicles are turning, which generates additional forces as the wheels turn. The central photograph shows the damage that has occurred to the resin, exposing the steel reinforcement beneath. The right hand photograph shows the rear wheel of an articulated lorry, passing directly over the damaged area. The left hand photograph shows the front wheels of a goods vehicle crossing the since repaired area.

This expansion joint, on a bridge over a busy urban dual carriageway, was in a very poor condition at a particular location across the carriageway. It was identified that the defect was where vehicles, often HGVs from a nearby industrial estate, were turning right onto a slip-road, and so the joint was subject to greater than normal forces.

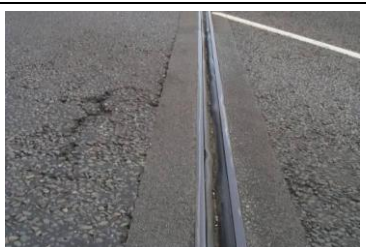
17.3 Deteriorated adjacent road surfacing This defect refers to the condition of the surfacing on either side of the joint. The only exception is where cracking has taken place directly over a buried joint (see defect 10.10). This could include cracks, tracking, pot-holes, depressed or any other defect to the surfacing, that is related to the expansion joint.

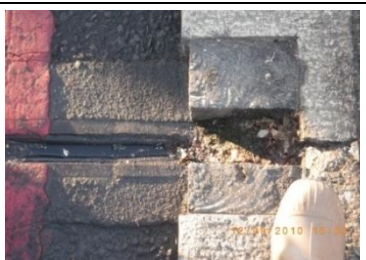
17.4 Loose/damaged fixtures Fixtures should generally be considered as ancillary parts, such as cover plates in the footway.

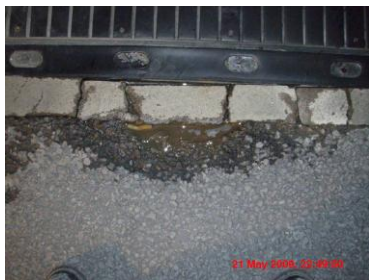
Defects affecting all other joint types (where relevant)	
<p>17.11 Deteriorated nosing This defect refers to the nosing, transition strip or resin strip that provides the surface between the joint itself and the adjacent carriageway surfacing.</p>

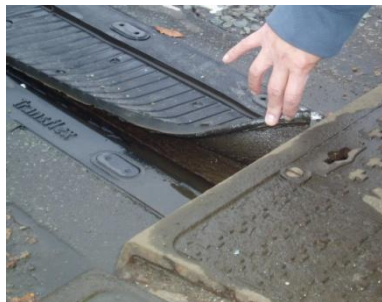
<p>17.14 Defects to components Components should be considered to be the major parts of the joint, such as an elastomeric component, or a rail.</p>

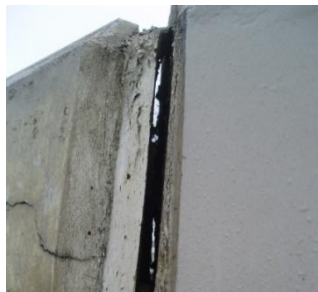
<p>18.1 Movement/Construction joints This new defect category is proposed to distinguish defects to movement joints in retaining walls and parapets from defects to seals in deck expansion joints, so that the condition of these does not influence the condition score of the deck expansion joint.</p>

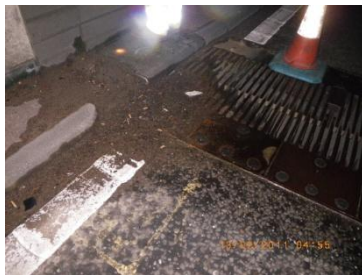
<p>8.x Highway drainage Defects to carriageway drainage should be reported under defect category 8. Wet areas of surfacing should be identified, for example on the higher side of the expansion joint, as indicators that there may be a problem with the drainage system.</p>

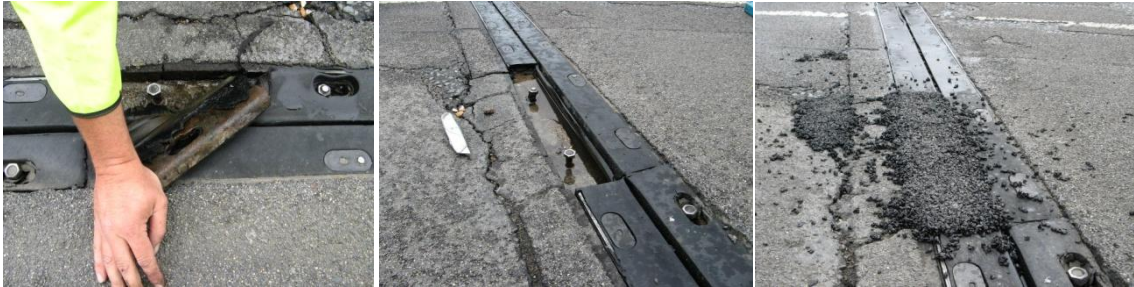
1	Fill holes/patch surfacing repairs
	<p>A quick temporary repair to joints, which ensures a safe running surface for road users and will reduce further joint damage, is to fill with surfacing material. This may be the filling of pot-holes on the joint approaches or the replacement of damaged components with surfacing until a permanent repair can be carried out.</p> <div data-bbox="247 1294 1385 1579">

</div> <p>In this example, the elastomeric component was broken. The affected component was removed and the space filled with surfacing material on a temporary basis.</p> <div data-bbox="247 1675 893 2022">

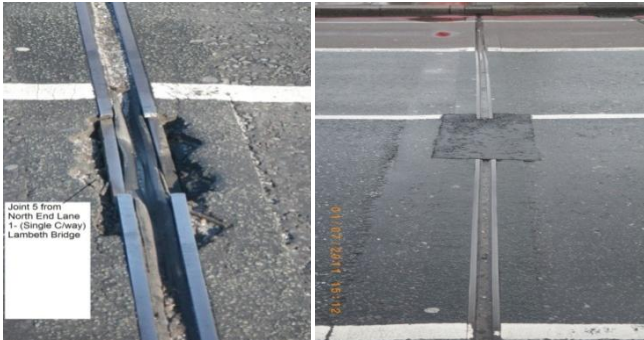
</div> <p>In this second example, the rails on the type 6 joint had fractured. A weld to repair the rails was attempted, but only survived a few days due to the very limited surface area available to the welder. As an alternative, the affected lengths of rails were completely removed, the air gap securely bridged and the space surfaced until full joint replacement.</p>

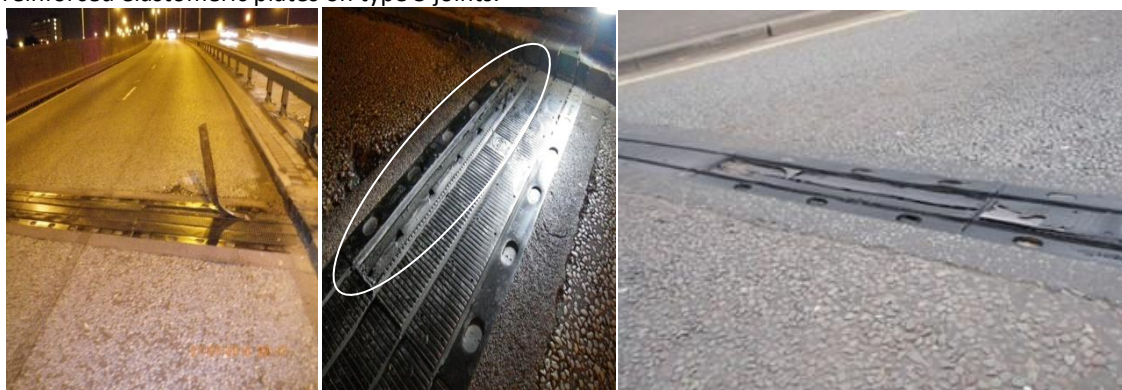
In the example above on the left, the plate was removed and the joint was still intact as there are more plates below the top (see centre). On the right hand side the plate was removed to avoid a failure such as that on the left, and joint replacement was adding to the renewal programme.

Some joints are comprised of modular components that can be fairly easily replaced during a lane closure, for example, type 5 joints are generally off-the-shelf components.

Sometimes, part of a component that has potential to cause a problem can be removed, for example the reinforced elastomeric plates on type 5 joints.

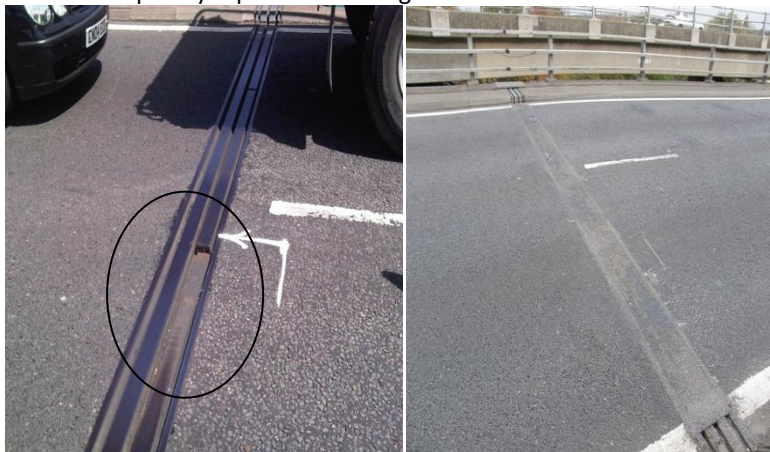
</div> <p>In this example, the rail had broken. In the very short term an emergency patch material was used to correct the level over the expansion joint. Within 24 hours, the rail was welded back in place, but this repair again proved unsuccessful. A more robust solution was to weld a metal plate over the entire joint, with anti-skid surfacing applied to the metal plate to ensure skid-resistance. This solution can only be temporary as it will not survive large temperature ranges. A solution to weld the plate to one side will not be considered acceptable due to the noise generated at the free end.</p> <div data-bbox="245 981 997 1462" data-label="Image">

3	Fix temporary plates, either by welding or bolts
	<p>As highlighted above, welding the rails of a type 6 joint is not effective, but welding plates can be a suitable temporary repair as a much greater surface area is available and so the weld is able to hold.</p> <div data-bbox="245 304 1018 754" data-label="Image">

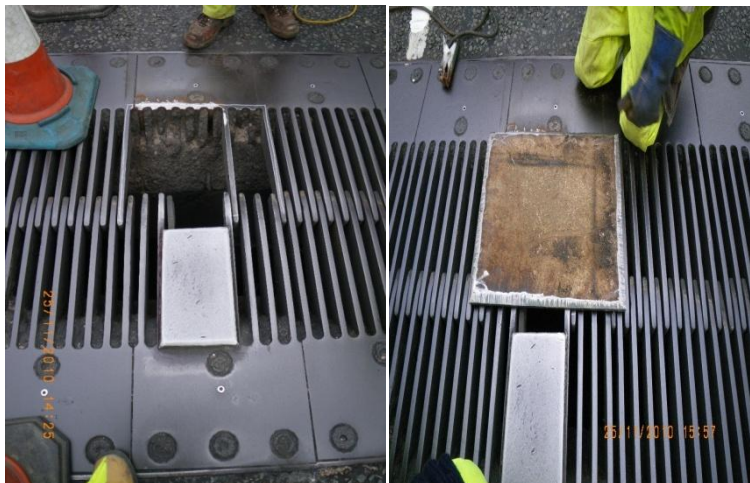
</div> <p>Broken teeth on type 7 joints can be repaired by welding a plate over the gap. Experience has found that the plate should be welded to at least four teeth each side of the gap. By welding to only one or two teeth each side puts excessive pressure on the weld, but also the teeth. This type of repair could last a few months, possibly up to a year. The metal plate edges should be chamfered and a skid-resistant covering should be considered.</p> <p>It has also been suggested that, on a temporary basis, a 15mm steel metal plate could be used to replace a HA type 5 unit, by bolting the plate to the existing fixings on one side of the joint only, and covering to finished level with surfacing material. It has also been recommended that HRA surfacing will provide a longer-lasting finish, although this will remain a short-term fix only, and must be subject to frequent inspection.</p>

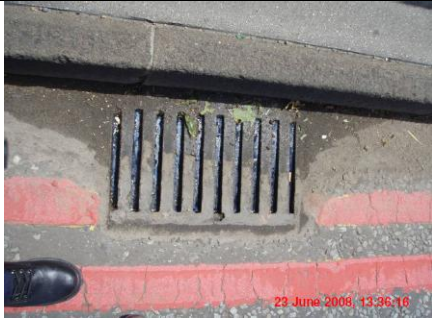
7	Clear drainage

<p>Blocked drainage stops water draining from the carriageway. Instead it will drain through any breaches in the joint seal and possibly lead to early deterioration of the structure, or the water will saturate the surfacing, leading to break up. Clearing the drainage and ensuring the outlets are clear (including the sub-surface drainage outlets) will help reduce the effects of water.</p> <p>Drainage channels on abutment shelves should also be cleared so water does not sit on the abutment shelves, affecting the abutment and bearings.</p>
