# When Competencies Replace Competence

Bill Harvey  
Bill Harvey Associates

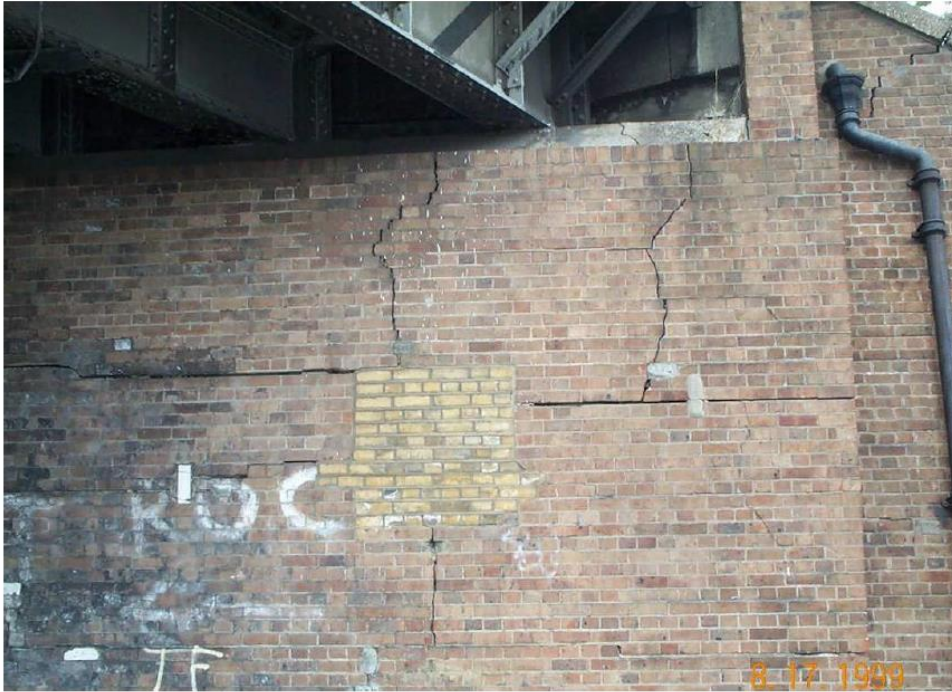
Photograph 2C.33: Abutment with horizontal and vertical cracks wider than 10mm (Severity rating O and L respectively)

Page from NR guide on  
Condition marking.

Is the size of the biggest crack  
The most significant thing here?

The patch has caused the  
damage.

The bearing shelf is tilted.

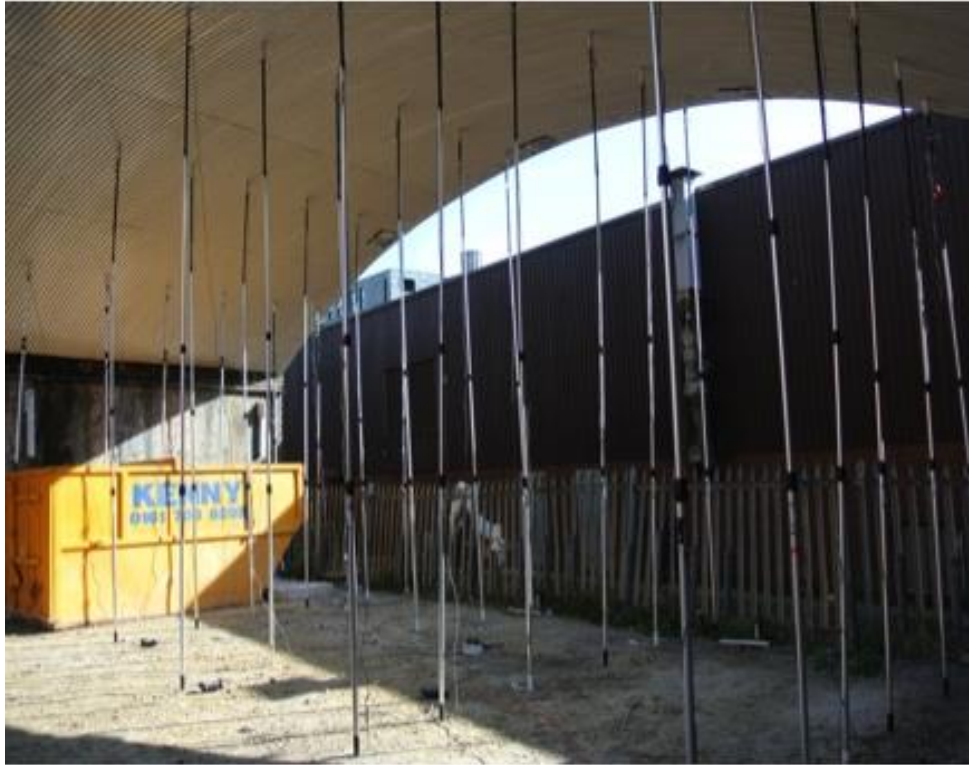
**Deflection poles for dense  
measurement of vertical  
deflection**

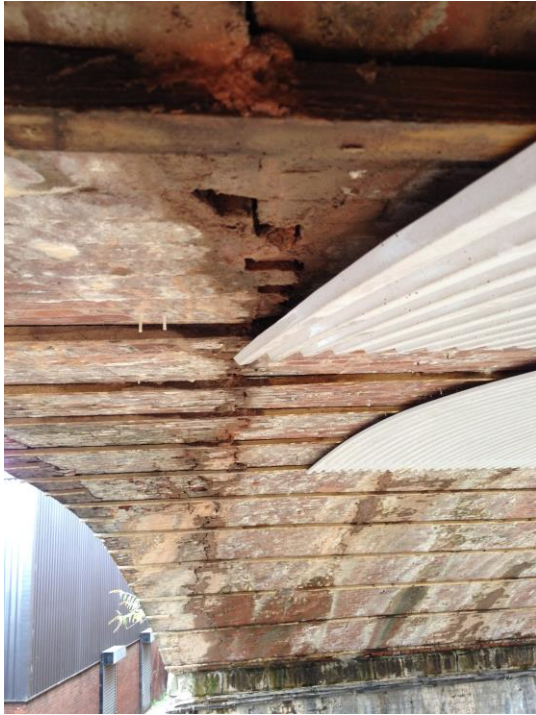
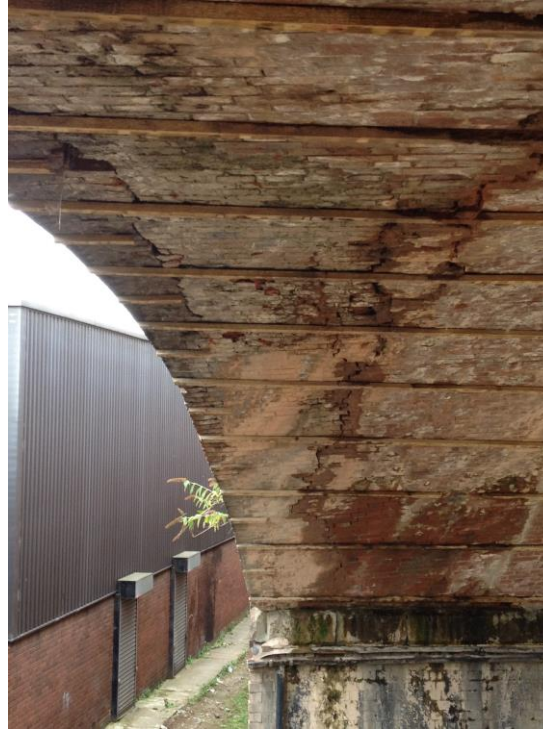
# Cracks were 1mm wide in 2006

Note the lining

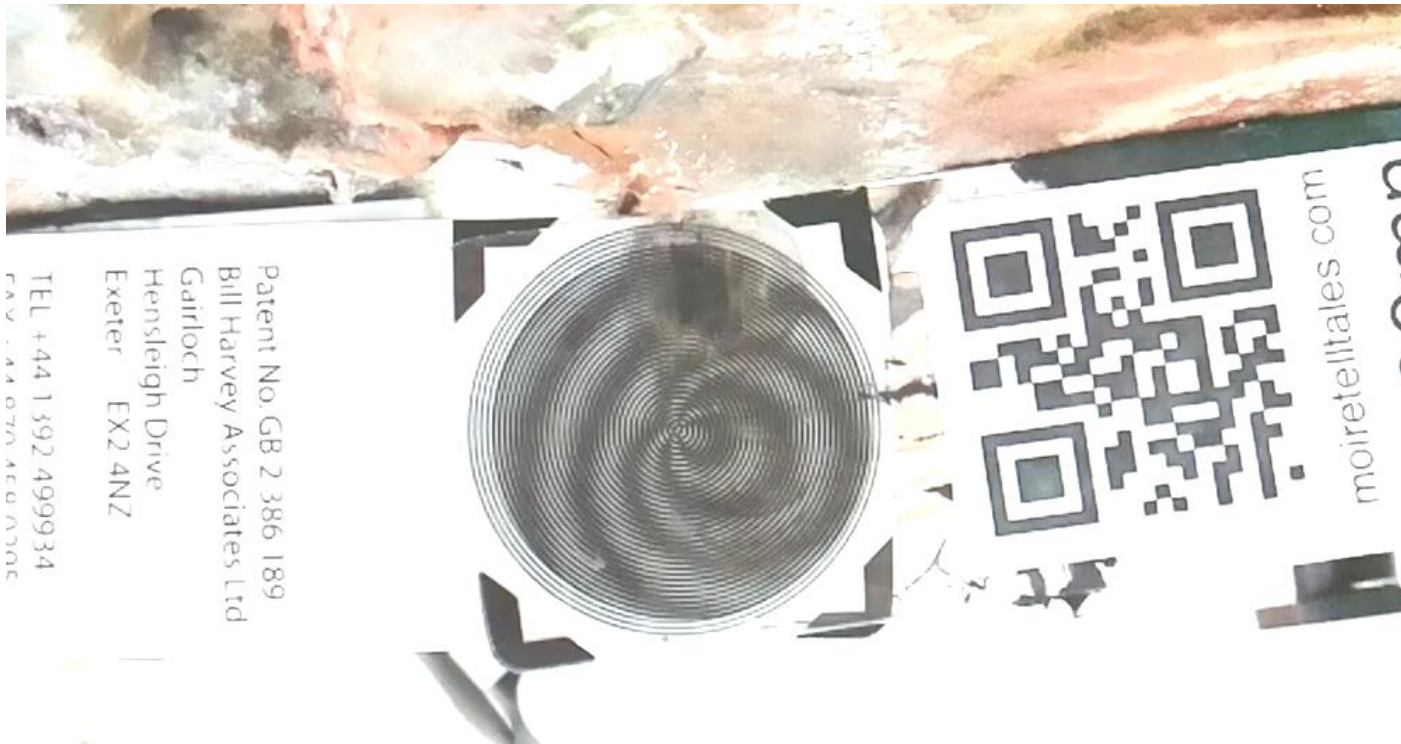
# Moiré Tell-Tale

After the crack  
was stitched

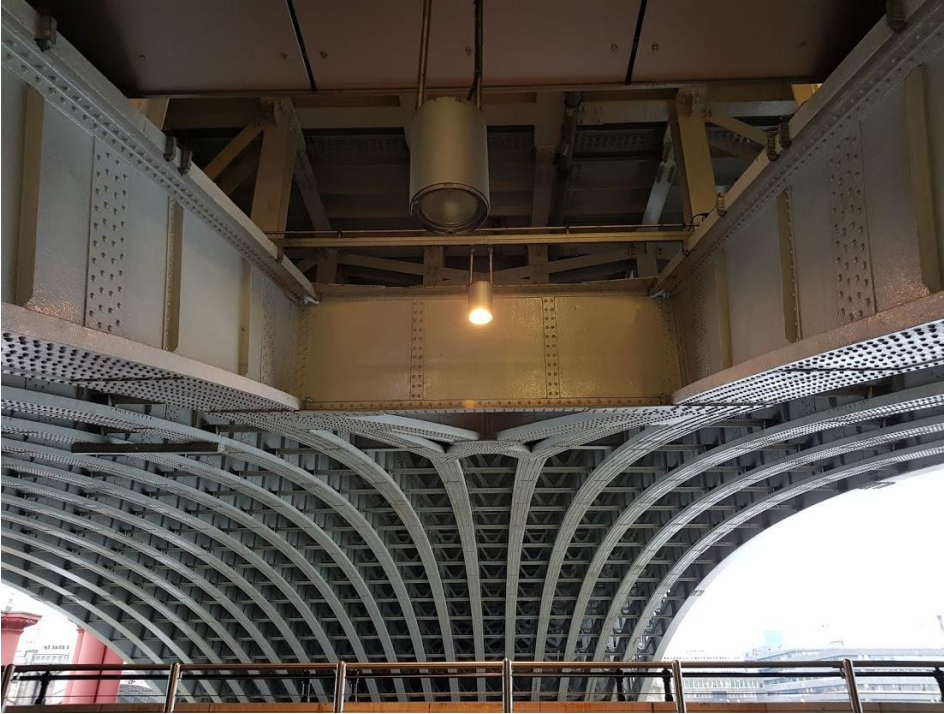
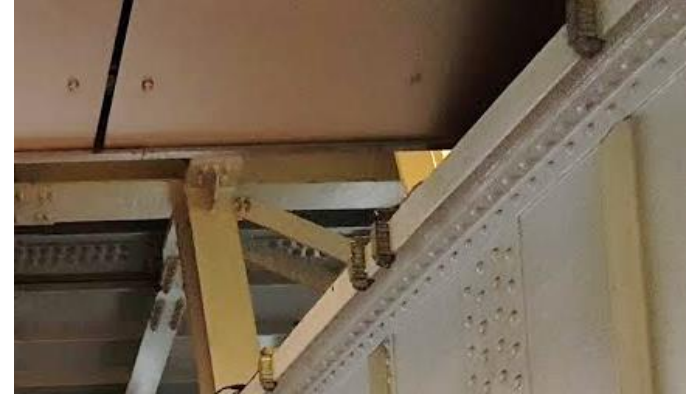
Single strain gauge on angle brace.

Single 50mm strain gauge on bottom of flange.

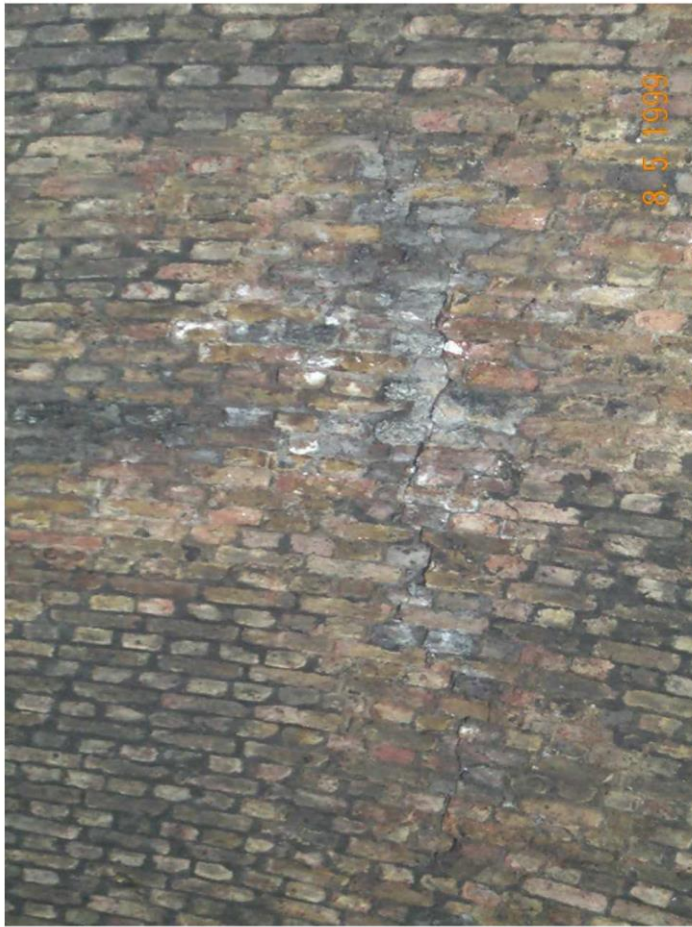
Photograph 2C.31: Longitudinal crack in barrel arch maximum width >5 to 10mm  
(Severity rating K)

# Curved beds, skew bridge

## Where cracked and WHY?

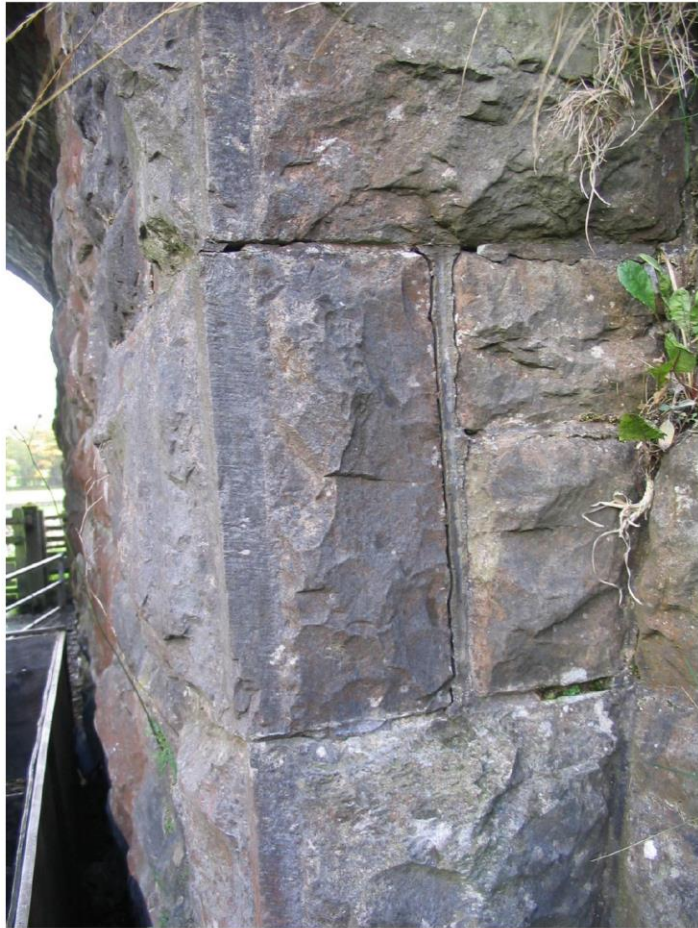
Photograph 2C.29: Example of a stone abutment with a displaced block (Severity rating Ex)

Loose stone OK  
But WHY  
Stone projecting?

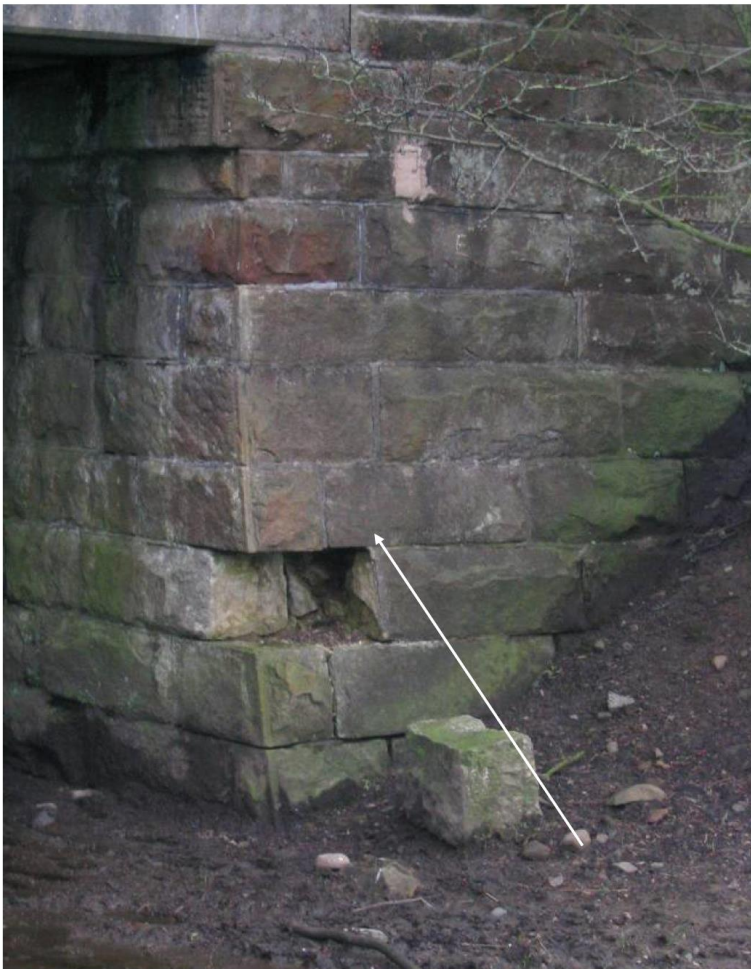
Photograph 2C.27: Example of an abutment with missing stone (Severity rating Ex)

Loose stone OK but  
Curl under?  
Big gap further back?

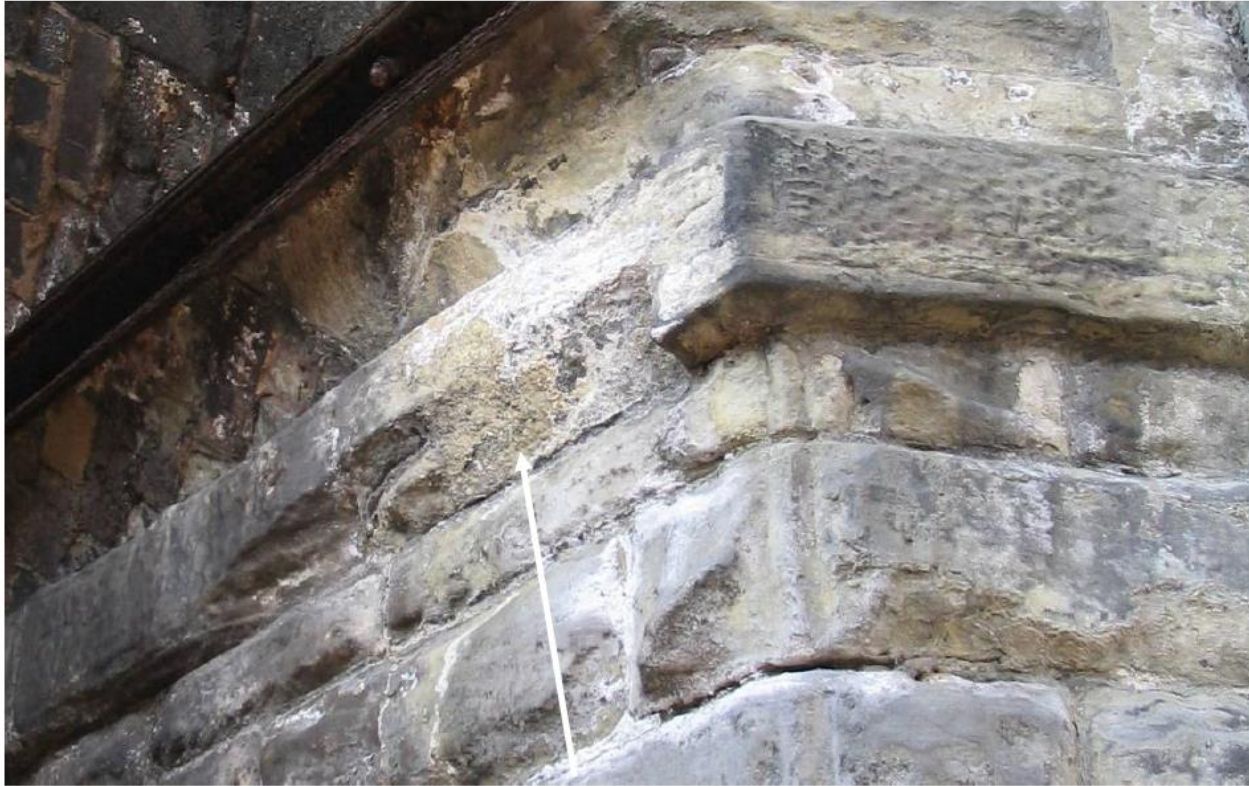
Photograph 2C.22: Example of a stone abutment with pointing profile is flush with the front face of the stonework where the depth of the defect  $\geq 20\text{mm}$  (Severity rating D)

What?

Single stone?

Why broken?

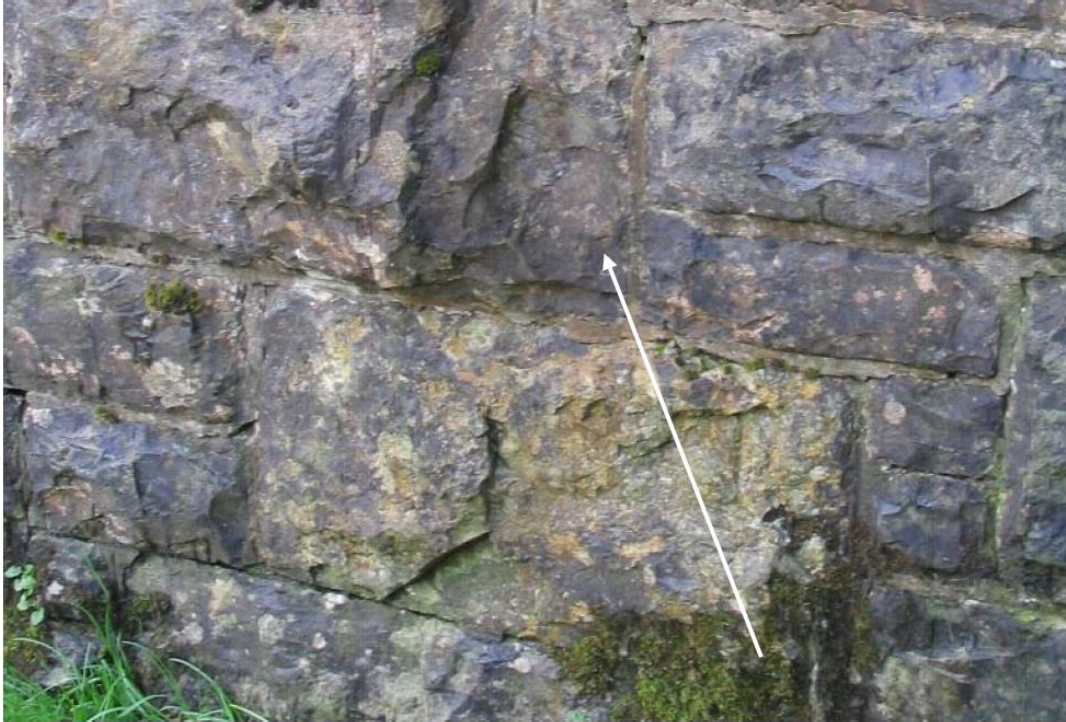
Photograph 2C.24: Example of a stone wing wall where the depth of the defect  $\geq 20\text{mm}$  (Severity rating D)

What?

What is the defect?

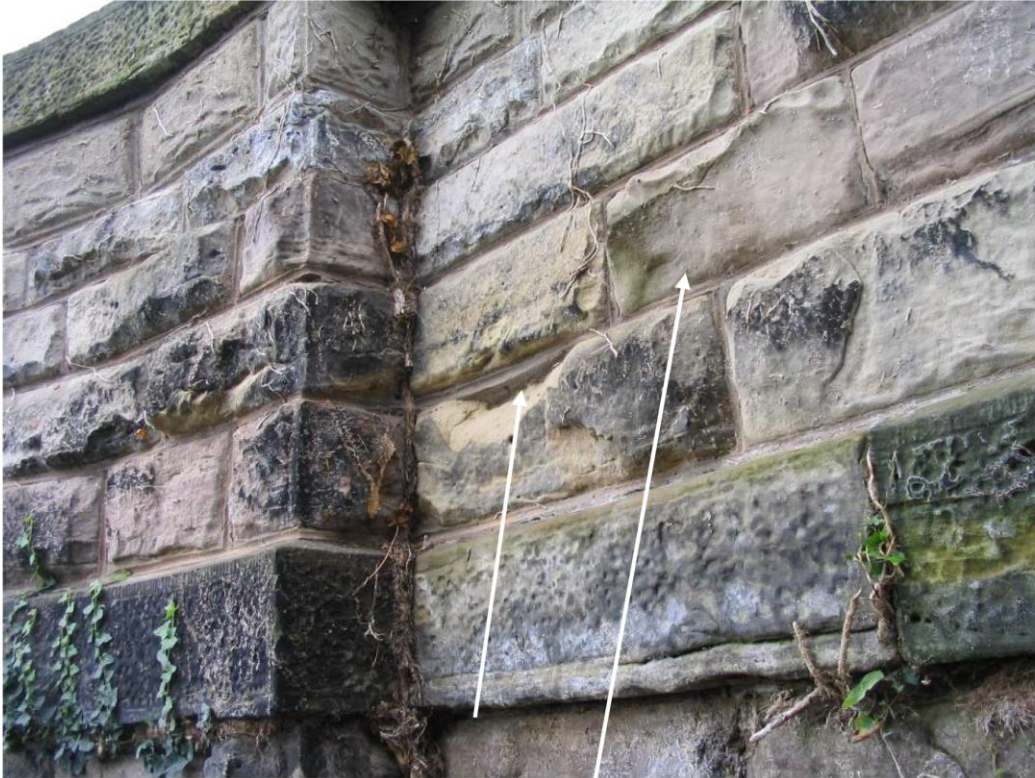
Photograph 2C.19: Example of a stone wing wall where the depth of the defect  $\geq 20\text{mm}$  (Severity rating D)

BUT 2 very  
different forms of  
damage  
Split-stone?

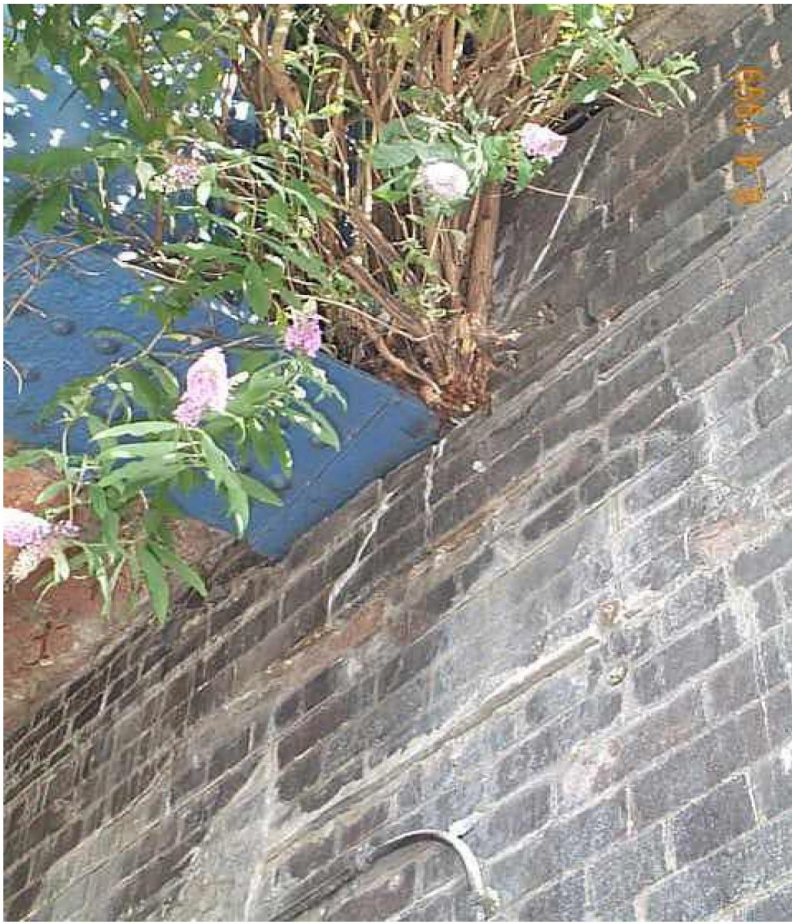
Photograph 2C.17: Bulging with associated cracking to be scored twice, once as severity rating F (bulging) under general masonry and once as severity rating N (horizontal crack, maximum width/displacement 5mm to 10mm) under cracked masonry

And no mention of the  
buddleia causing the  
problem?

Or the severely displaced  
bricks?

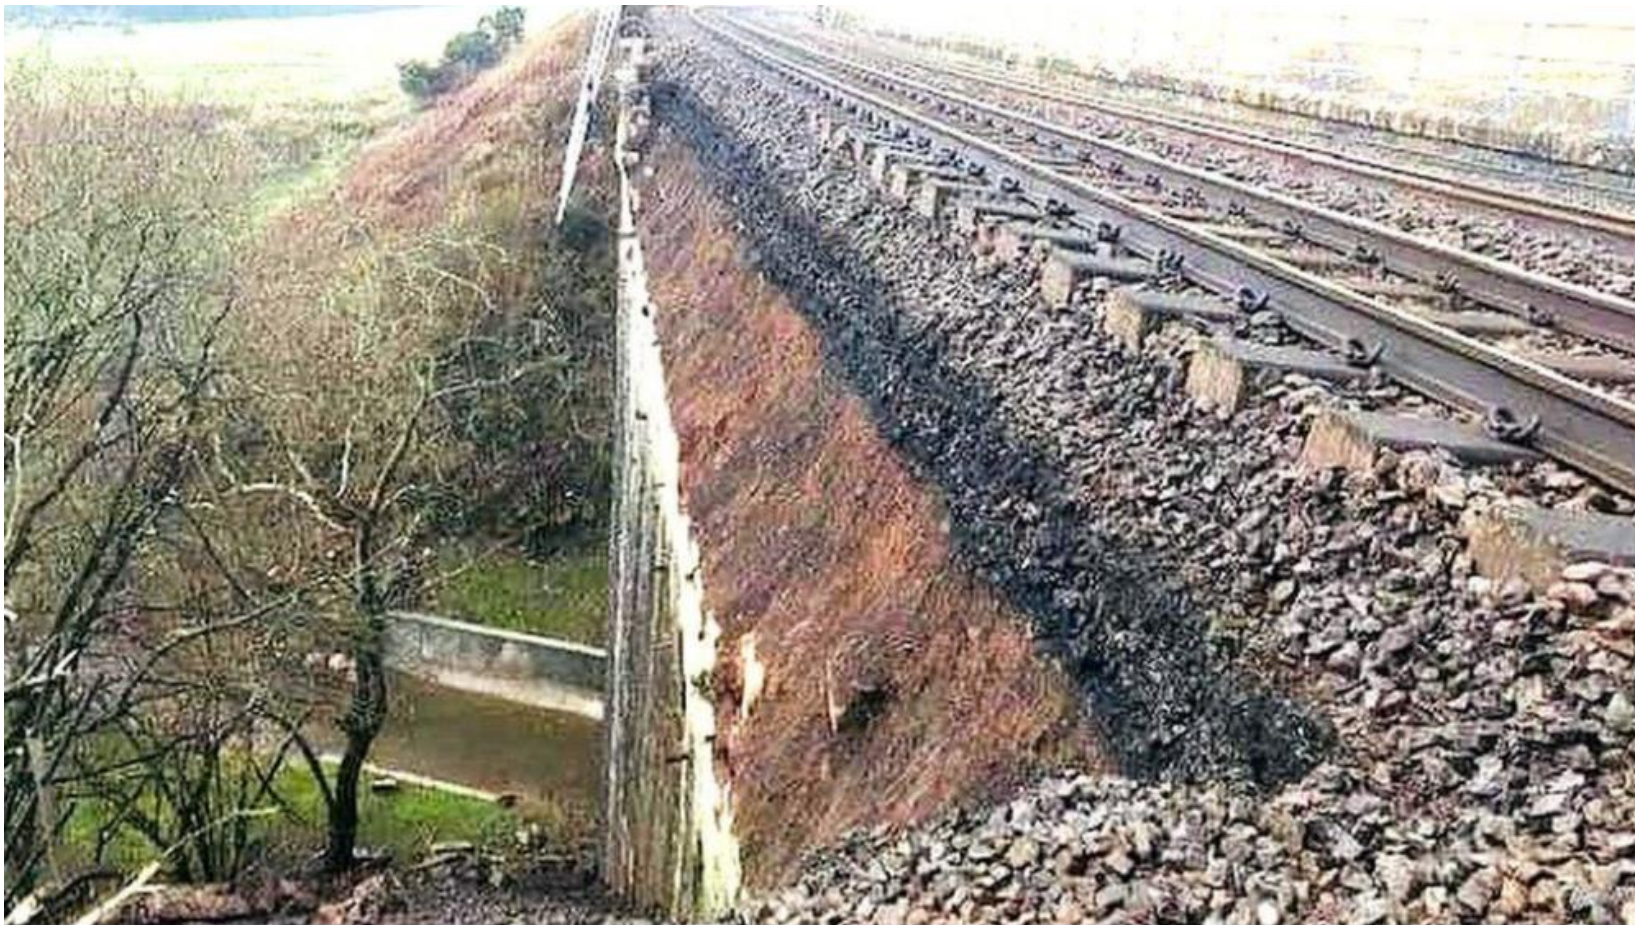
A 24m section of the bridge parapet collapsed
