TECHNICAL AUDIT OF BA79 – THE MANAGEMENT OF SUB-STANDARD STRUCTURES

Final Project Report

Job No: HBR 80616A
Version: Final
Date: December 2003

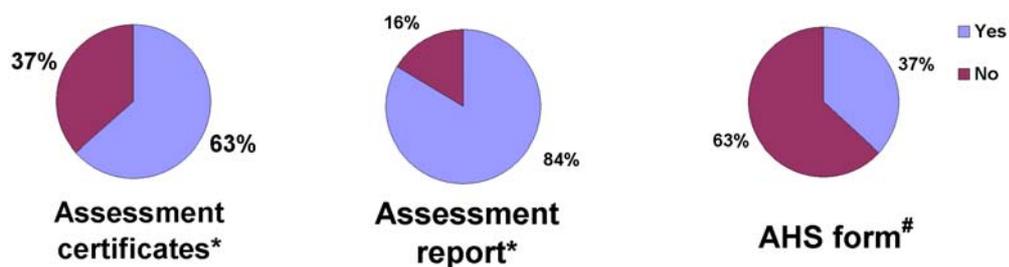
* - based on all structures

- based on motorway and trunk road structures only

Figure 5.1 – Availability of assessment data documentation

One of the primary key pieces of data in the management process is the assessment rating. This information can be found in one of a number of pieces of documentation; namely the assessment report, assessment/check certificates, and in the case of certain bridge owners AHS forms. Figure 5.1 demonstrates the availability of these pieces found during the audits and illustrates that this key data is not always available. In turn this forces the engineer to rely heavily on the contents of the asset database, which as has already been identified may not always be correct.
